July 13, 2022

Mr. Brad Ryan
Municipality of Skagway
PO Box 415
700 Spring Street
Skagway, Alaska 99840

RE: RAILROAD DOCK LANDSLIDE, INITIAL SITE VISIT TRIP REPORT, SKAGWAY,
ALASKA

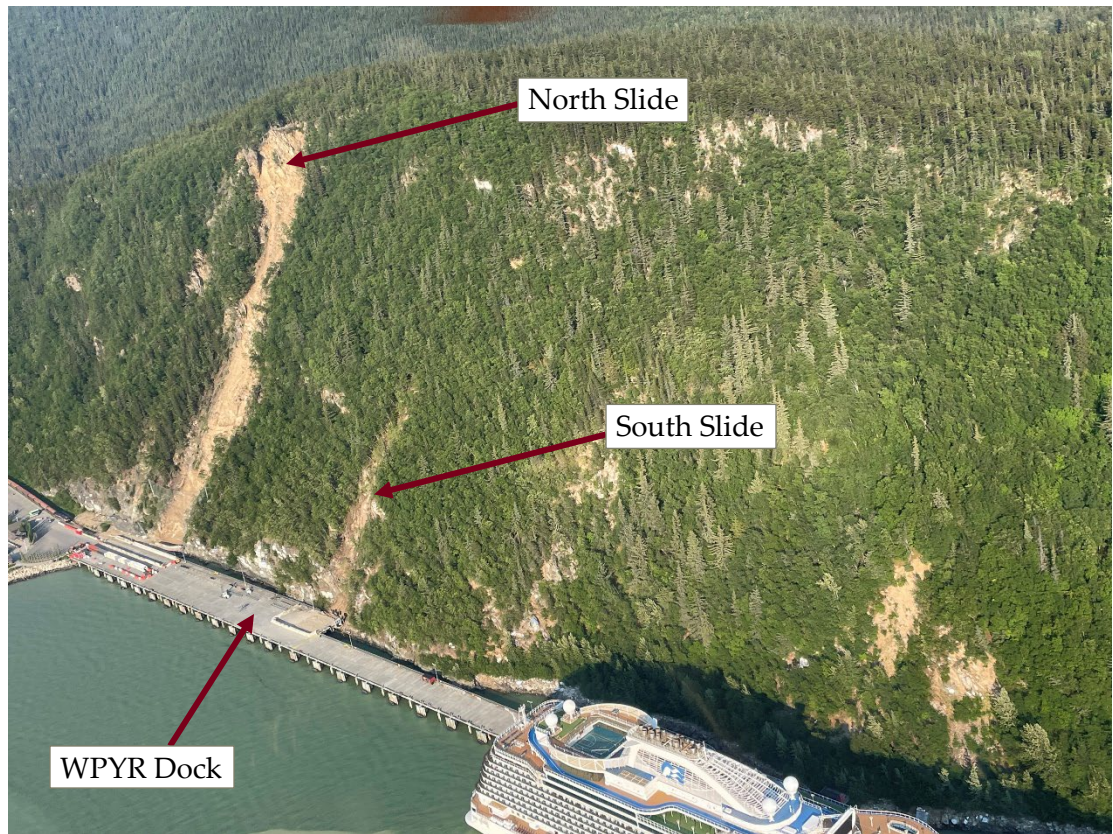
Photo 1: Oblique aerial view of the WPYR Dock and slope to the east of the dock showing site layout, slope, and ground topography/vegetative cover. Note the location of the two slide features referenced below in this letter.

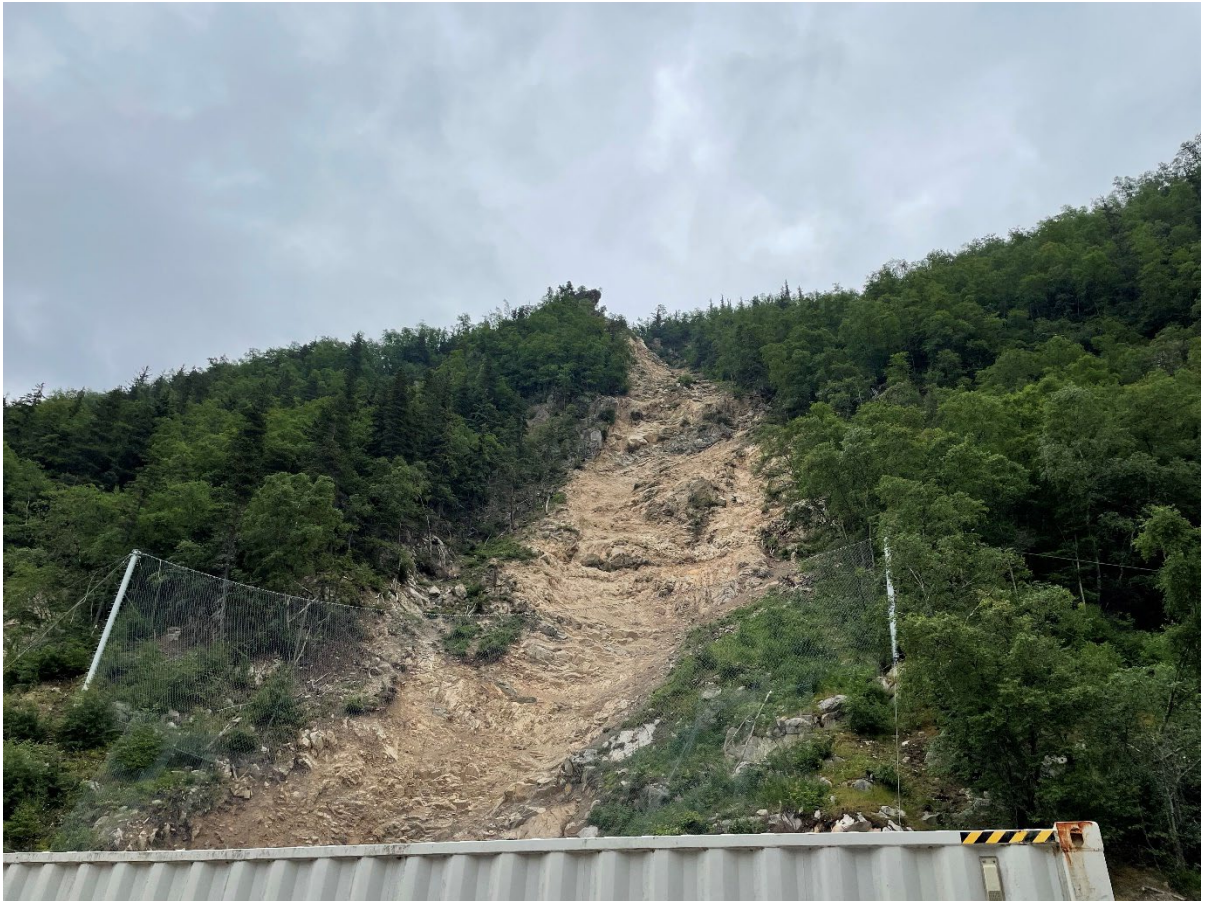
The North Slide is located near the north end of the railroad dock and has been active for at least seven to ten years and currently generates rockfall throughout the year. There have been multiple, significant slide events associated with this feature, the most recent are two slides within two weeks of each other in the fall of 2017. The initiation zone of this slide appears to be a large rock mass near the top of the natural slope with bifurcated rockfall slide paths on the north and south side of the mass. The primary rockfall slide path is to the south of the mass, but both have been treated with attenuators and other catchment remediation in an effort to reduce the risk of rockfall impacting the dock. We understand that this feature receives nearly annual scaling maintenance and debris cleanout coordinated by the WPYR. The WPYR has also installed instrumentation at the top of the slide mass in the form of survey prisms, tilt meters, and extensometers. The instrumentation is automatically logged and collected data can be read and downloaded remotely. We understand that since the fall of 2017 when the instrumentation was installed, the instrumentation has indicated approximately 1.5 inches per year of movement in the slide mass, but that recently the rate of movement has increased to approximately 2.5 inches per year.

Photo 2: View of the North Slide from the YPWR Dock. Rockfall attenuator is shown at the base of the slope and connex box in foreground is the southernmost in a series of connected connexes that are used as covered/protective walkways by pedestrians and users of the dock.

Based on our observations, it appears that this slide feature is a progressive toppling failure with a stair-stepped basal feature. It is difficult to determine how much material is in the slide mass at the top of the slope, but we observed rocks in excess of 20 feet in diameter within the mass. The surface expression of the mass at the top of the slope is at least 130 feet long (parallel to the ridgeline) and 160 feet wide (from the outermost expression of the mass back into the slope to apparently stable material). The toe of the slide mass exposed in the south slide path is at least 80 feet below the top of the slide mass. We believe that the consequences of full failure of this feature could be catastrophic and would cause significant damage to the railroad dock, upland civil works at the base of the slope, and collateral damage to the small boat harbor and other waterfront developments in the Port of Skagway.

Given our onsite observations, reported historic movement of the slide mass, and the apparent increase in movement rates measured by the instrumentation, we believe that there is a significant risk associated with complete failure of this feature. It is our opinion that the slide mass will eventually fail and the consequences of such failure will be catastrophic in nature with significant risks to life and property. The timing of such a failure is difficult to predict but accelerating movement rates suggest that the failure event is approaching.

Based on our observations, the only reasonable option for mitigating the risk of full failure of the north slide is a controlled excavation to re-shape the slope. The amount of debris is too great to control using debris arrestors or rockfall protection, and too much movement has occurred in the slide mass to allow for stabilization with pattern rock anchors or dowels. If it is the desire of the MOS and the railroad to keep the dock and adjacent upland areas open, we recommend installing real-time monitoring tied to an alarm system so that if movement rates exceed a certain threshold, the dock and area below the slope can be

evacuated and closed to access until the risk is removed. In the mean-time, we recommend that mitigation measures consisting of reshaping the slope and controlled excavation of the slide mass be designed and implemented as soon as possible. The excavation would have two major phases. First, the stable rockmass upslope of the existing slide would be removed to prevent progression of this failure mode upslope and to provide a safe bench to perform slide removal. Second, the active rockslide would be removed in lifts until a stable slope configuration is achieved that removes the failure mode. There should be some urgency in developing a solution to this issue because there will come a time when the slide mass movement rates will be too great to perform any mitigation in a controlled and safe manner and limit downslope impacts.

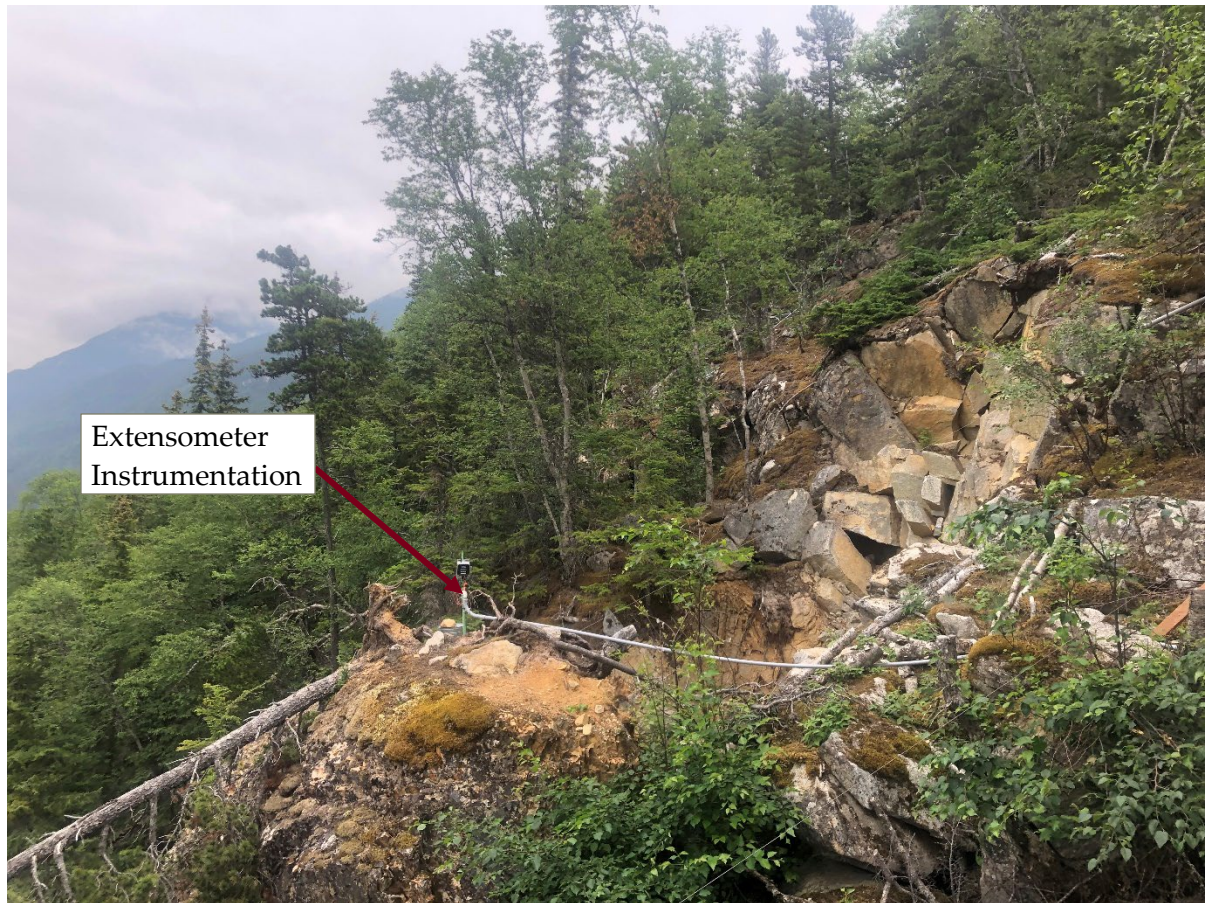
Photo 3: View of the top of the North Slide standing on the slide mass, looking back at the slope, additional slide mass, and head scarp on the ridge. Extensometer instrumentation is visible on the slide mass and significant fracturing and dilated joints are visible and typical of that observed in the slide mass.

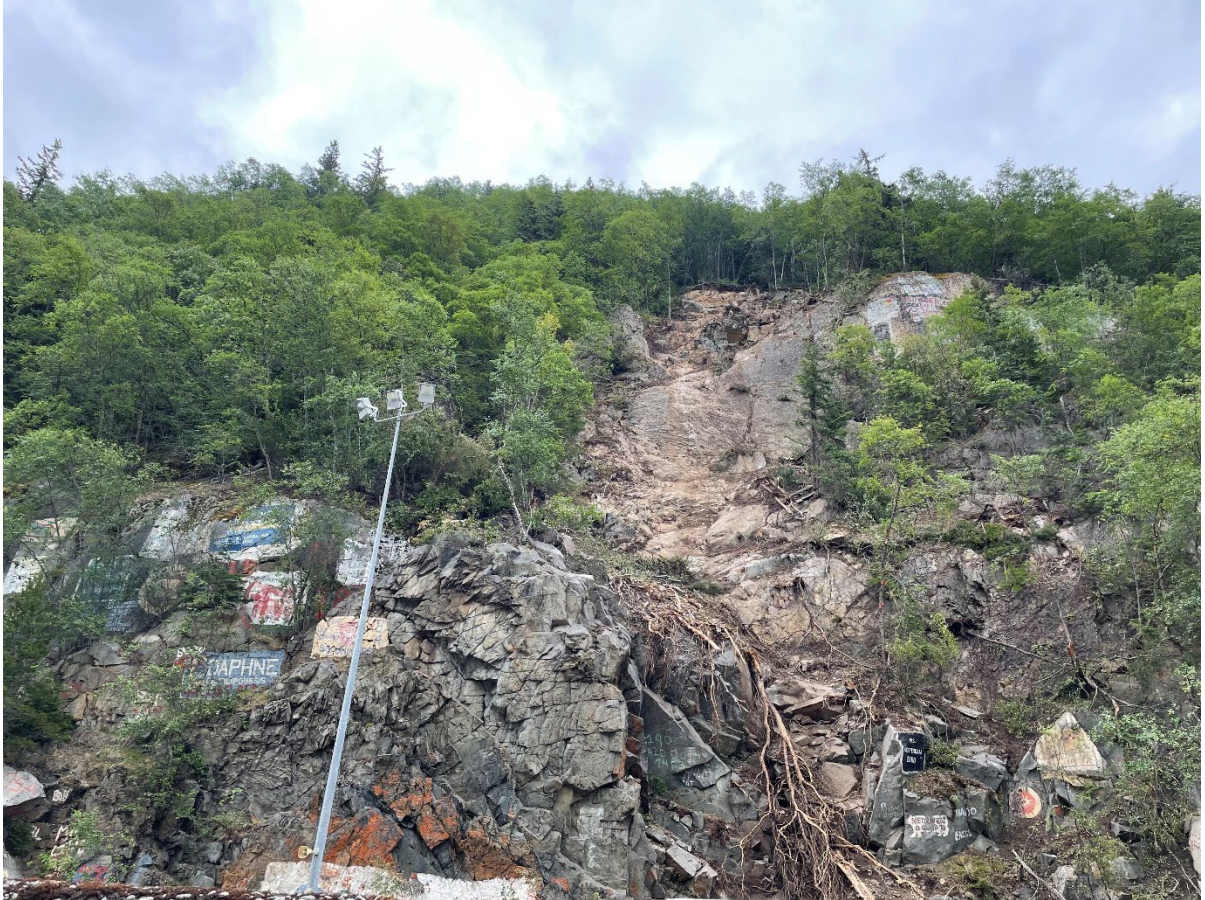
The South Slide is located roughly 600 feet south of the North Slide at the point where the dock transitions from its full approximately 80-foot width on the north end to a narrower approximately 50-foot width to the south. This slide consisted of an isolated failure that initiated approximately midway up the slope. The event released several large rocks estimated to be in excess of 5 to 6 feet in diameter, which landed on the dock surface adjacent to the slope. One of the larger rocks penetrated the dock surface and smaller rocks broke apart upon hitting the dock and shattered, spreading debris across the full width of the dock, some of which impacted a moored cruise ship adjacent to the place of impact. The event occurred at approximately 6:00 AM and no people were within the vicinity of the impacts. While no human injuries resulted from the event, the impact zone on the dock is in

Photo 4: View of the South Slide from the WPYR Dock. Photo was taken after scaling activities.

We did not observe the surface conditions directly on the ground, but according to Tim Blackwood the failure appeared to be caused by toppling of an isolated block with a relatively clean break. According to the railroad, mechanical and hydraulic scaling activities were conducted at the slide area in the week preceding our site visit. The scaling removed an additional 4- to 5-foot-deep block behind at the initiation point and additional rock along the slide path. Tim Blackwood suggested that an additional 10 to 20 cubic yards of material is still on the slope that will eventually need to come down with additional scaling. He estimates that remaining rock on the slope is less than 3 feet in diameter with most material being approximately 18 inches in diameter or smaller.

The toppling failure mechanism that caused this slide is consistent with our rock structure observations on other parts of the slope. Persistent, high angle jointing, which forms overhanging rockmasses, was observed along the crest of the slope, indicating that similar failures are possible along the entirety of the slope where cliff bands are exposed. The presence of this ubiquitous hazard was confirmed by Tim Blackwood during conversations with him on-site. In addition to the toppling failures, lower persistence but ubiquitous discontinuities were observed that form kinematically admissible plane shear failures were observed within the rockmass. These additional structures contribute to the hazard as smaller rock fall events may occur sporadically along the length of the dock and likely are involved in the basal shearing of larger toppling failures. The timing and frequency of similar future events is difficult to predict, but there is little question that similar events could occur in the future along the entire length of the dock with little to no warning.

Based on our observations and the information provided by Tim Blackwood, we believe that the recent south slide is an isolated event and the risk of further, progressive failures from that isolated area is low. However, we believe that the slide highlights an unpredictable rockfall hazard that exists along the entire length of the dock. We recommend that mitigation measures be taken immediately to reduce exposure to these risks in the short term while long-term, permanent rockfall mitigation can be designed and constructed. We recommend that operations on the dock be evaluated to determine how much of the east side of the dock (up against the slope) can be blocked off to allow for a catchment zone and still maintain dock operations. Moving

In addition to limiting access to the east side of the dock, temporary mitigation measures that can be taken immediately include the installation of temporary barriers such as Eco Blocks, rockfall fences, or other similar barriers. The rockfall barriers should protect users from falling rocks as well as rocks that shatter upon impacting the dock surface in the catchment zone. Permanent solutions would include more permanent versions of the temporary measures but should be based on rockfall modelling, taking into account actual slope geometry, various initiation zones, debris sizes, and trajectories. We recommend that the rockfall mitigation be designed to retain a percentage of the modelled rockfall that is consistent with Alaska DOT&PF standards or other recognized standard for protection for similar intermodal/transportation facilities.

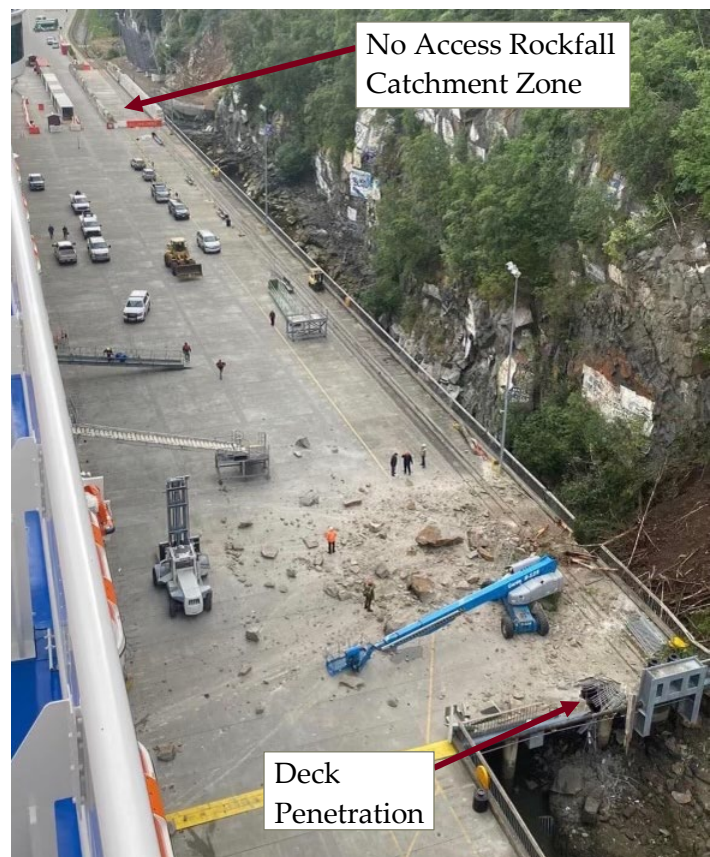
Photo 5: View of South Slide debris immediately after the event.

Note the spread of the debris across the deck and the full penetration of the dock surface. Also note blocked access zone on north end of dock under the North Slide. Photo courtesy Cody Jennings.
