**Municipality of Skagway**

# **West Creek Dike Inspection Report**

**Skagway, Alaska**

December 2022

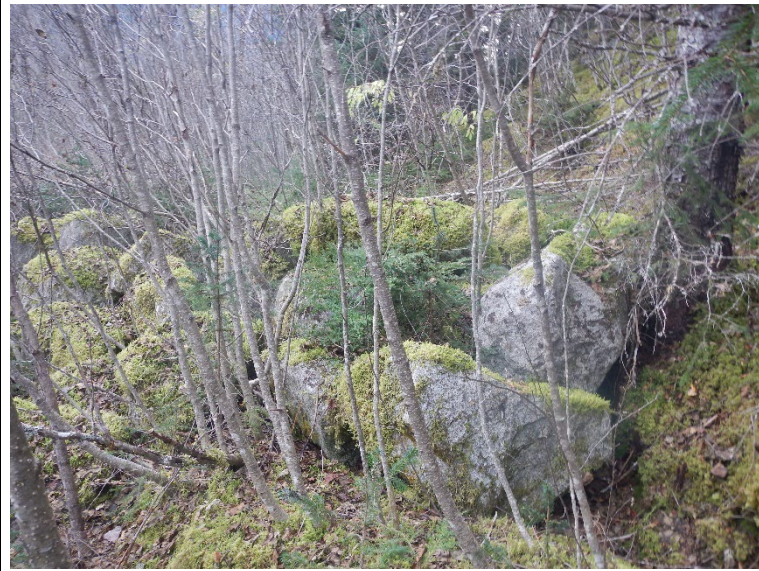
**Photograph No. 1**

View showing where the West Creek Flood Control Dike ties into the bank on the upstream end. (59° 31' 34.3" N, 135° 21' 27.9" W).

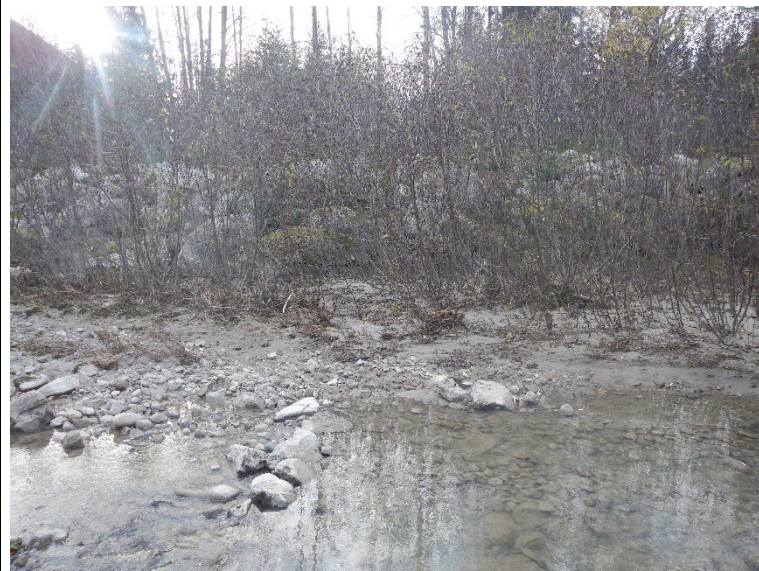
**Photograph No. 2**

Rated Deficiency Category	Rating	Location/Remarks/Photos/Recommendations
Unwanted Vegetation Growth	U	There is generally pervasive vegetation growth over everything, including between stones, generally consisting of alders, with some spruce growth seen on slopes. Vegetation growth is along both the toe of the dike and the top of the embankment. Vegetation is located along the entire length of the dike. <b>Recommendations: Remove small vegetation and brush. Cut all large vegetation as close to the base of the trunks as possible and remove from site.</b>
Sod Cover	N/A	N/A
Encroachments	A	No deficiencies noted
Closure Structures	N/A	N/A
Slope Stability	M	No sign of undercutting visible, although recent flooding may have eroded natural material along hidden toe. Undermining may be a risk if there is no riprap where it cannot be seen continuing below the water in the main channel where it abuts the slope. Large (~5') toe rocks keep the slope in place, however not all rocks are fully keyed into the rock mass, with some rocking/shifting seen mid slope. <b>Recommendations: Regrade portions that are steeper than 1.5:1, re-using existing riprap and supplementing with new materials as required. Install new sections at 2:1.</b>

View looking south towards the Flood Control Dike showing typical Unwanted Vegetation Growth on the water's side of the dike and along slope.

1. Implement a brush-clearing program to provide initial and periodic maintenance clearing. Trees and brush should not be allowed to grow back to the same level that was observed during this inspection. A 15-foot vegetation-free zone, measured in either direction from the riverside toes and landside shoulders, should be maintained where practical in order to preserve a 3-foot root-free zone, or at least prevent the further growth of root systems already established.

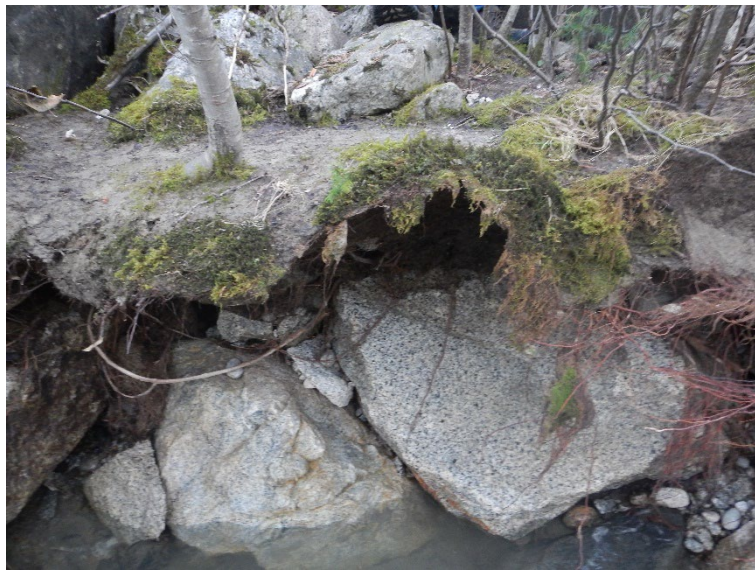
**Photograph No. 3**

The dike was found to be in fairly good condition, with the predominant deficiency found along almost the entire length being Unwanted Vegetation Growth. A gap in levee coverage of approximately 20-30 feet was observed about midway along the levee (59° 31' 35.6" N, 135° 21' 13.1" W). The gap in coverage does not currently pose a risk to the structure, however should be monitored, and MOS should consider installing this portion of levee to tie the two segments together into a continuous system. Some gradual Erosion/Bank Caving was noted at this gap, with one large tree being undermined and close to falling into the river. Adding riprap protection here to tie the two segments into one will protect against potential future erosion, outflanking of the downstream revetment segment, and flooding onto the road.

Erosion/Bank Caving	A, M	Where the levee exists, there is minimal to no erosion or bank caving and the condition is Acceptable. There is a short break in slope coverage between two segments. Some toe erosion is apparent between the downstream end of one levee and upstream end of the next. This is an approximately twenty to thirty-foot-long break. (59° 31' 35.6" N, 135° 21' 13.1" W). In this section, erosion and bank caving is evident but constrained by the levees on either side, so the condition is Minimally Acceptable. <b>Recommendations: Close gap in levee coverage and re-grade adjacent existing sections to tie all in together, creating a consistent, continuous mass.</b>
Settlement	A	No deficiencies noted; settlement was not observed.
Depressions/Rutting	A	No deficiencies noted; depression/rutting was not observed. No scattered, shallow ruts, pot holes, or other depressions were observed on the dike.

View showing toe Erosion, at the upstream end of the 20-30 foot break between levees located at approx.  $59^{\circ} 31' 35.6''$  N,  $135^{\circ} 21' 13.1''$  W

3. Install a new section of levee along the 20-30-foot-long location where there currently isn't any erosion protection, keying this new segment into the segments upstream and downstream. The existing conditions leave this area exposed to additional erosion, as well as expose the upstream end of the lower dike segment to potential outflanking which could quickly undermine and destroy large segments of the levee wall under extreme flood conditions.

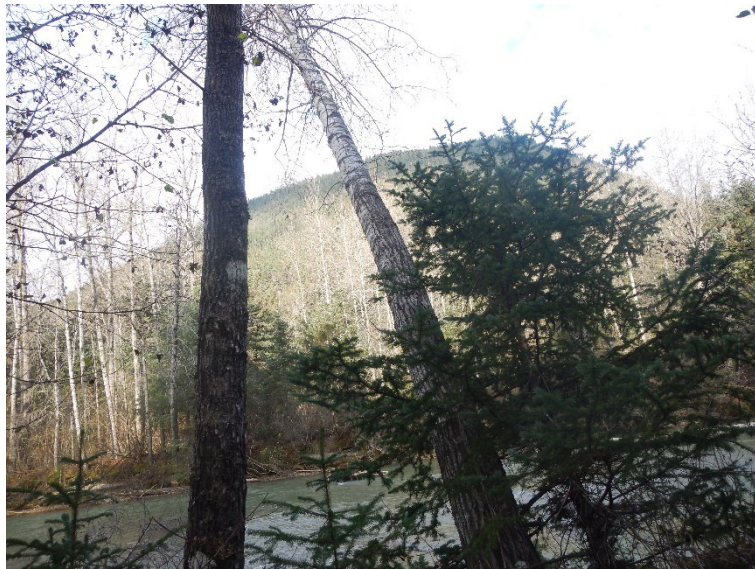
**Photograph No. 4**

View showing a tree that was observed which looks close to falling due to Bank Caving at ( $59^{\circ} 31' 39.1''$  N,  $135^{\circ} 21' 3.0''$  W).

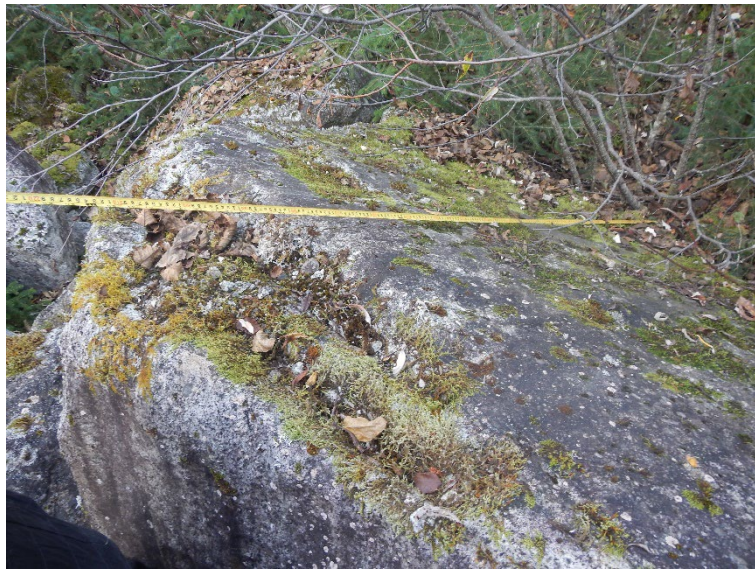
**Photograph No. 5**

View showing the first of two large toe berm rocks that were measured, measuring approximately  $7' \times 8' \times 3'$ . ( $59^{\circ} 31' 33.6''$  N,  $135^{\circ} 21' 24.1''$  W).

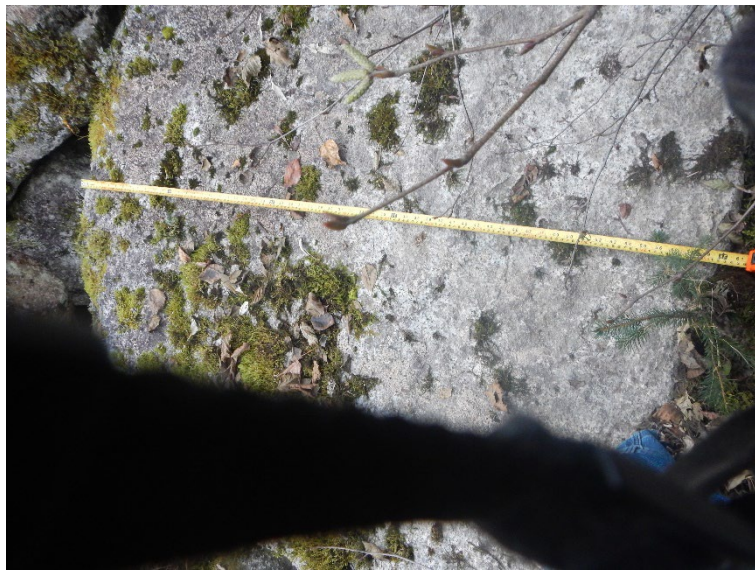
**Photograph No. 6**

View showing the second of two large toe berm rocks measured, measuring approximately 5' x 5' x 2'. (59° 31' 34.1" N, 135° 21' 23.2" W).

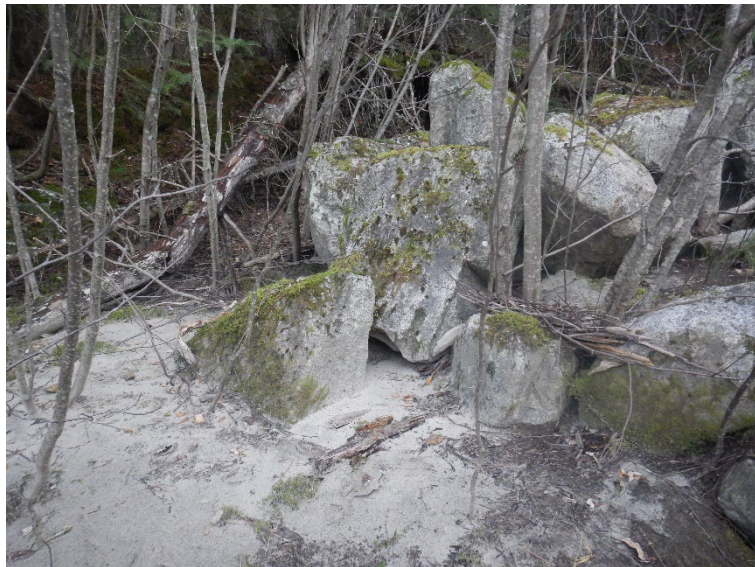
**Photograph No. 7**

View showing where the embankment ties back into the bank for approximately 650 ft, upstream side (59° 31' 35.9" N, 135° 21' 10.9" W).

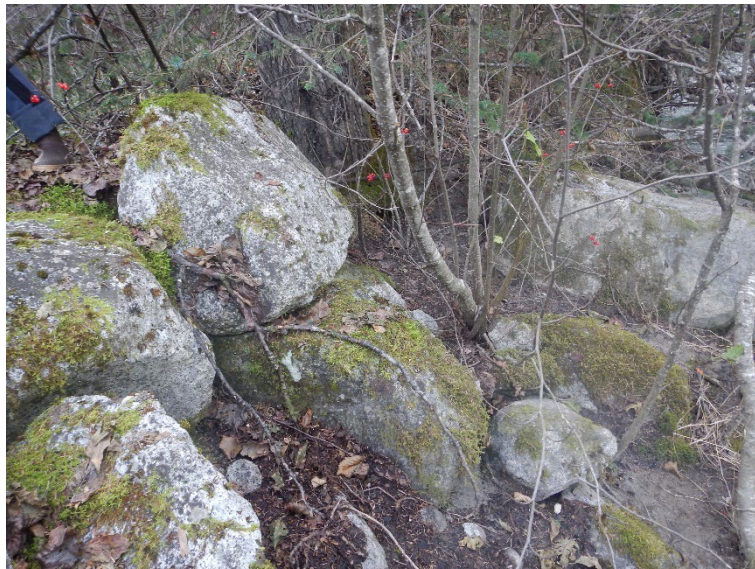
**Photograph No. 8**

View showing where the embankment ties back into the bank for approximately 650 ft, downstream side (59° 31' 40.5" N, 135° 21' 1.5" W).

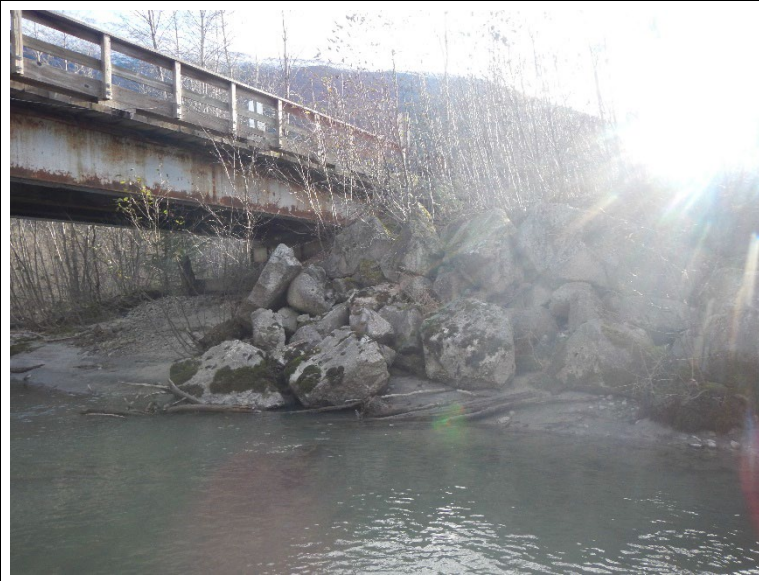
**Photograph No. 9**

View looking south towards the Flood Control Dike showing where the embankment ends at West Creek bridge. (59° 31' 42.9" N, 135° 20'55.8" W).
