MUNICIPALITY OF SKAGWAY

MAIN STREET

CONDITION ASSESSMENT REPORT

Project Number I1014.22003

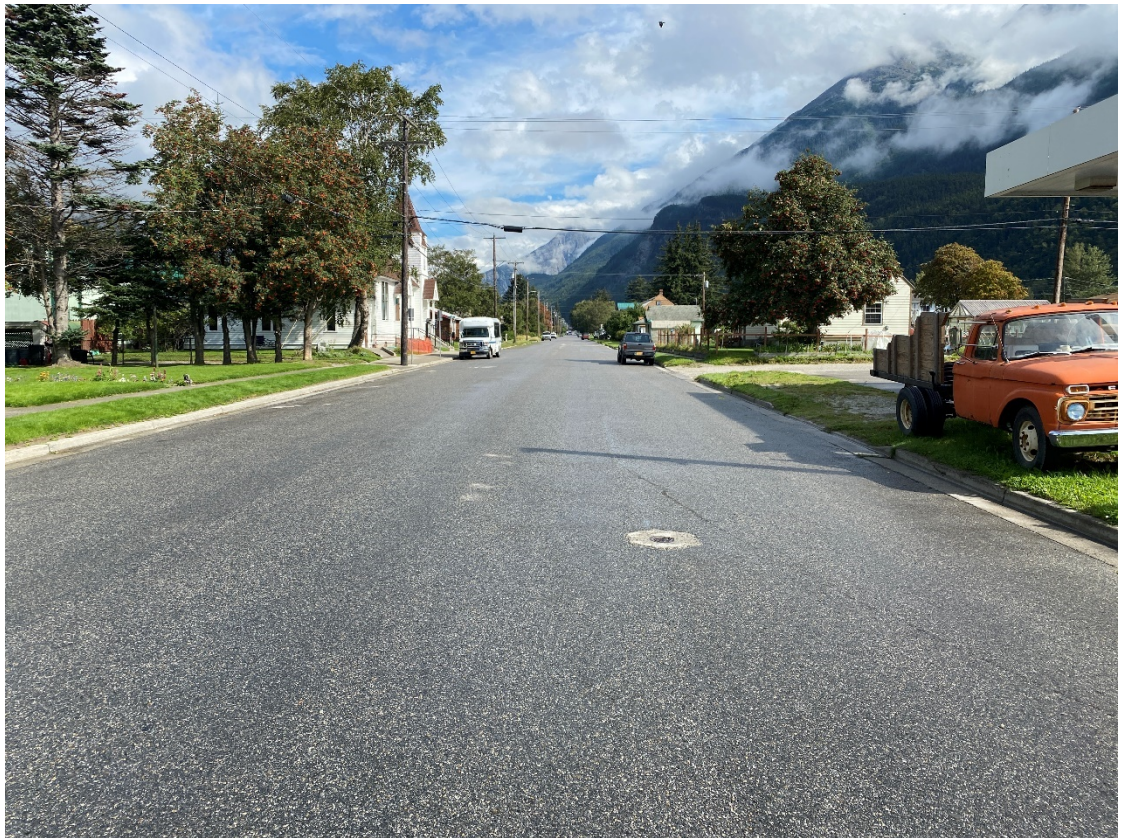
Figure 1. Main Street looking north from 4th Avenue

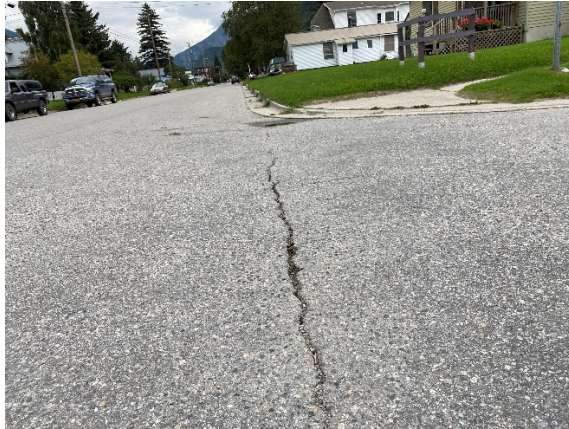
Photo 1 Example of a pavement joint failure

Most of the roadway sections fall into the poor condition category or below and will continue to deteriorate at a rapid pace. The asphalt pavement is failing from alligating, stress cracks, settlement, potholes and longitudinal joint failure. It is recommended that the Main Street roadway be completely rebuilt from 1st avenue to 23rd avenue including a new subbase Grading A section of 2.5’ in depth with a subgrade reinforcing geotextile fabric, new 6” depth of base course grading D-1 and 3” depth of asphalt pavement. See Appendix B for Main Street typical sections.

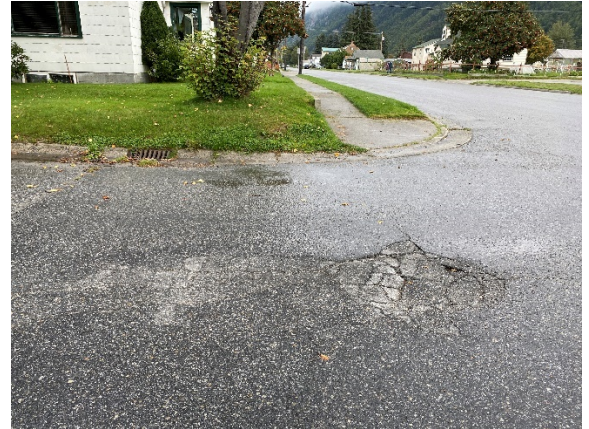
Photo 2 Example of alligator cracking

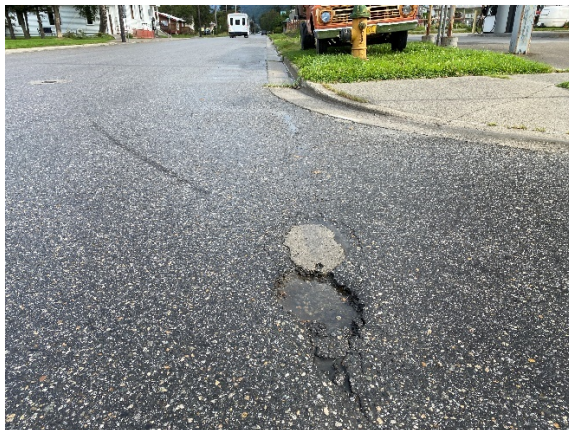
Photo 3 Example of a pothole

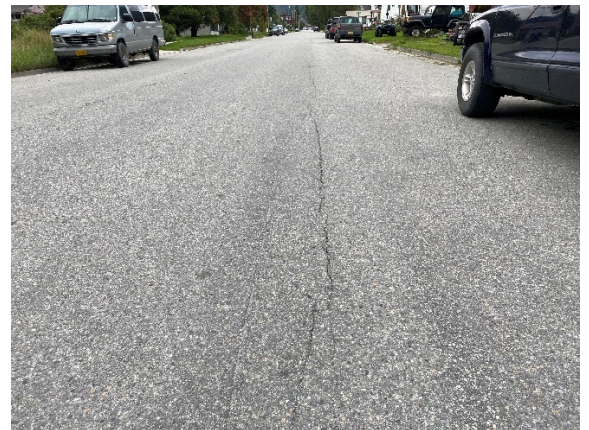
Photo 4 Example of longitudinal cracking

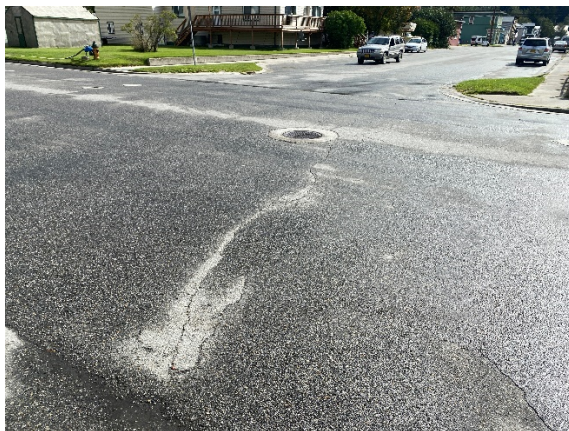
Photo 5 Example of transverse cracking

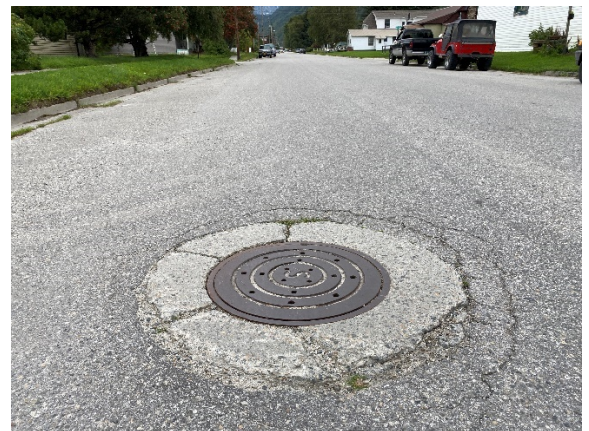
Photo 6 Example of cracked concrete collar around storm drain manhole and surrounding alligator cracking

Nearly every single CMP storm pipe inspected was found to have corrosion along the invert of the pipe. This condition is conducive to the transportation of fine aggregate from the surrounding soil, compromising the integrity of the roadway. As such the entire storm sewer system should be replaced with new corrugated plastic piping (CPP). CPP will enhance storm water hydraulic capacity and provide for a longer service life. Many of the storm structures were completely missing steps, creating a hazard for maintenance. All the storm sewer and sanitary sewer manhole lids were not sealed and showed evidence of leaking at the lid and/or the lid risers, allowing water and oils from the roadway to enter the system. Nearly every storm sewer manhole access frame is positioned above the finished grade of the road creating a challenge for snow removal that damages both the Municipality's equipment and the individual structures. Due to structural damage observed in many of the storm sewer manholes it is recommended that all of the storm sewer manholes be replaced with new frame and grates installed below the finished grade of the road.

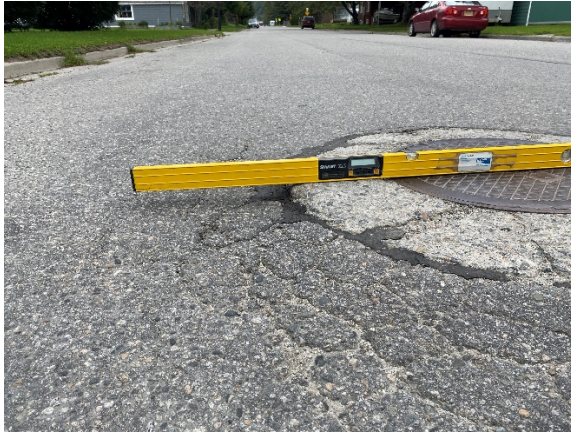
Photo 7 Example of manhole lid above grade

It is recommended that all the sewer manhole lids and risers be replaced along Main Street to properly seal the systems from water infiltration. The existing sanitary sewer system structures were found to be without issues other than the frames and risers leaking and the frames being above the roadway grade. Nearly every sanitary sewer manhole access frame is positioned above the finished grade of the road creating a challenge for snow removal that damages both the Municipality's equipment and the individual structures. It is also recommended that the existing sewer manhole structures have the manhole structure joints waterproofed with a exterior water proofing system.

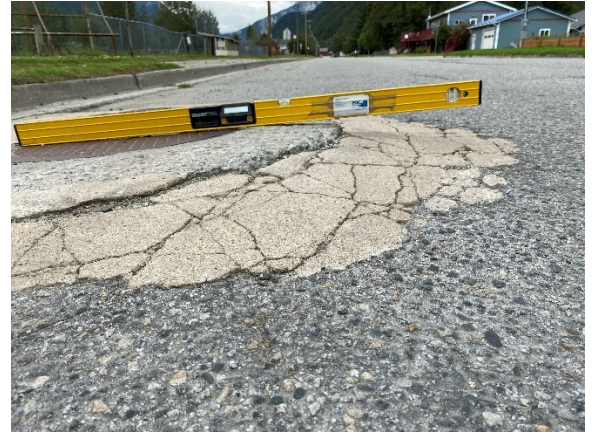
Photo 8 Example of manhole lid above grade

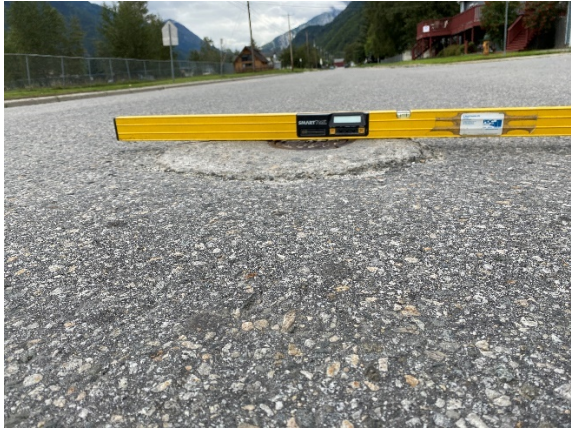
Photo 9 Example of water valve box above grade

It is recommended that the existing 8" ductile iron drinking water system be replaced with a 10" HDPE water line with accompanying new 10" gate valves and fire hydrants. New hydrants would be placed with asphalt pads and bollards for ease of access for the MOS Fire Department.

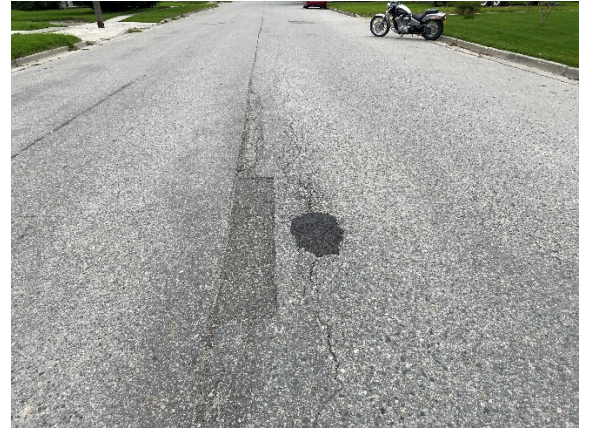
Photo 10 Example of longitudinal cracking and patch work

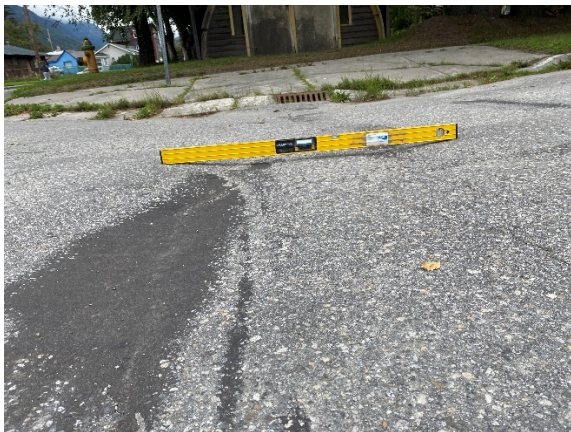
Photo 11 Example of distortion.

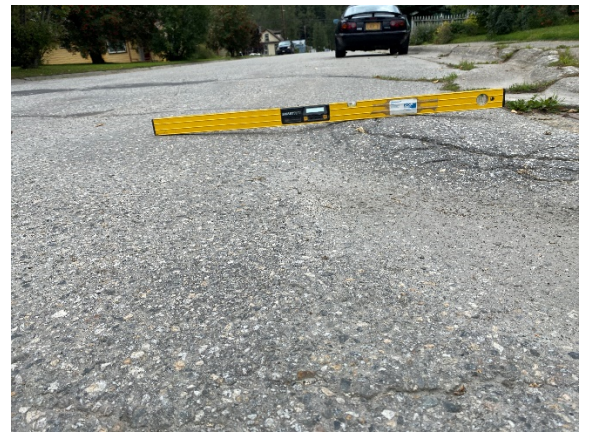
Photo 12 Example of heaving.

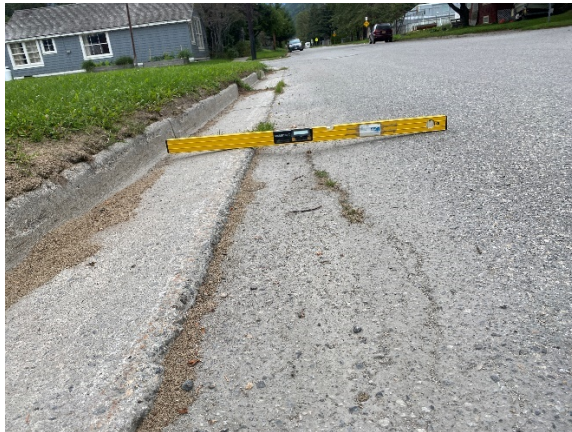
Photo 13 Example of rutting

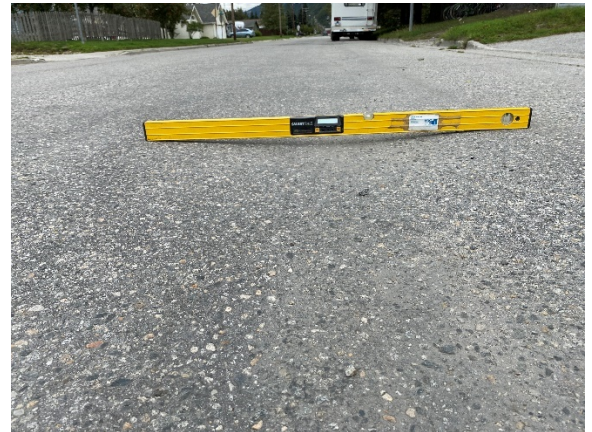
Photo 14 Example of rutting

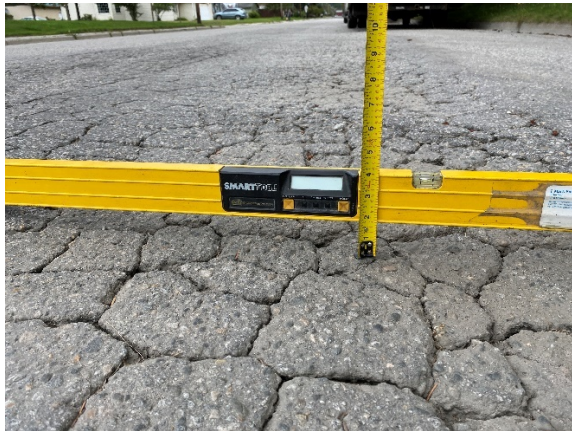
Photo 15 Example of rutting and alligator cracking

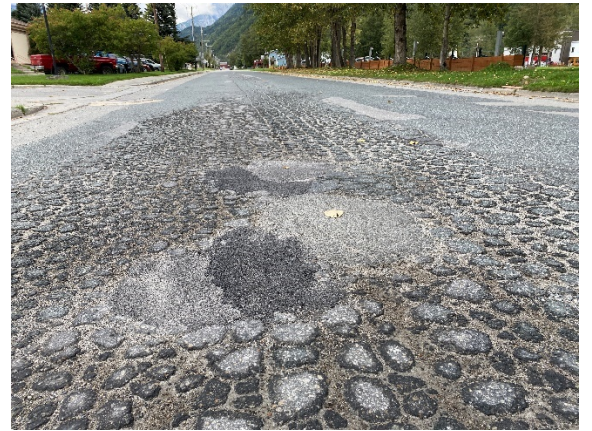
Photo 16 Example of severe alligator cracking and patch work

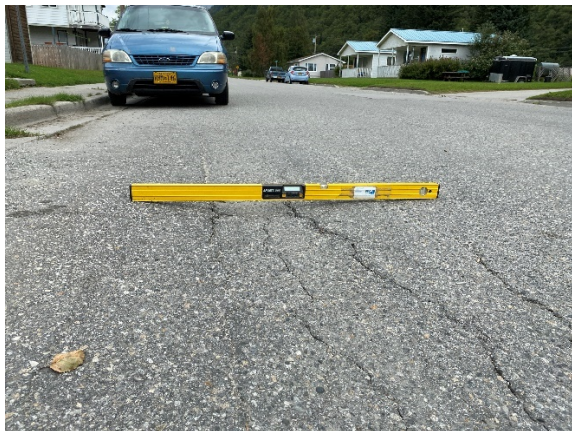
Photo 17 Example of rutting and longitudinal cracking

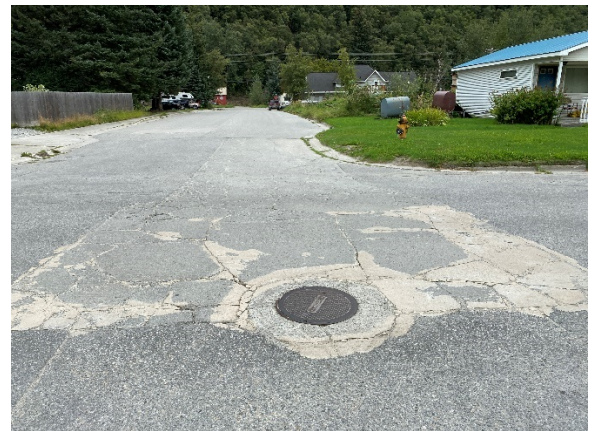
Photo 18 Example of concrete patch

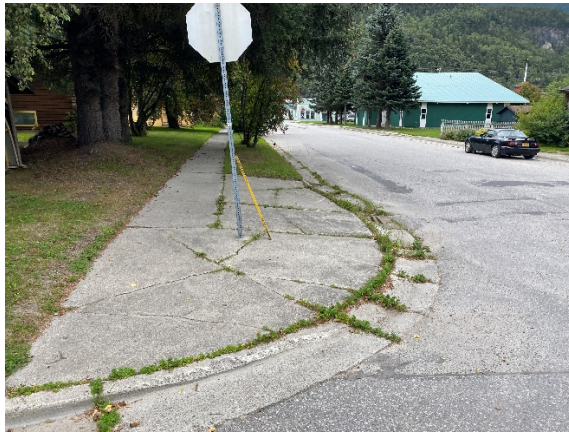
It should also be noted that approximately 50% of the sidewalk surfaces along Main Street were found to have cracks and vertical settlement, cracks creating trip hazards. Curb and gutter joint separations/settlement was also observed.

Photo 19 Example of concrete sidewalk cracking

A large portion of the sidewalk curb ramps do not meet ADA standards and those that do have frequent cracking throughout. Although Main Street does not see the pedestrian traffic volume that Broadway or State Street do, it still see’s heavy pedestrian traffic from tourists and community members including a large number of children either by foot or by bike. It is recommended that the Municipality replace all of the existing sidewalks along the west side of Main Street with new 5’ wide sidewalks and ADA compliant curb ramps and add 5’ wide sidewalks to the east side of the street with accompanying ADA compliant curb ramps or utilize the space on the east side of the street for a bike path.

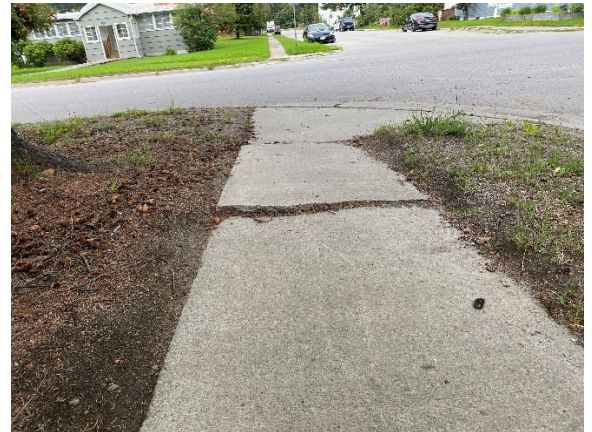
Photo 20 Example of concrete sidewalk cracking and heaving

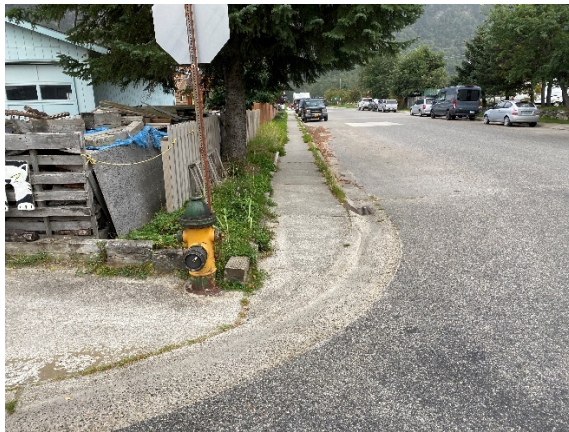
Photo 21 Example of sidewalk curb ramp not meeting ADA standards

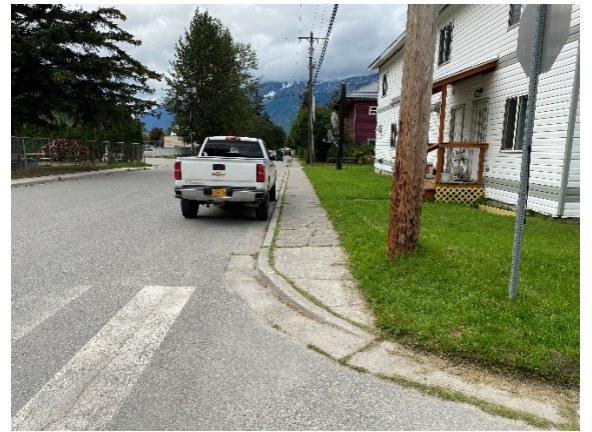
Photo 22 Example of concrete sidewalk not meeting ADA standards

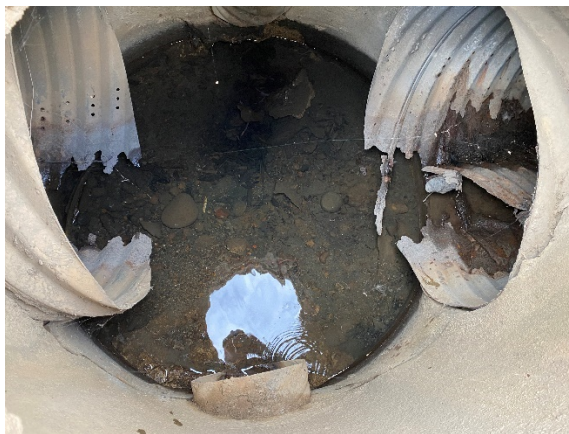
Photo 23 Example of corroding storm drain pipes

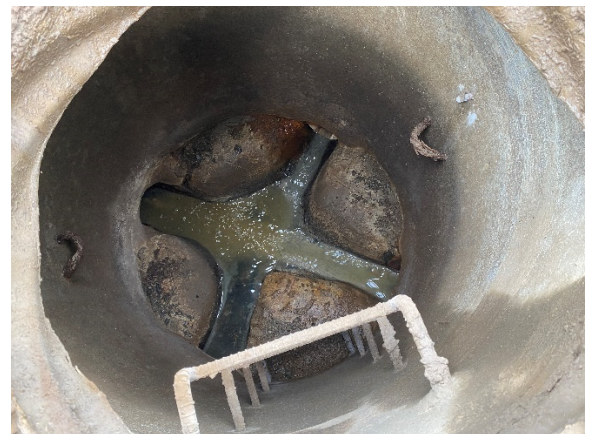
Photo 24 Example of a sanitary sewer manhole

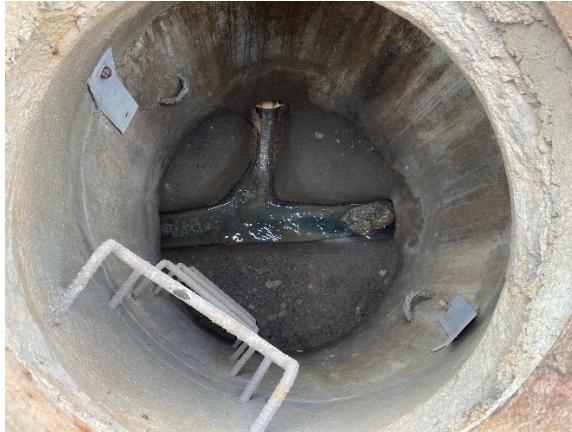
Photo 25 Example of sanitary sewer manhole with infiltration

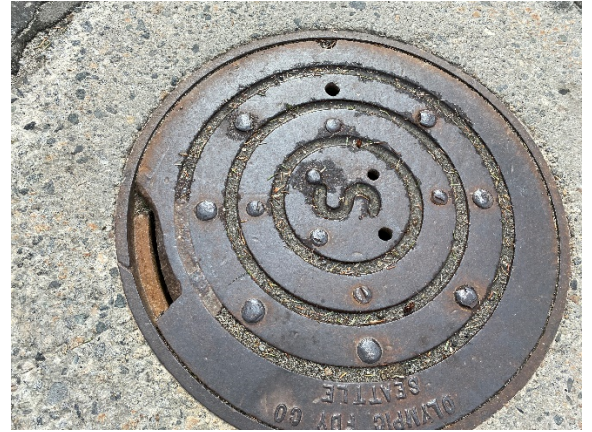
Photo 26 Example of damaged sanitary sewer manhole lid
