Observer	Elliot Wilson, PE	Report Date	6/18/2021
Visit Date/Time	5/10-5/11/21	Client #	
Temperature	-	PDC #	20216JN
Weather	-	Project Name	Skagway Waterfront Master Plan
RE	Skagway Ore Dock – Condition Review / Engineer’s Estimate of Value – Rev 1

INTRODUCTION

PDC Engineers, a RESPEC Company, was hired to conduct an inspection of the ore dock in Skagway, Alaska. The intent of the inspection was to determine the current condition of the dock to aid in the assessment of dock value. The site visit was conducted on May 10 and 11, 2021. Attending the site visit were Elliot Wilson, PE, from PDC; Matt O’Boyle, Harbormaster; and Brad Ryan, Skagway Manager for the Municipality of Skagway.

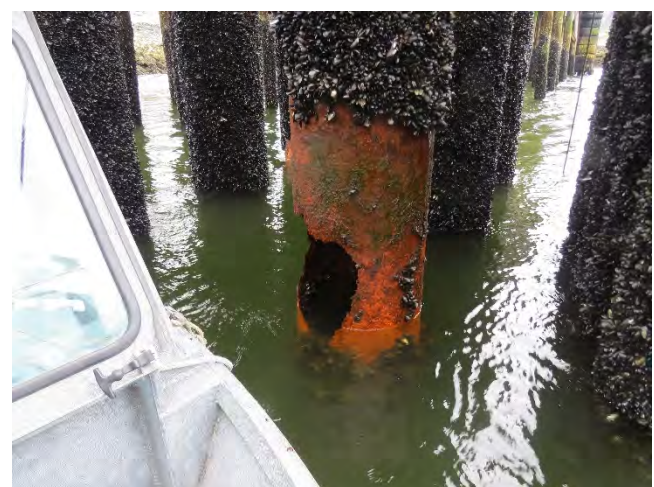
- Ore Ship Loader Breasting Dolphins – Concrete-capped, painted steel piles (paint no longer remains), designated as D1 thru D5:
 - Vertical Piles: Deterioration of piles varies, but all piles show significant rusting. Rusting ranges from 0-100% loss in thickness of steel. One location on Dolphin D2 had complete section loss at the -1 to -2-foot elevation; see Photo 60. Other locations showed pitting of 30-50% section loss; see Photos 86 & 87.

Capacity of dolphin assemblies is in question due to the extent of damage found on D2 and the inability to inspect steel below the waterline.

The estimated dock value used in for this report assumes that piles in the service platform and the Ore Ship Loader Breasting Dolphins need to be replaced. This damage is located at the -2-foot level of the steel piles; see Photos 60 & 85. These may be isolated locations; however, without additional underwater inspection that cannot be assumed at this time. Further investigation of these piles would enable further refinement of this engineer’s estimate, possibly allowing us to extend the assumed service life of the pier and decrease the expected repair costs assumed in the estimate.

Photo 60 – Dolphin D2 (2 of 2)

Investigation of piers below the -1-foot level is advisable for the steel piles located on the Ore Ship Loader Breasting Dolphins and the piles located on the Service Platform. PDC recommends underwater investigation of all of these steel piles to verify the service life and the installation of cathodes. Without this additional information, it should be assumed that all the estimated repairs are needed within the next 5 years in order of in-service date of the platform and the dolphins.

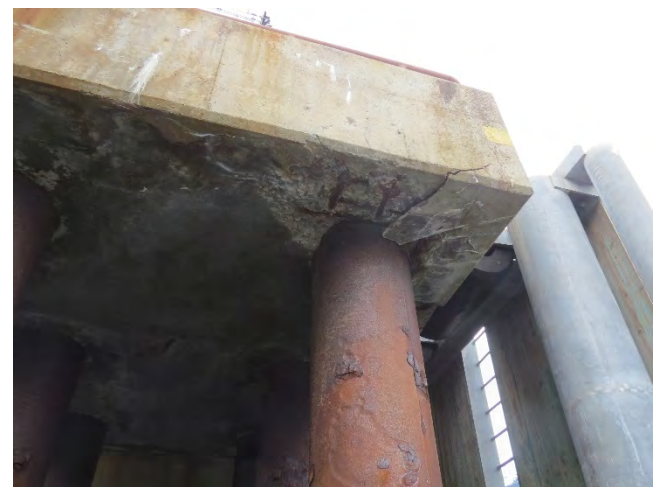
- Concrete Caps: Concrete on piles appeared to be in fair condition except for one location at Dolphin D4; see Photos 68 & 70.
- Two sets of fenders need repair.
- Numerous ladders accessing dolphins from the waterline were missing rungs.
- Ship Loader – Outside scope of work
- AML Dolphins and Barge Dock (outside scope-of-work)- Galvanized steel, designated as AML1-AML4.
 - Vertical Piles: Bent in numerous locations, and broken at AML2; see Photo 89.

Photo 68 – Dolph D4 (2 of 4)

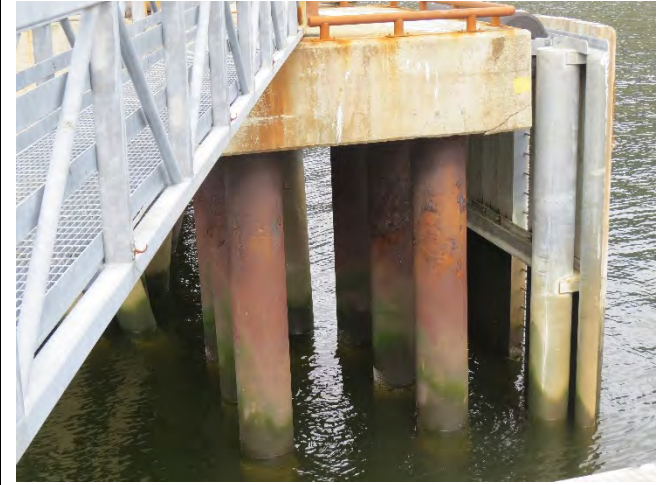
Photo 70 – Dolphin D4 (4 of 4)

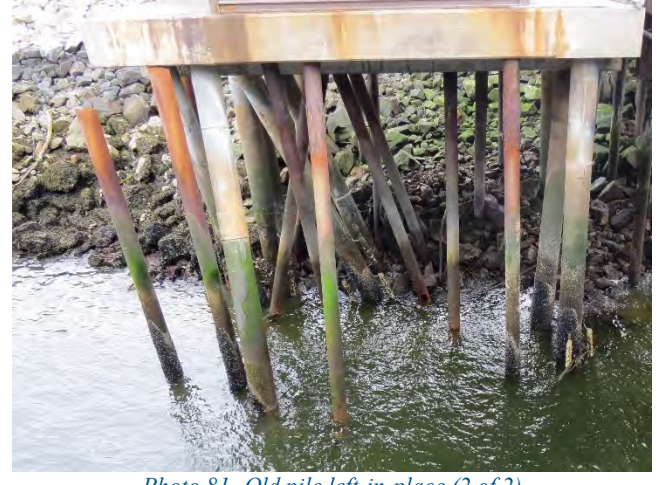
Photo 81- Old pile left-in-place (2 of 2)

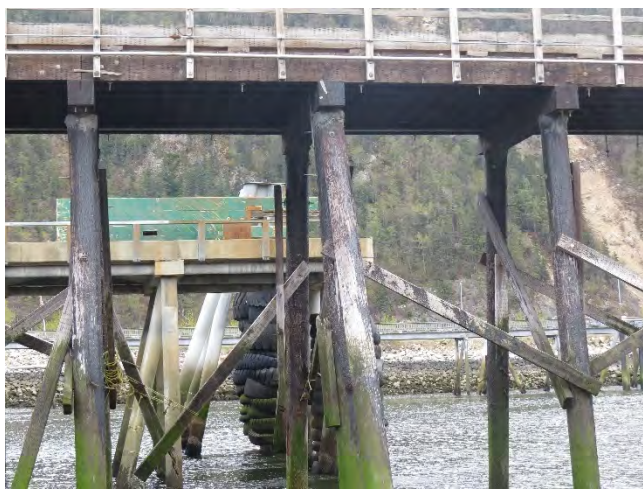
Photo 82- Broken cross-bracing (1 of 2)

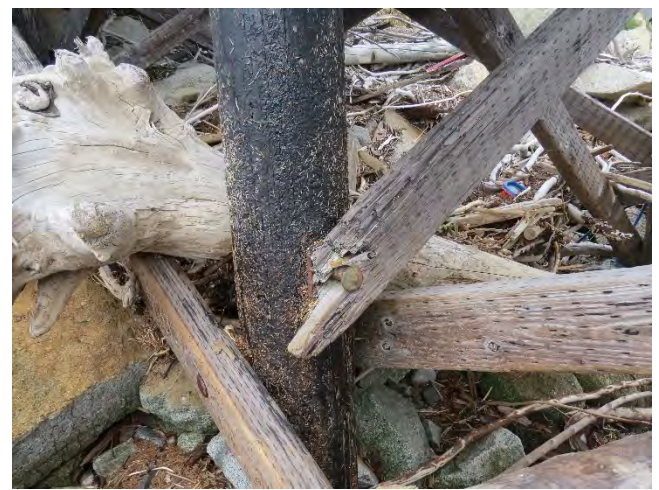
Photo 83- Broken cross-bracing (2 of 2)

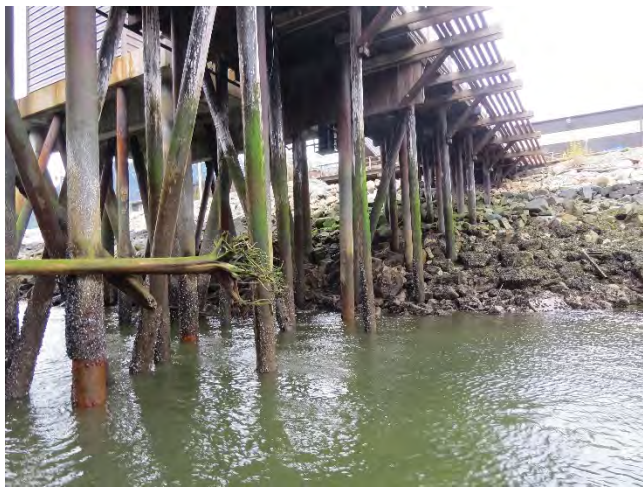
Photo 84 - Alternating steel and wood columns

- Covered Walkway:
 - No damage present other than typical wearing.
- Service Pier:
 - Vertical Piles: There are (12) steel piles on the access platform connecting the shore that may need to be replaced. There was a large hole found on one, and further underwater inspection is warranted, see photos 84 & 85.

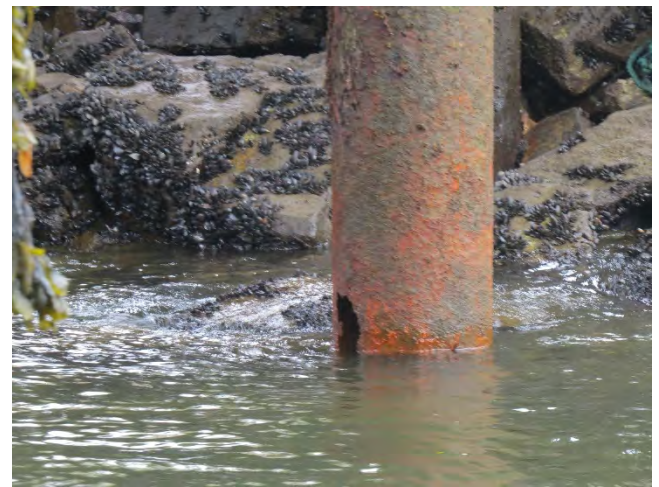
Photo 85 - Enlargement of steel pile (previous image)

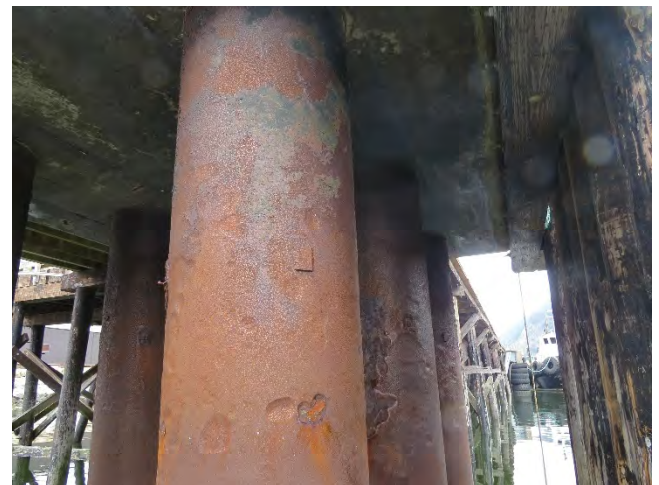
Photo 87- Large pitting at ore dolphin piles (2 of 2)

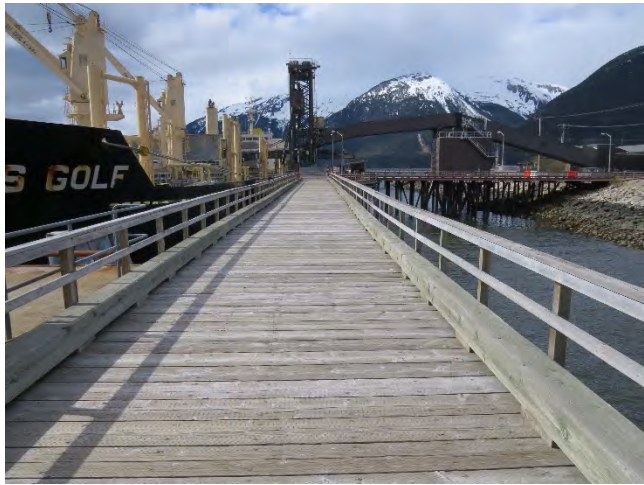
Photo 88- Decking surface condition

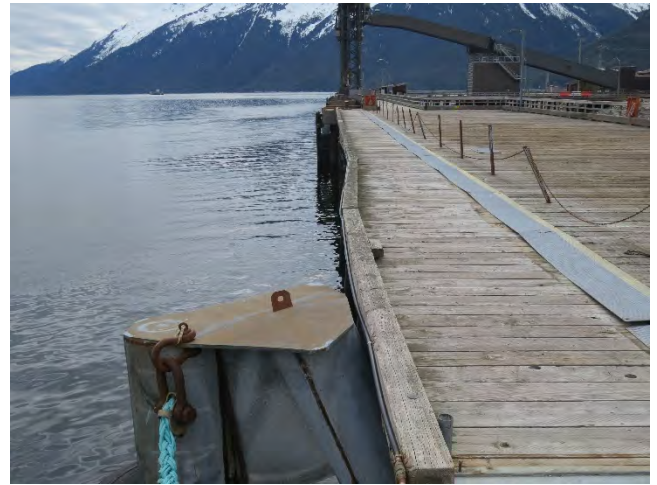
Photo 89- Old portion of dock

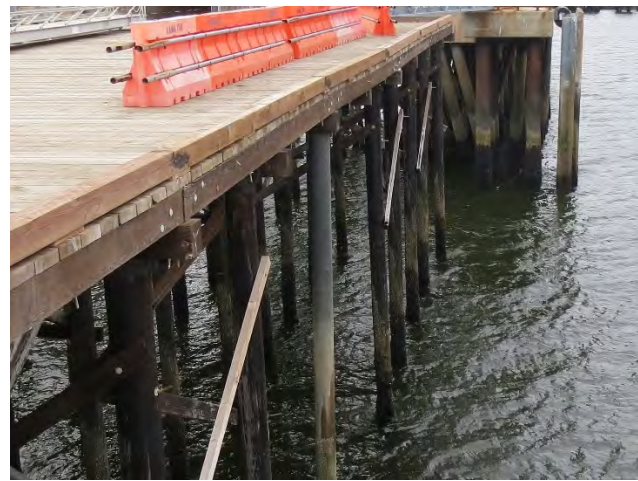
- Piles: One vertical is missing at eastern face of platform, see photo 90. Vertical and batter piles are otherwise in fair condition.
 - Decking/Beams: These are in good condition.

Photo 90- Southern timber platform, vertical pile missing
