CONDITION ASSESSMENT REPORT

November
2023

SKAGWAY K-12 SCHOOL FACILITY CONDITION SURVEY

**MUNICIPALITY OF
SKAGWAY BOROUGH**

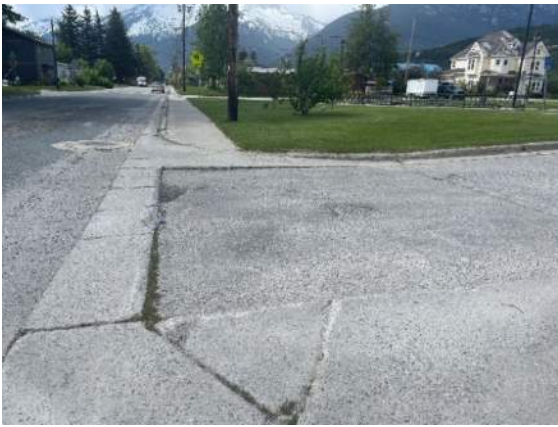
Photo 1 – Worn asphalt pavement at entrance

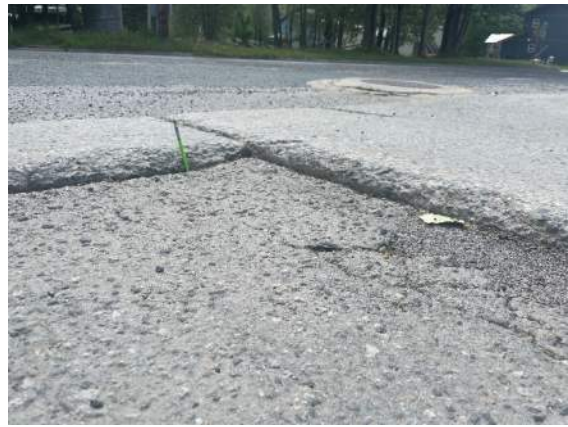
Photo 2 – Close up of worn asphalt surface

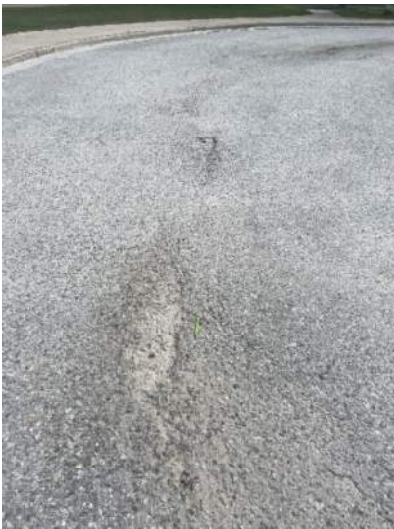
Photo 3 – Asphalt deterioration on driveway

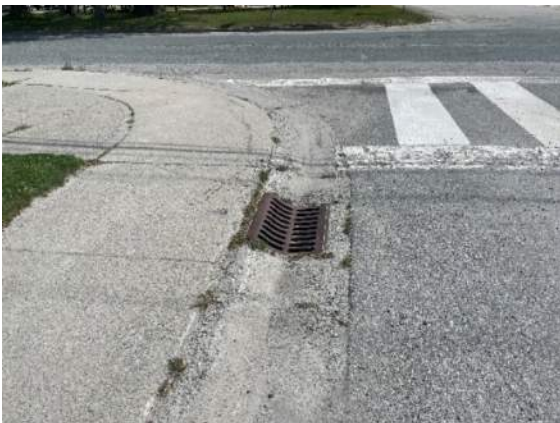
Photo 25 – Worn crosswalk striping

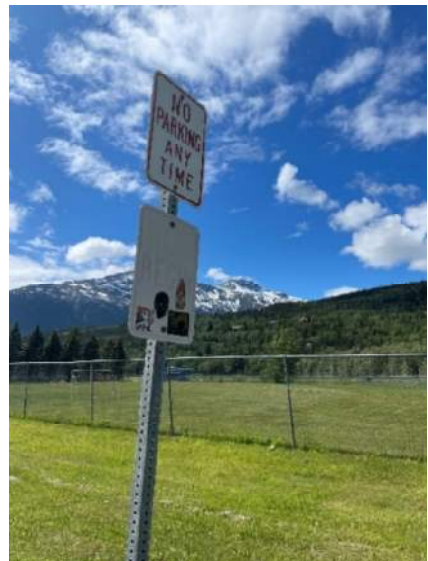
Photo 26 – Faded sign

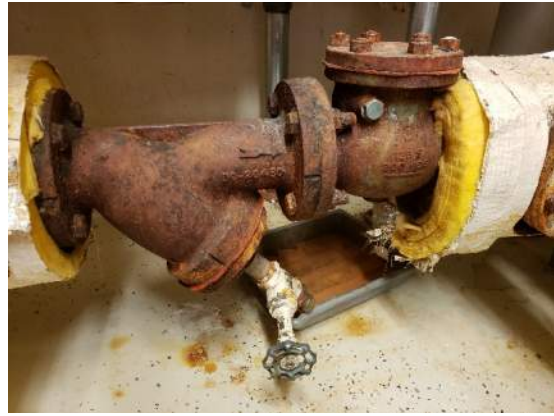
Rusting Strainer & Check Valve

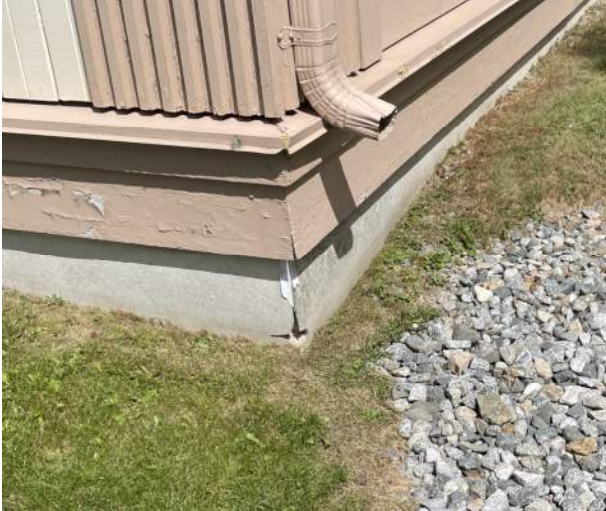
Photo 39 — Damaged foundation insulation and flashing.

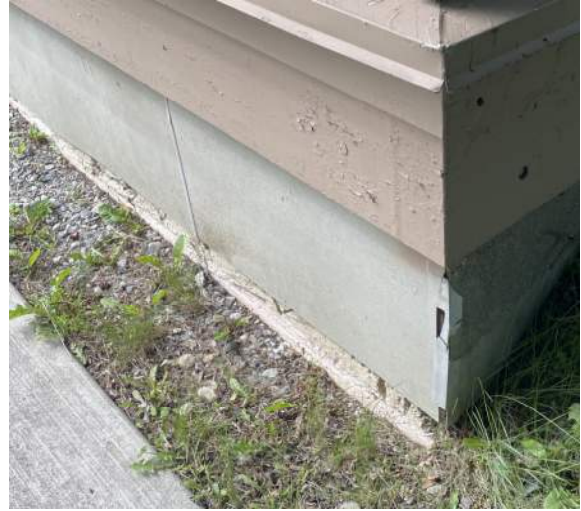
Photo 40 — Damaged foundation insulation and flashing.

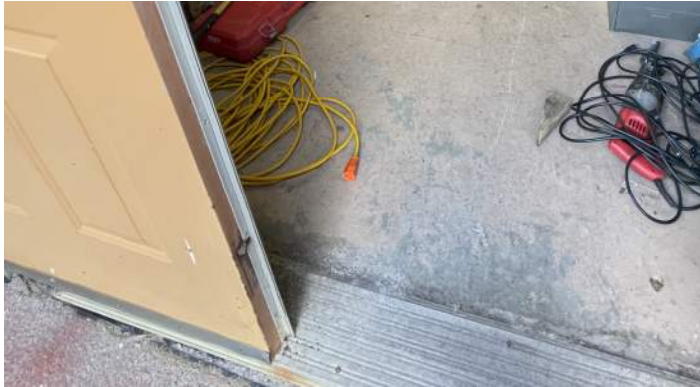
Photo 41 — Spalling at interior slab-on-grade (Boiler Room).

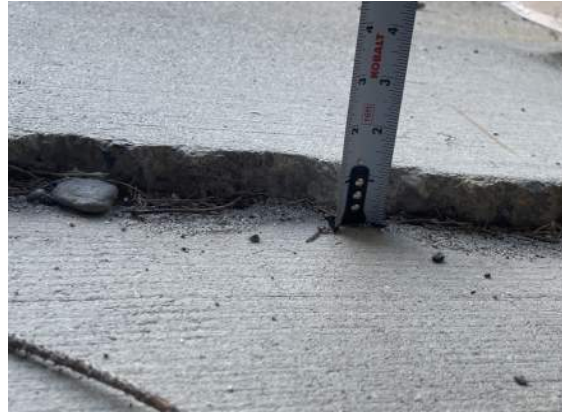
Photo 42 — Significant cracking at exterior slab near door 125.

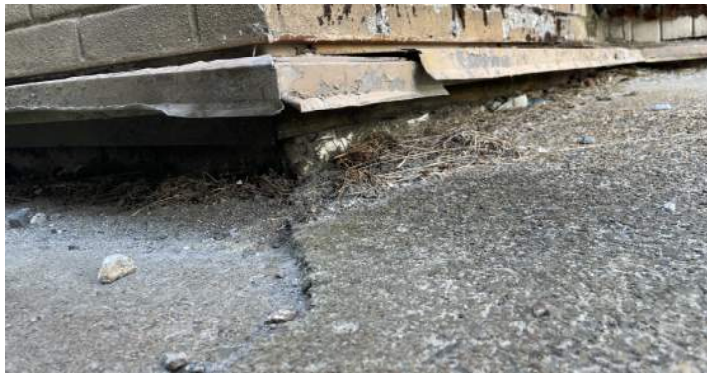
Photo 43 — Typical settlement and spalling of exterior slabs.

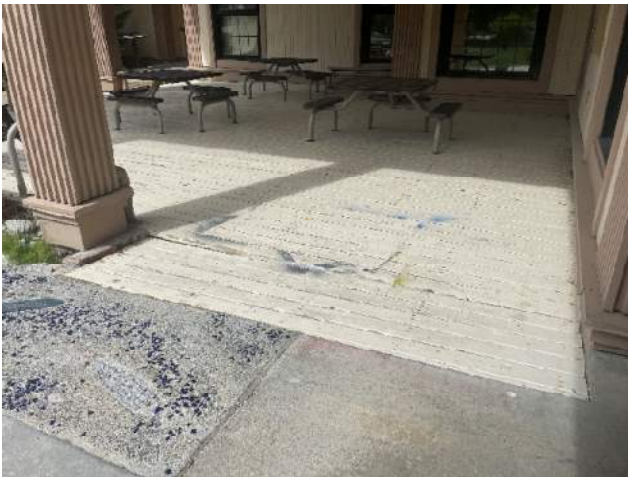
Exterior Accessories:

Painted 2x wood space deck assumed to be installed on furring over concrete. It appears that surrounding concrete flatwork was possibly added after the construction of the deck, which has ramped surfaces leading to what we assume was original grade. At these conditions the ADA threshold height offset limit is exceeded and a significant trip hazard exists. The decking itself is in fair to poor condition.

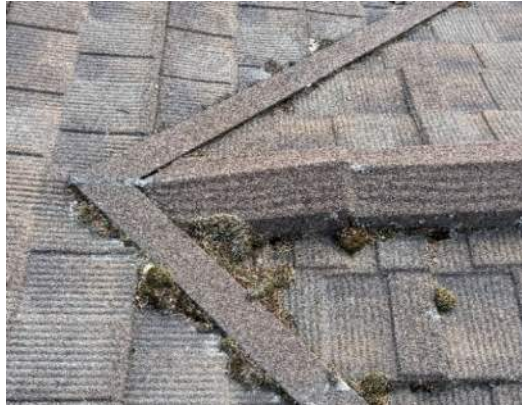
Photo A29 - Reroof 3:12 slope, ridge and valley support growth

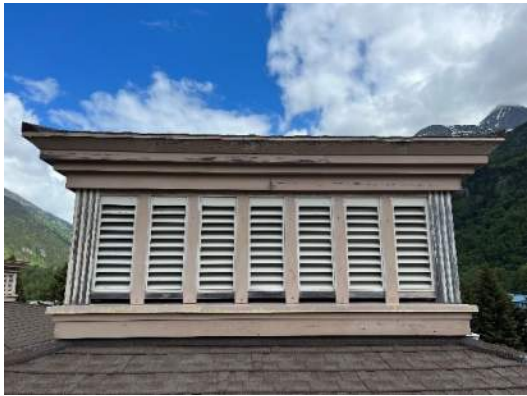
The replacement roofing is performing less well in the approx.1:12 applications at each of the two cupolas. It is likely that this system is not warranted for low slope conditions. Moss and lichen growth are significant, causing possible infiltration. It should also be noted that the cupolas serve as the high-side venting for the roof system. The manner in which they are framed and flashed create two likely infiltration points in the cupolas' interior: positive but unsealed flashing laps in very low-slope areas is very vulnerable to infiltration from wind-blown rain as it drains down to the bottom edge of the cupolas' louvers. The vertical framing members penetrate this flashing system and appear to rely exclusively on sealant to prevent moisture intrusion at these vulnerable joints. At least one leak was identified in Gym 12 in the region of the cupola.

Photo A34 - Reroof 1:12 slope at north cupolas

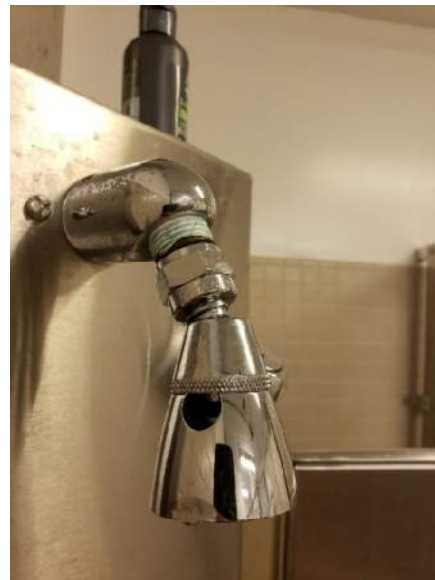
Showerhead Missing Valve Handle

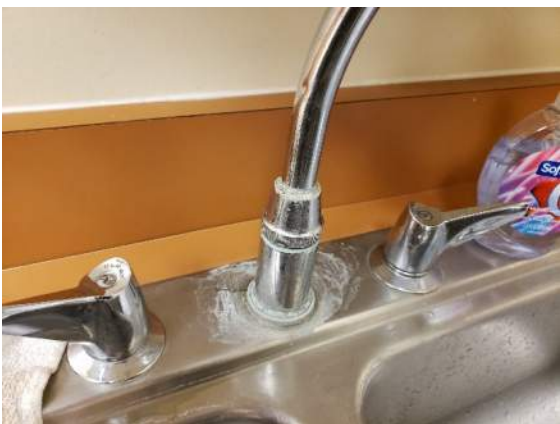
Storage 10A Sink Corrosion

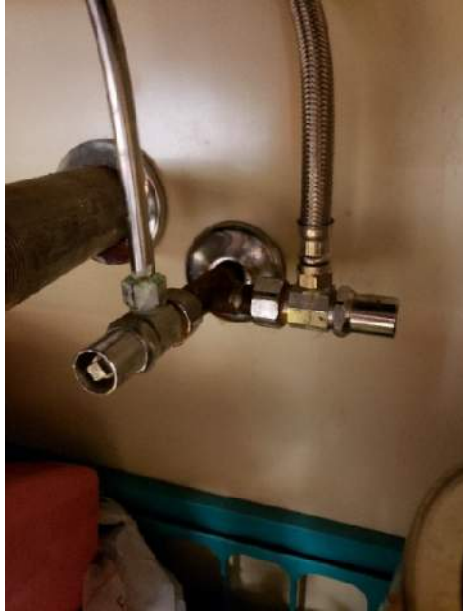
Angle Stop Valve Corrosion

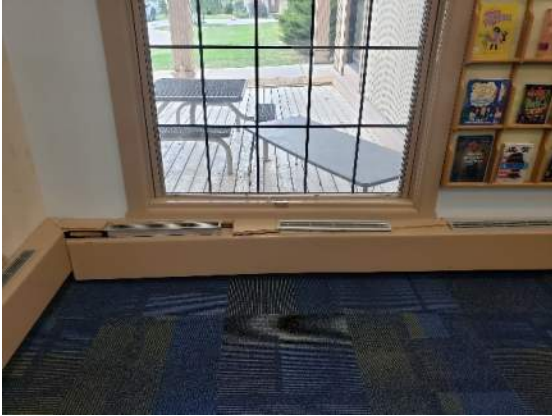
Damaged Fintube Enclosure (Library)

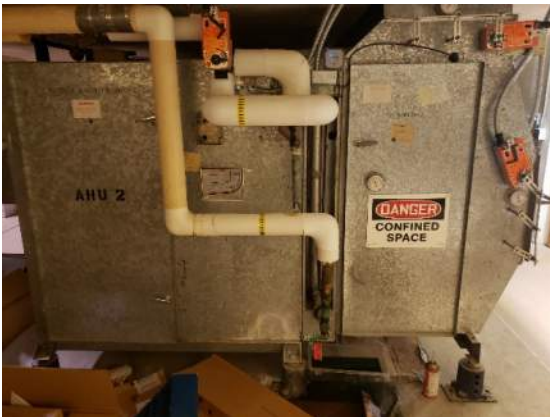
AHU-2 Heating Coil Leak

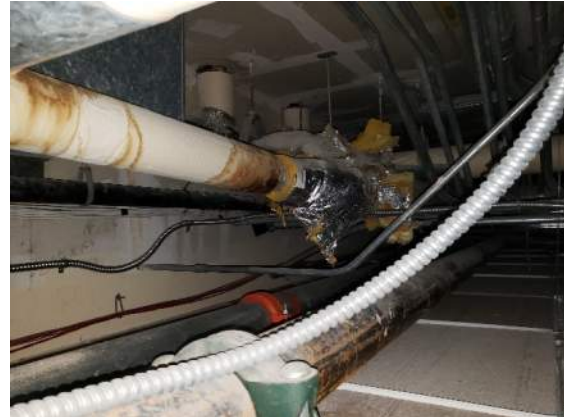
Hydronic Mains Old Leak

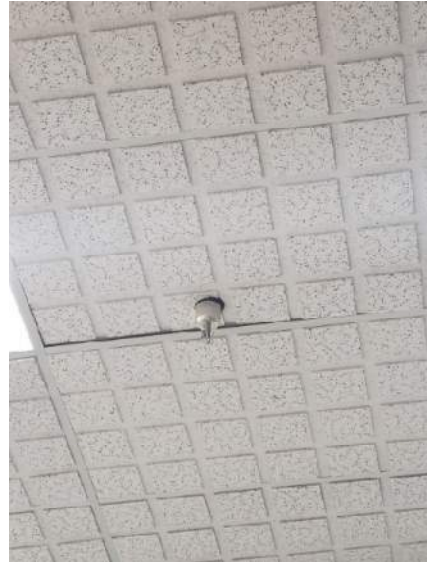
Sprinkler Head Missing Escutcheon

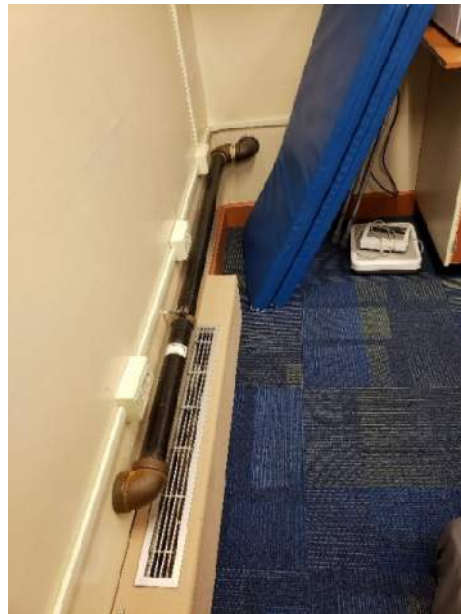
Exposed Sprinkler Drain Line

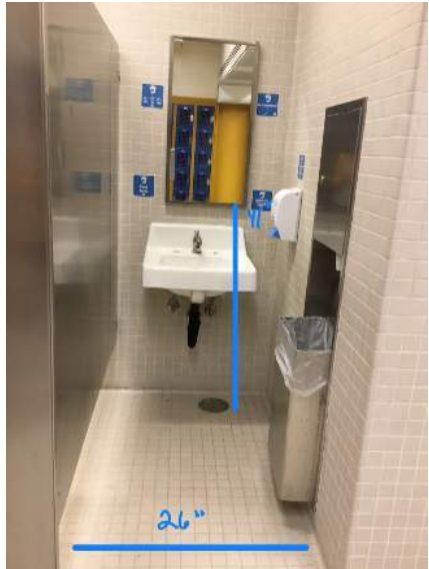
<p>ADA Section 604.7: Dispensers</p> <p>ADA Section 604.8.2: Flush controls</p>	<p>Toilet tissue dispenser located above grab bar</p> <p>Flushing mechanism is located on the "closed", or wall-side, of the toilet</p>	<p>Move toilet tissue dispenser so the the toilet paper outlet is a maximum height of 48" above the finish floor</p> <p>Replace toilet with one which has flushing mechanism on the "open" side</p>	<p>Girls locker room</p>

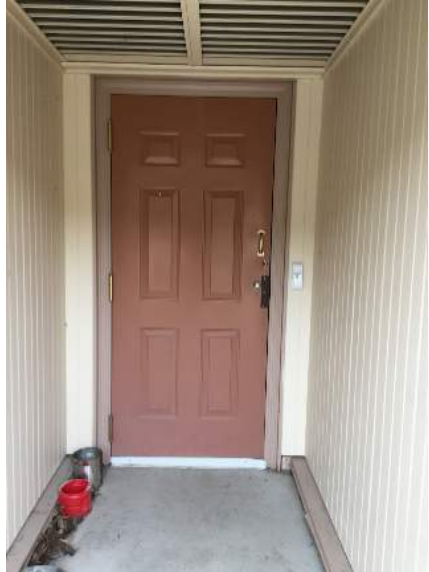
<p>303: Changes in level 302.3: Openings in floor or ground surface</p>	<p>Gaps and/or damage in sidewalk access route exceed 1/2 inch wide and 1/4 inch tall in places</p>	<p>Repair concrete path so that it is level</p>	<p>Back entrance (near playground)</p>

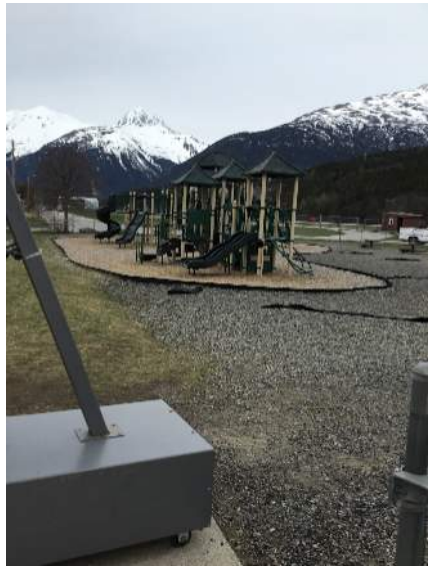
<p>American Society for testing and Materials (ASTM) F 1487, ASTM F 1951-99</p>	<p>Inaccessible surface en route to, an under, swingset</p>	<p>Replace with surface such as rubber tiles or poured in place rubber.</p> <p>Consider accessible swing seat accessory and harness</p>	<p>Playground</p>

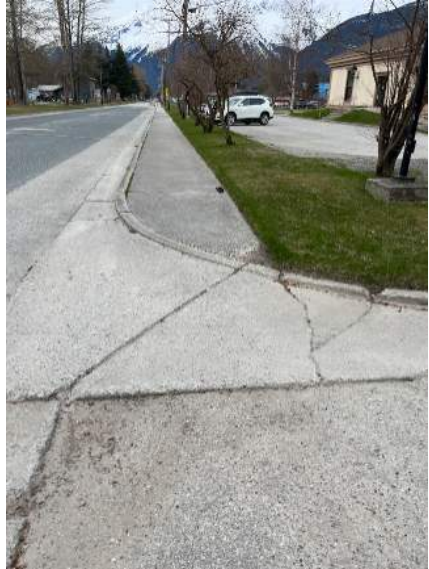
<p>302.3 Openings in Ground Surface</p>	<p>Gaps and/or damage in sidewalk access route exceed ½ inch wide and ¼ inch tall in places</p>	<p>Repair concrete path so it is smooth and level</p>	<p>Sidewalk near school parking</p>

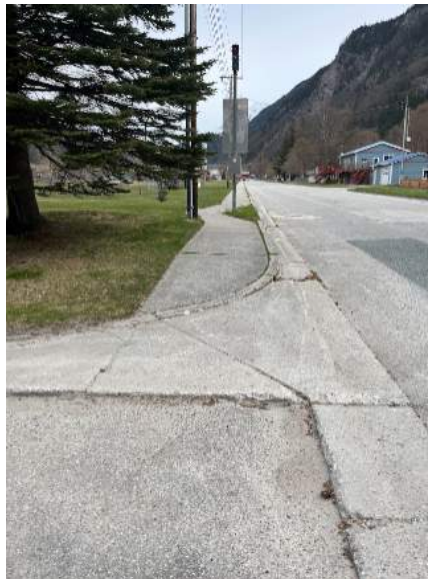
<p>ADA Section 303.4: Ramps</p> <p>406: Curb ramps</p> <p>406.8: Detectable warnings</p>	<p>Curb ramp not marked</p>	<p>Install ADA-complaint, marked curb cut. Introductory guide to installation requirements found in above footnote</p>	<p>Sidewalk near school parking</p>
