Observer	Elliot Wilson, PE	Report Date	6/18/2021
Visit Date/Time	5/10-5/11/21	Client #	
Temperature	-	PDC #	20216JN
Weather	-	Project Name	Skagway Waterfront Master Plan
RE	Skagway Ore Dock – Condition Review / Engineer’s Estimate of Value – Rev 1

INTRODUCTION

PDC Engineers, a RESPEC Company, was hired to conduct an inspection of the ore dock in Skagway, Alaska. The intent of the inspection was to determine the current condition of the dock to aid in the assessment of dock value. The site visit was conducted on May 10 and 11, 2021. Attending the site visit were Elliot Wilson, PE, from PDC; Matt O’Boyle, Harbormaster; and Brad Ryan, Skagway Manager for the Municipality of Skagway.

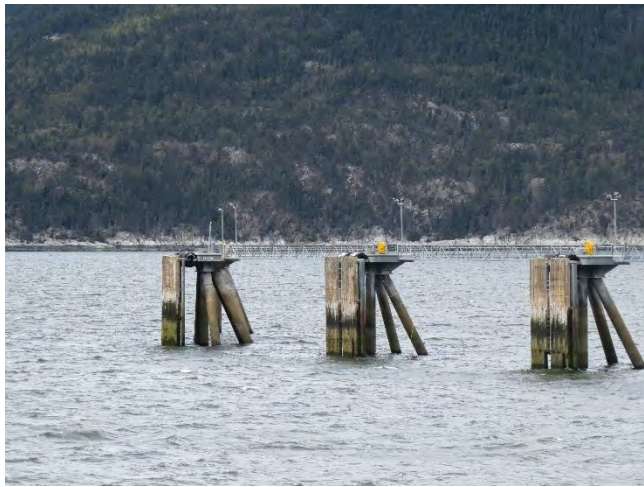
Photo 1- Dolphin addition, galv. steel (1 of 2)

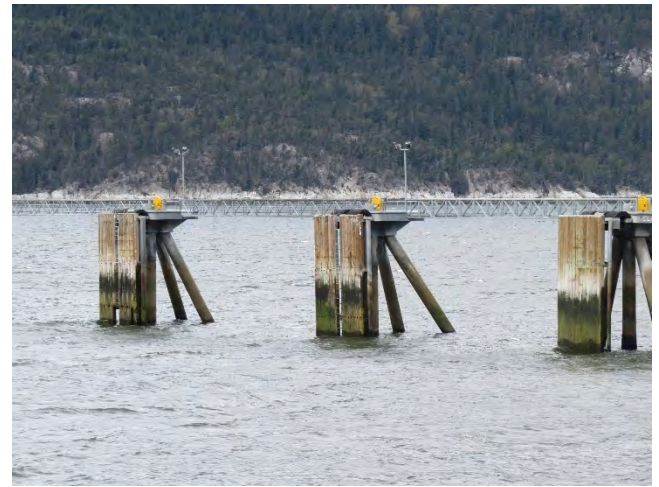
Photo 2- Dolphin addition (1 of 2)

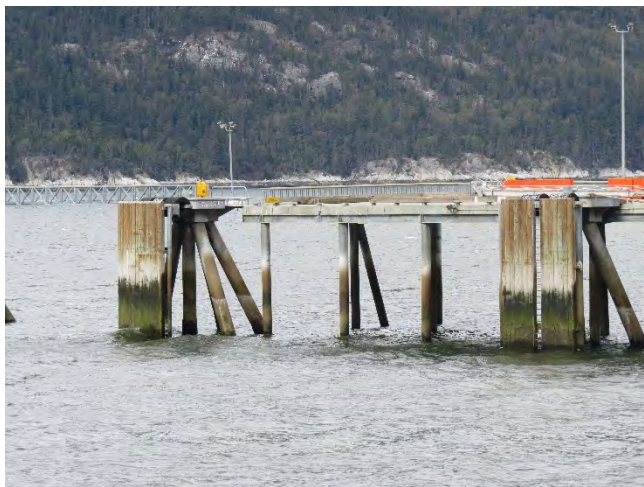
Photo 3- Concrete platform, galv steel with concrete deck (1 of 2)

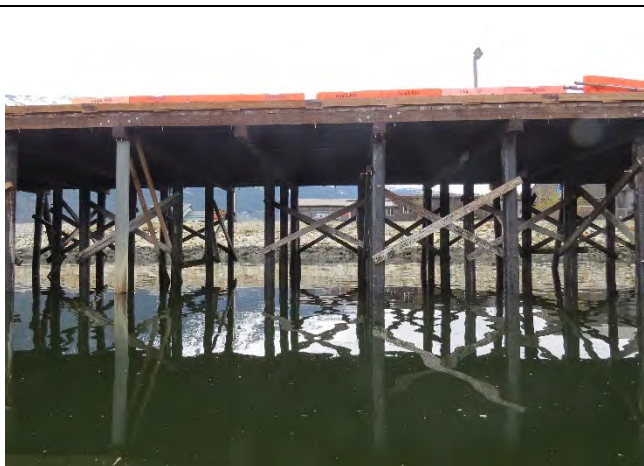
Photo 5- South timber platform (1 of 2)

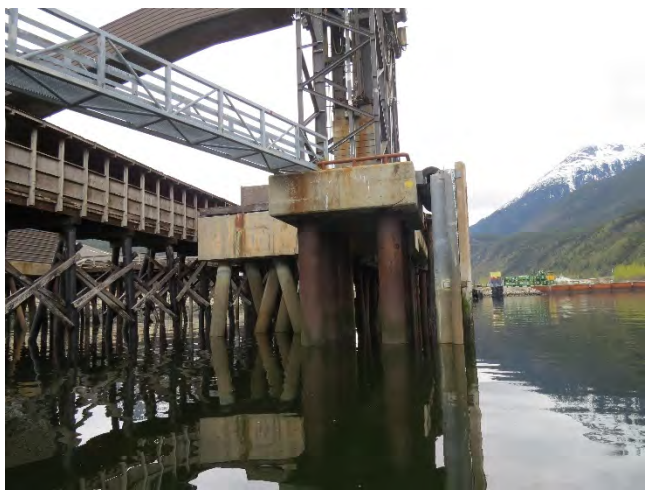
Photo 7- Ore ship loader dolphin, painted steel with concrete cap

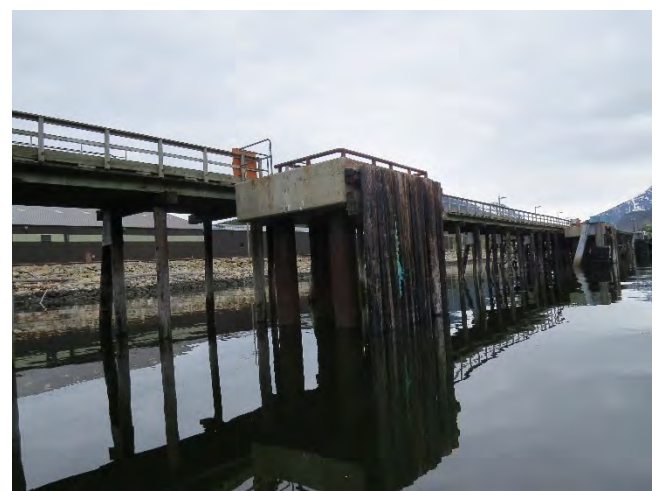
Photo 12- - Ore ship loader dolphin, steel with concrete cap

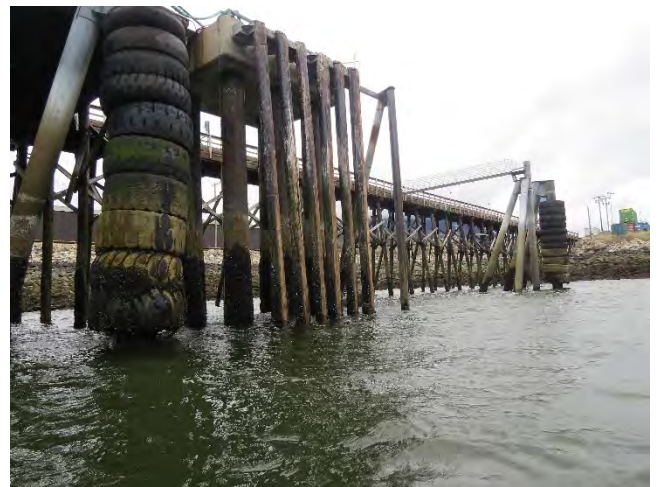
Photo 18- North timber platform, near AML3 and DI (2 of 4)

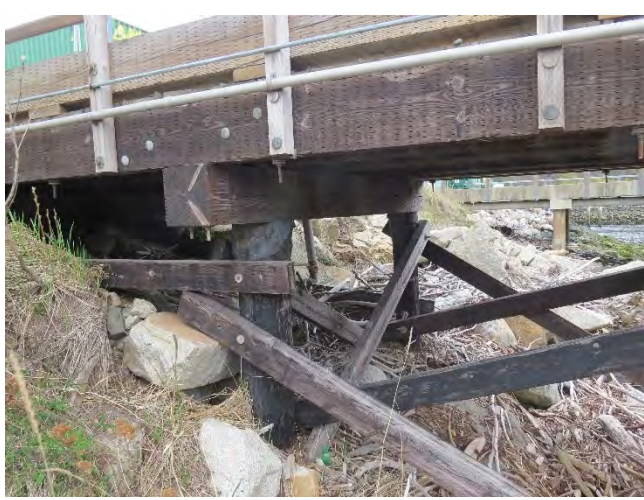
Photo 21- North timber platform, west side (1 of 7)

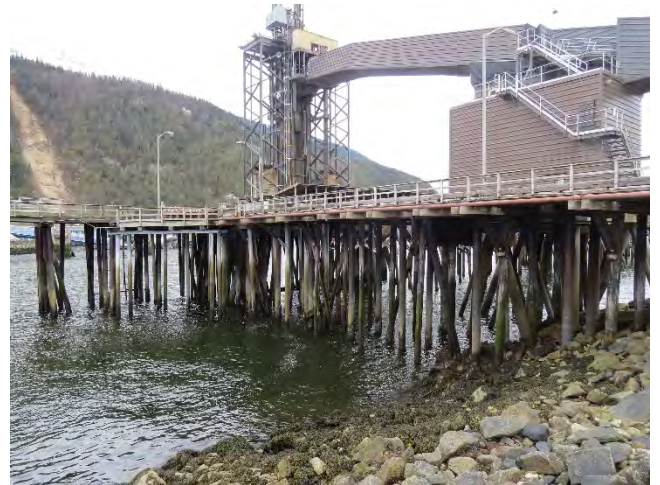
Photo 29- Ore ship loader and timber approach, (1 of 6)

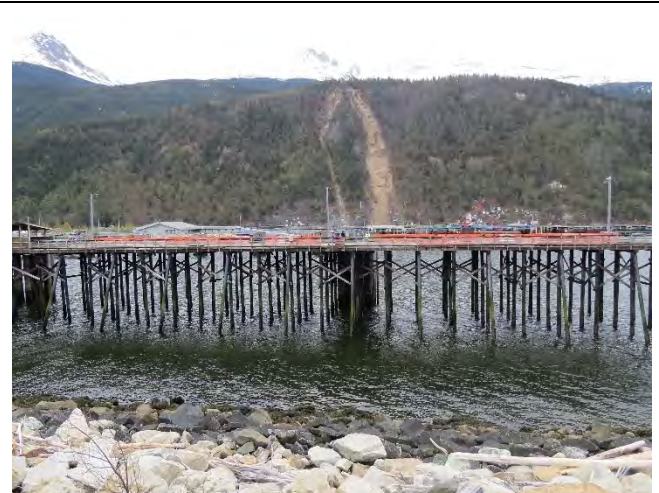
Photo 35- South timber platform (1 of 3)

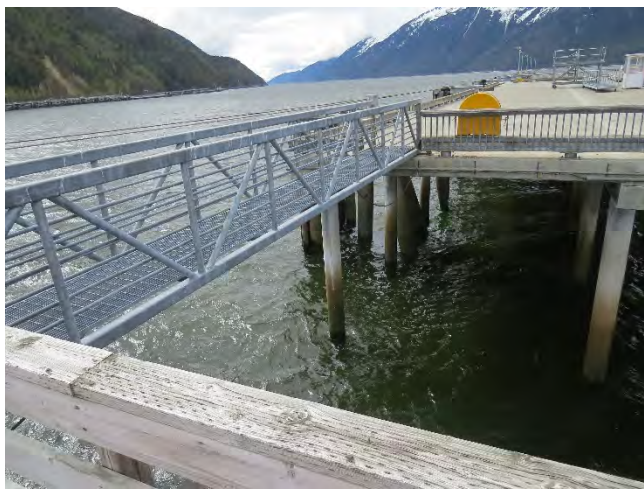
Photo 38- Concrete platform, north elevation (1 of 4)

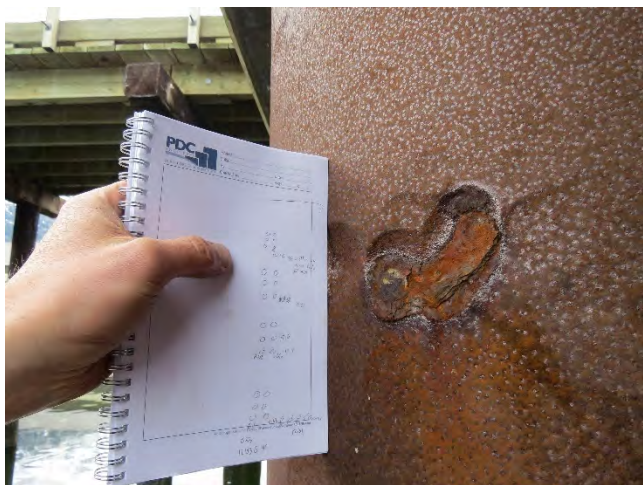
Photo 85 - Enlargement of steel pile (previous image)

The estimated dock value used in for this report assumes that piles in the service platform and the Ore Ship Loader Breasting Dolphins need to be replaced. This damage is located at the -2-foot level of the steel piles; see Photos 60 & 85. These may be isolated locations; however, without additional underwater inspection that cannot be assumed at this time. Further investigation of these piles would enable further refinement of this engineer’s estimate, possibly allowing us to extend the assumed service life of the pier and decrease the expected repair costs assumed in the estimate.

Investigation of piers below the -1-foot level is advisable for the steel piles located on the Ore Ship Loader Breasting Dolphins and the piles located on the Service Platform. PDC recommends underwater investigation of all of these steel piles to verify the service life and the installation of cathodes. Without this additional information, it should be assumed that all the estimated repairs are needed within the next 5 years in order of in-service date of the platform and the dolphins.
