CONDITION ASSESSMENT REPORT

November
2023

SKAGWAY K-12 SCHOOL FACILITY CONDITION SURVEY

**MUNICIPALITY OF
SKAGWAY BOROUGH**

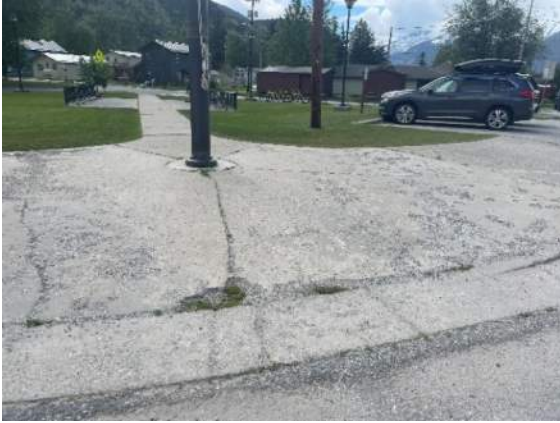
Photo 4 – Pitted sidewalk

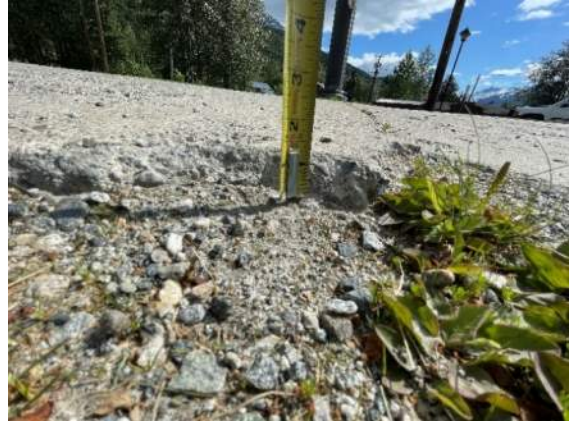
Photo 5 – Chipped sidewalk

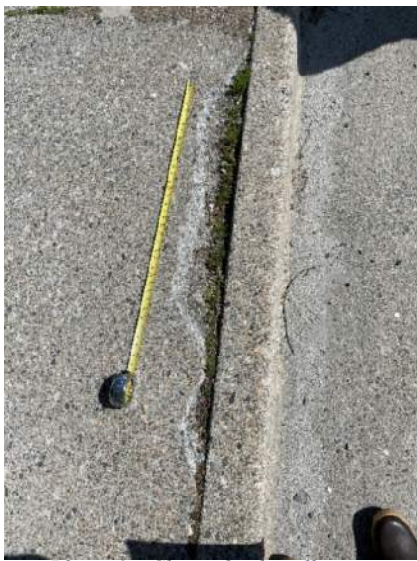
Photo 6 – Chipped sidewalk

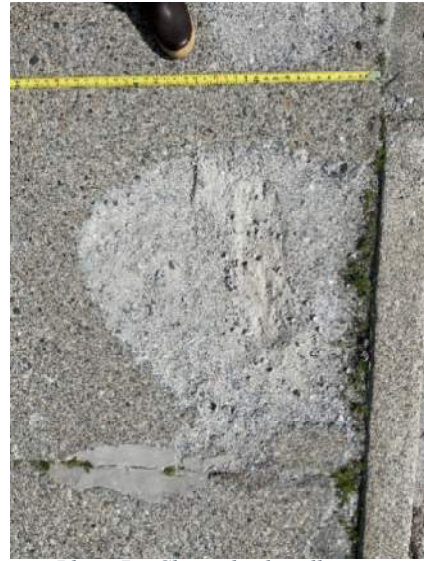
Photo 7 – Chipped sidewalk

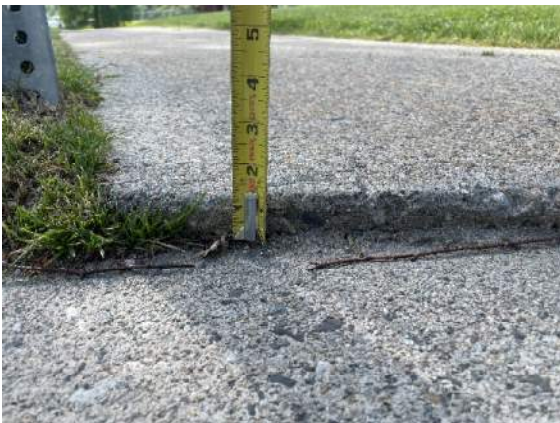
Photo 8 – Raised sidewalk panel

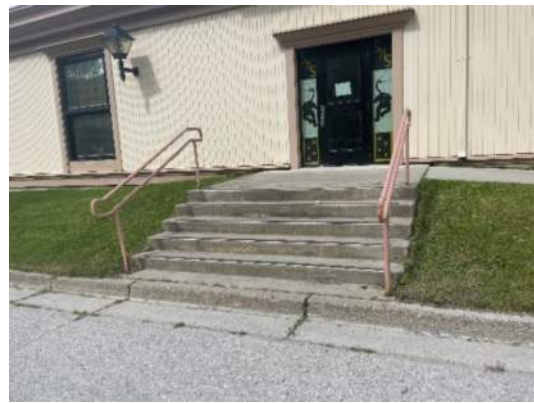
Photo 11 – Exterior door stairs and handrails

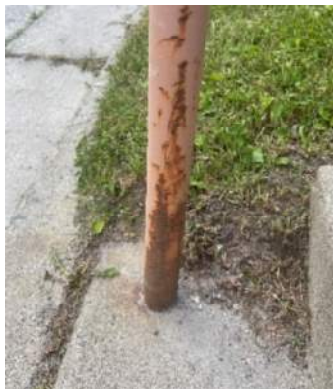
Photo 12 – Close up of handrail corrosion

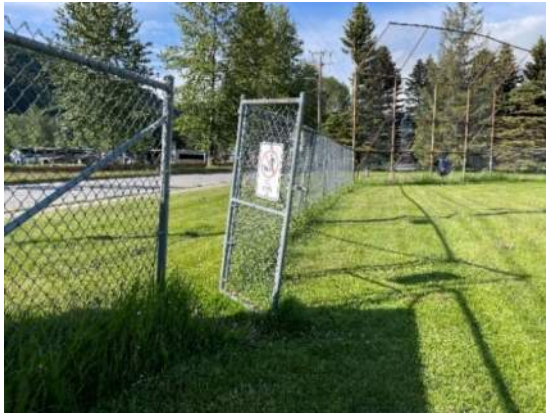
Photo 17 – Out-of-plumb gate

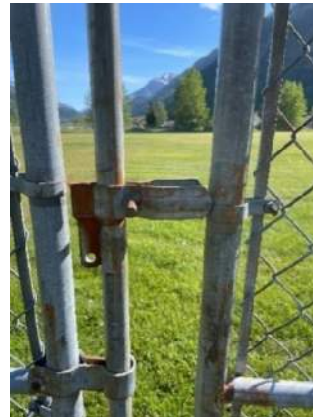
Photo 18 – Typical gate latch gap

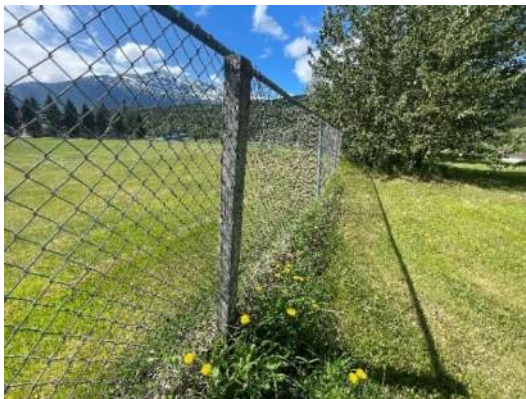
Photo 19 – Wood fence post

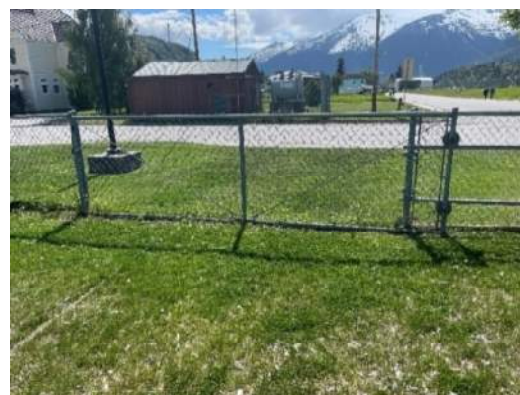
Photo 20 – Inoperable playground rolling gate

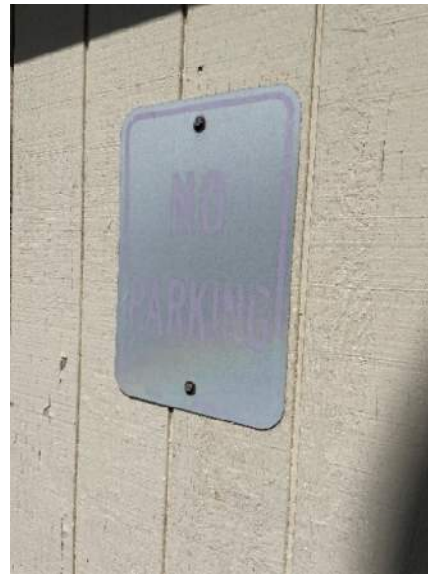
Photo 24 – Faded "No Parking" sign

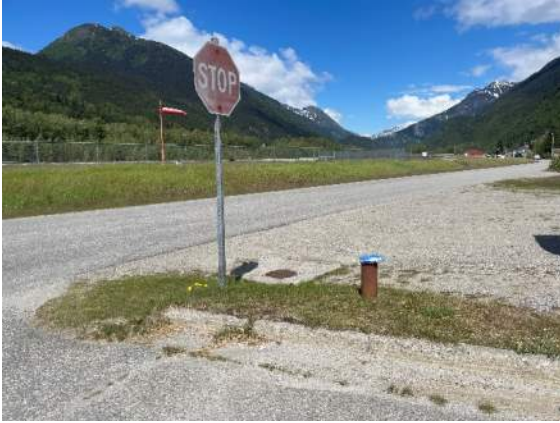
A wellhouse is located on site and serves the municipal water system. A second wellhead is located on the west side of the school adjacent to a storm drain field inlet. The Municipality reports that this is a monitoring well. Site plans from 1983 and 2021 show a fire hydrant in approximately the same location as the wellhead, which is no longer present. Two fire hydrants are located further east along Alaska Street.

Photo 32 – Monitoring well

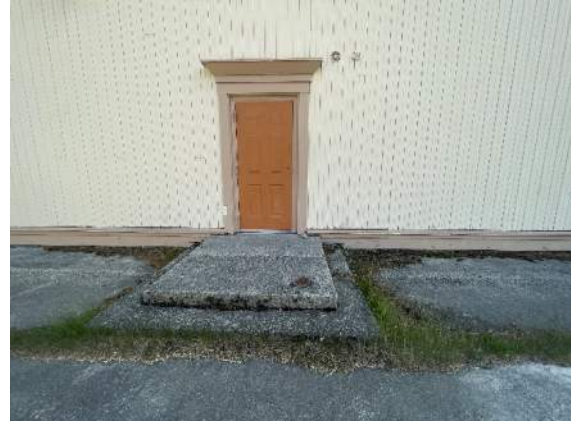
Photo 33 – Mainline valve/ valve box in concrete step

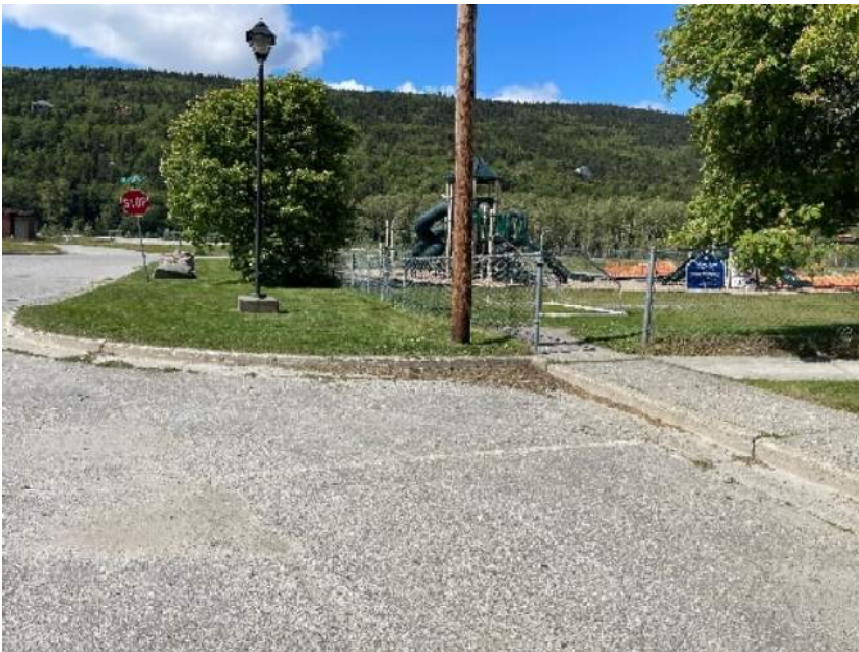
Photo 36 Low spot near playground

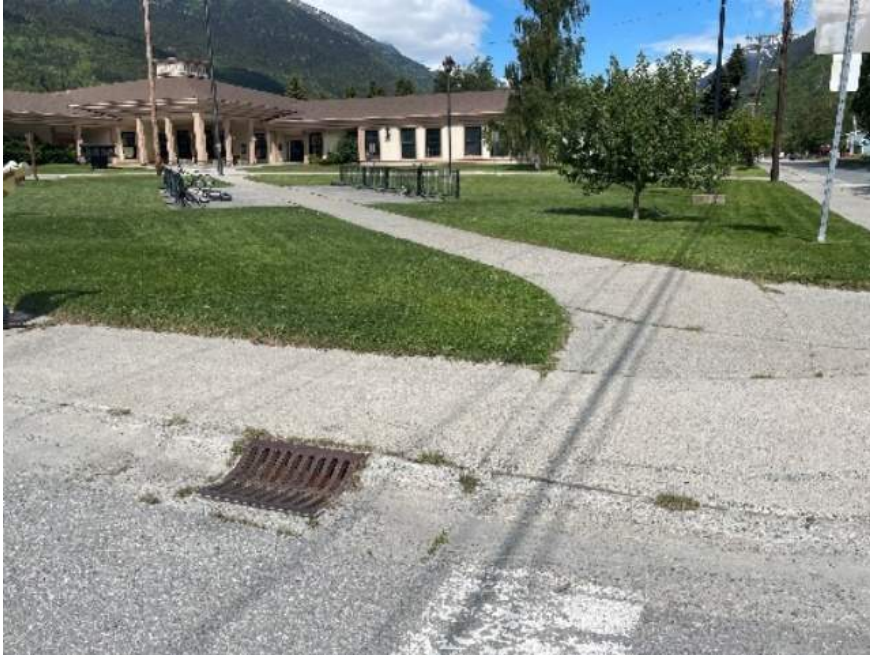
Photo 37 – Storm drain curb inlet along Fifteenth Street

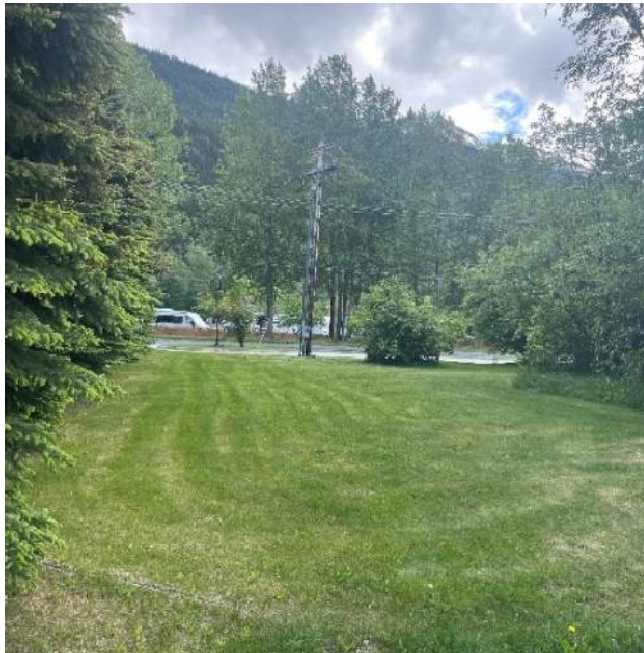
Photo 38 Low spot near generator pad

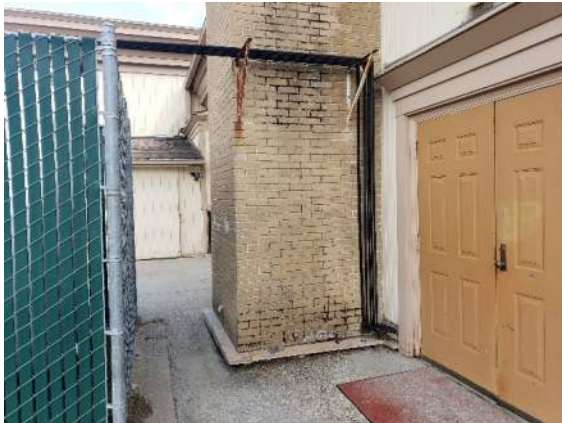
Exterior Fuel Oil Piping

The fuel oil storage tank and associated appurtenances are in poor condition and are corroding and rusting. The fuel piping angle iron supports that are connected to the boiler flue chimney are in poor condition and are severely rusting. The spill box containment has particularly widespread and severe corrosion and rusting. Within the spill box containment, the camlock fitting was removed from the fill port connection and stored in the spill containment box along with an oily rag. The normal vent cap was propped open with a steel rod. The fuel oil piping was in fair condition, however there was no vent extended above grade 12 feet or more. There is a wooden platform that spans between either side of the metal fencing across the fuel storage tank adjacent to the tank gauge that appears to be used to access the tank gauge. The tagging and other identification components, including the hazard symbol, have faded beyond recognition. The fuel storage tank was located within five feet of the building edge. For existing grounding conditions, see electrical. For existing support and pad conditions, see structural.

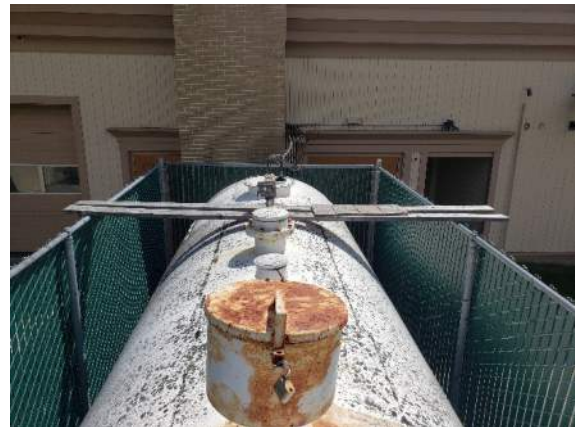
Fuel Storage Tank

The fuel oil storage tank is located within five feet of the building edge which is in violation of NFPA 30A. There is no vent located 12 feet or more above the finished ground level as required by the 2021 International Fire Code (IFC) Section 5704.2.7.3.3. The normal vent cap was propped open allowing hazardous gases to escape the fuel storage tank. The hazardous tagging for the fuel storage tank has faded and is illegible.

- Replace the above ground fuel storage tank and correct the foundation and grounding issues.
- Relocate science lab propane storage tank to a code-compliant location and extend the piping accordingly.

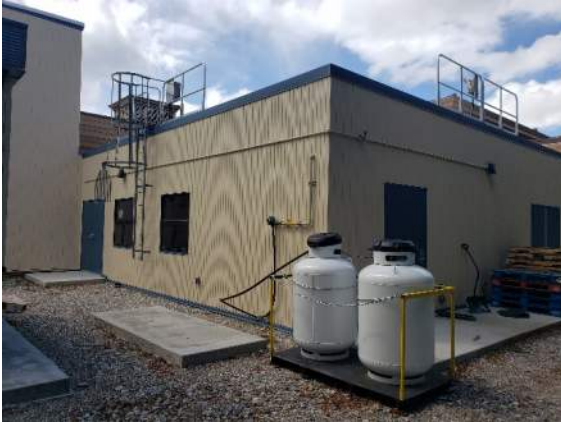
Kitchen Propane System

The propane gas system associated with the kitchen is in good condition.

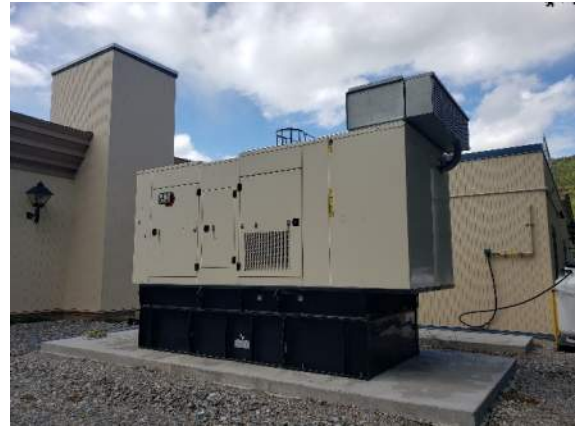
Generator Subbase Fuel Tank

The generator subbase fuel storage tank is in good condition.

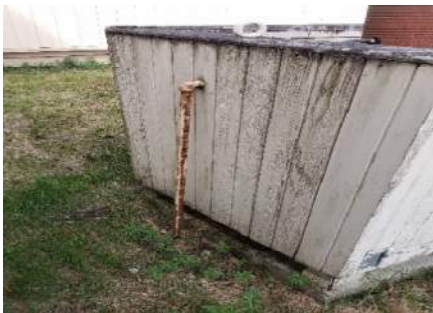
Science Lab Propane Piping

The propane tank that serves the science lab is in fair condition and is moderately rusting. The associated propane gas piping is in poor condition.

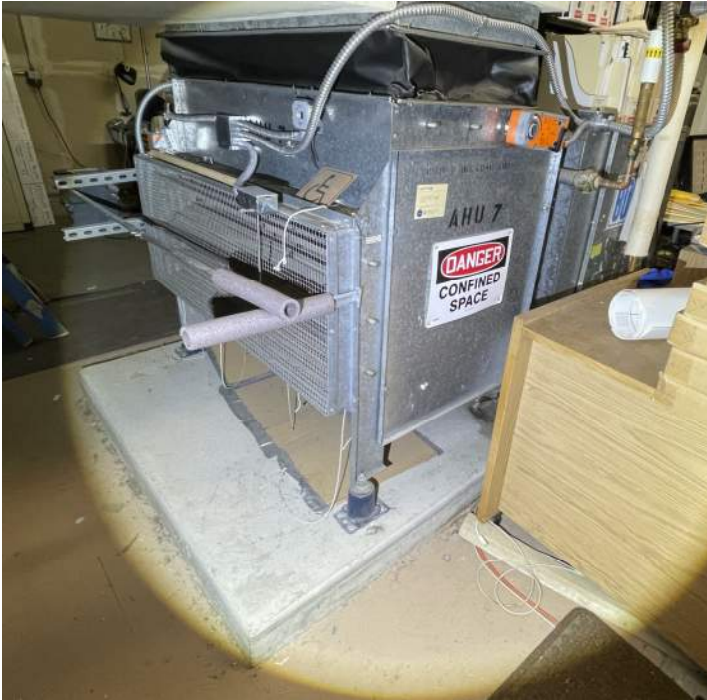
Photo 44 — Typical mezzanine level housekeeping pad and mechanical equipment.

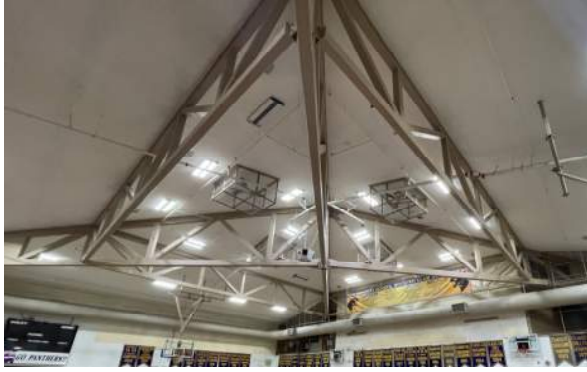
Photo 45 — Tube steel trusses supporting gym roof.

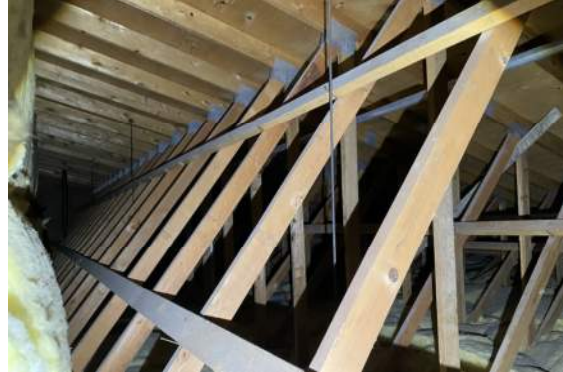
Photo 46 — Pre-engineered wood trusses

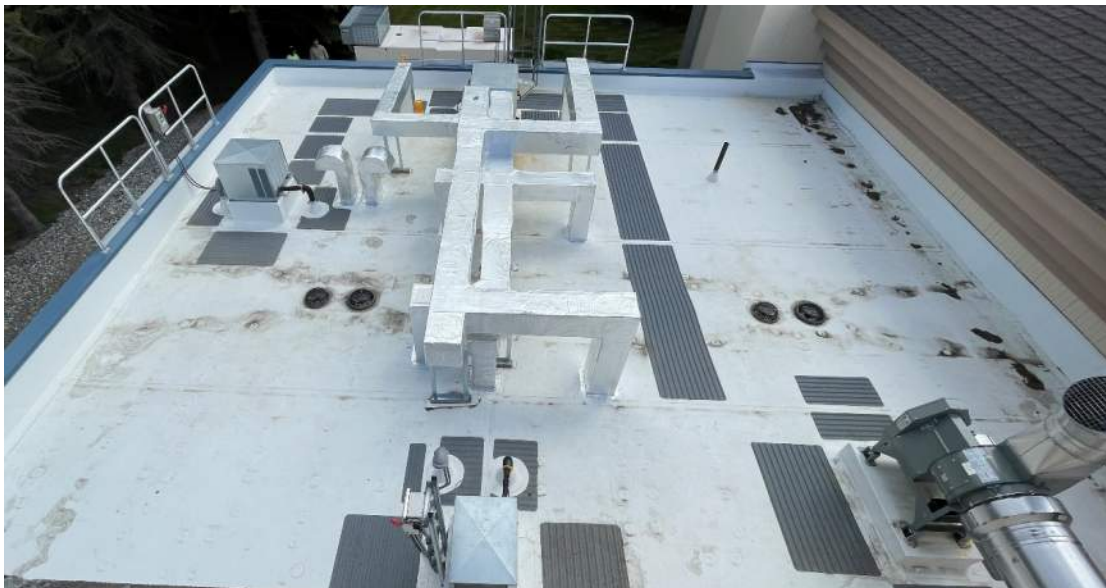
Photo 47 — Flat roof above kitchen.

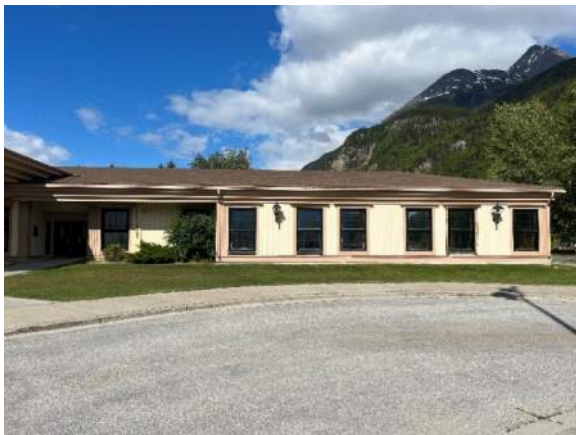
Photo AE01– East wing south wall – greatest exposure

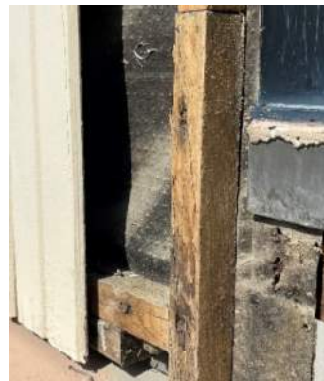
Photo AE02– Orig wood cladding assembly, typ

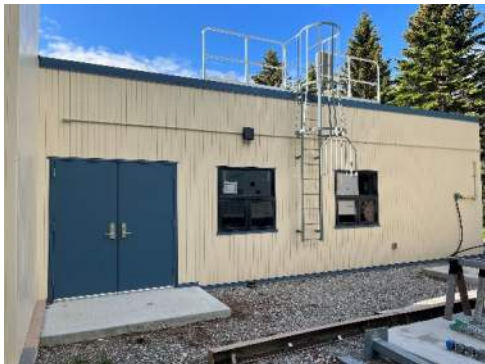
Photo AE03– New wood cladding at kitchen add

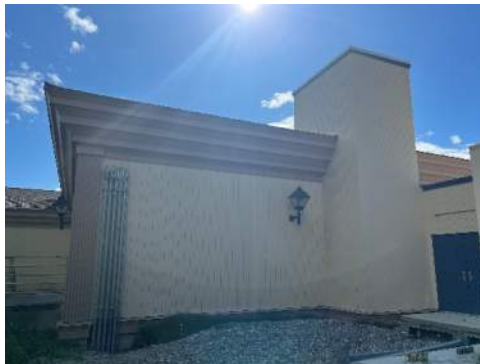
Photo AE04– New wood cladding at north chase

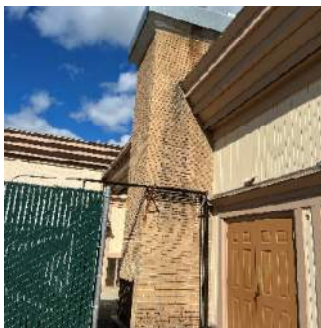
Photo AE05 – Orig brick veneer at south chase

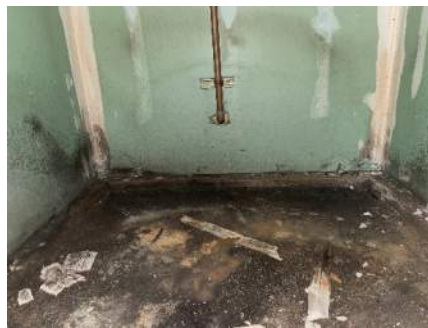
Photo AE05a – Moldy interior of chase

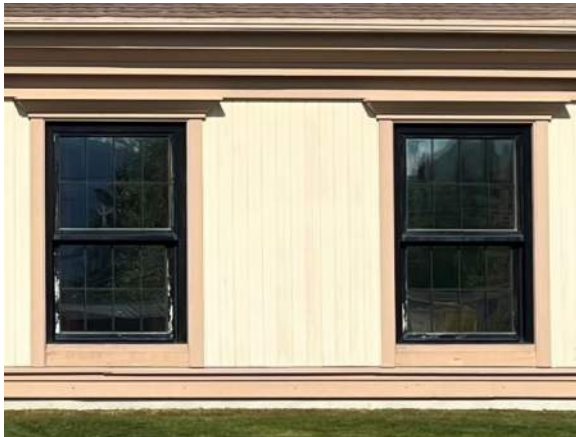
Photo AE06– Orig ext fin cap – window trim, water table

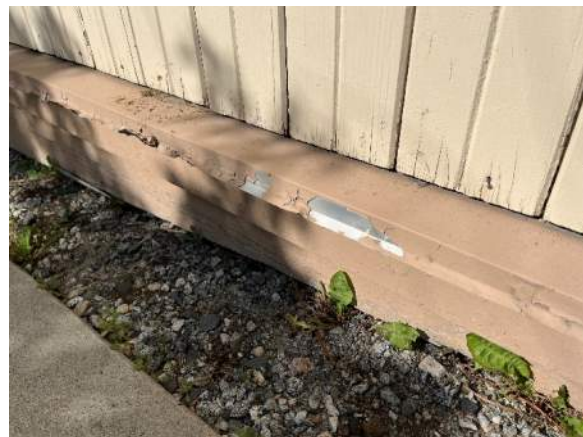
Photo AE07– Orig ext fin cap - water table

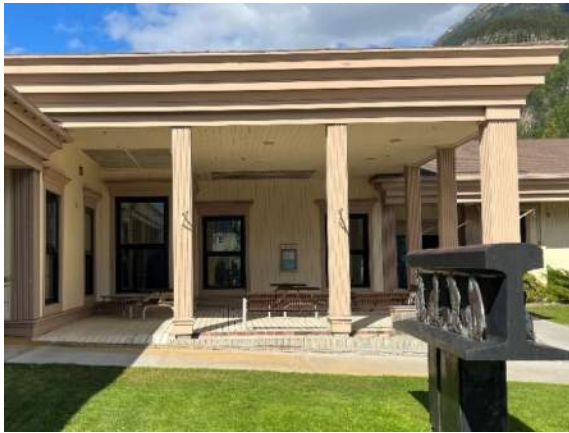
Photo AE08– Orig ext fin cap – column enc

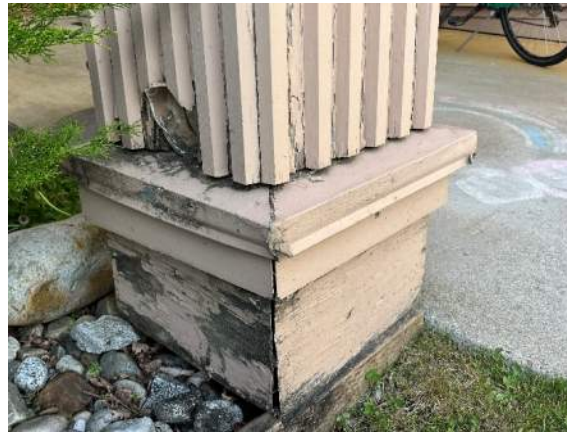
Photo AE09– Orig ext fin cap at canopy – column enc water

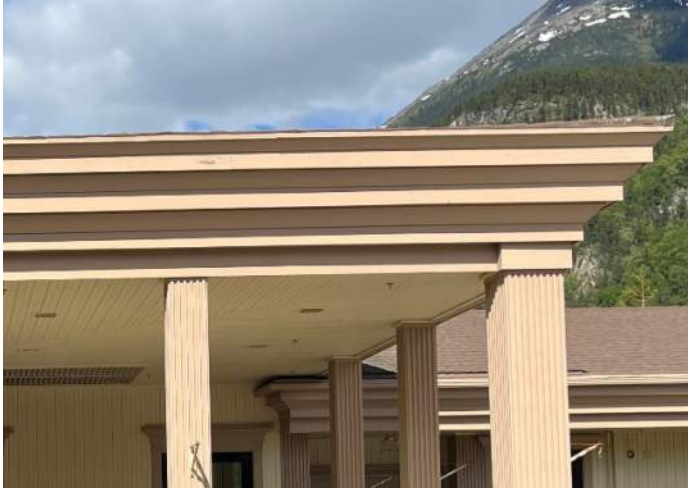
Photo AE10– Orig wood soffit/fascia, typ

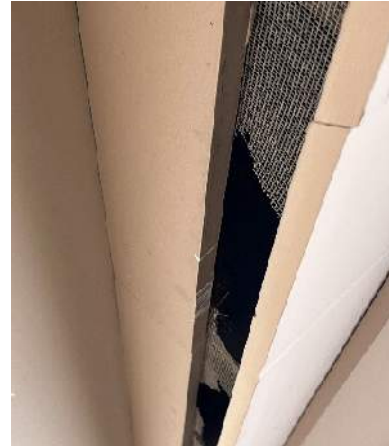
Photo AE11 – Orig vented soffit, typ

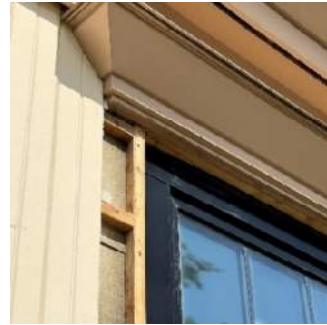
Photo AE14– Window head, typ

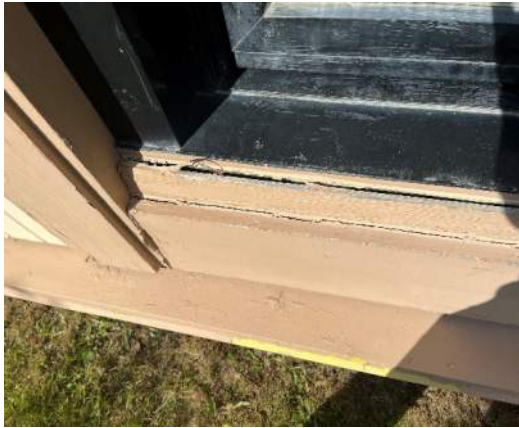
Photo AE15– Window sill, typ

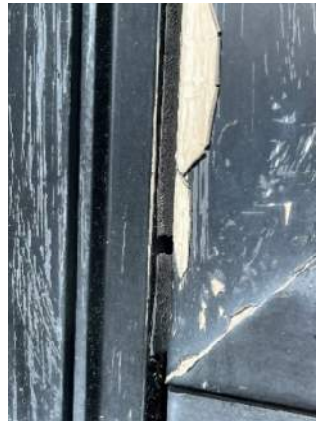
Photo AE16– Window finish, typ

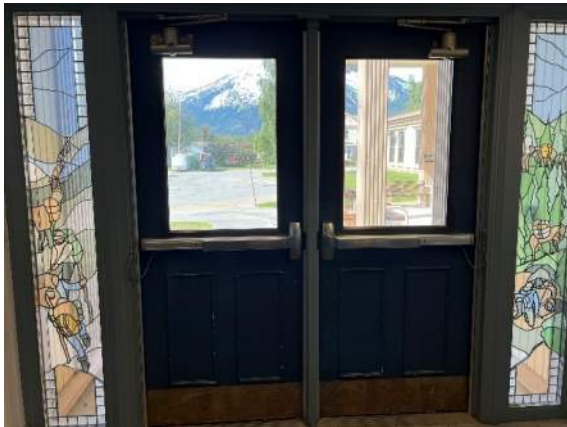
Photo AE17– Door E01, orig HM door, typ of orig doors

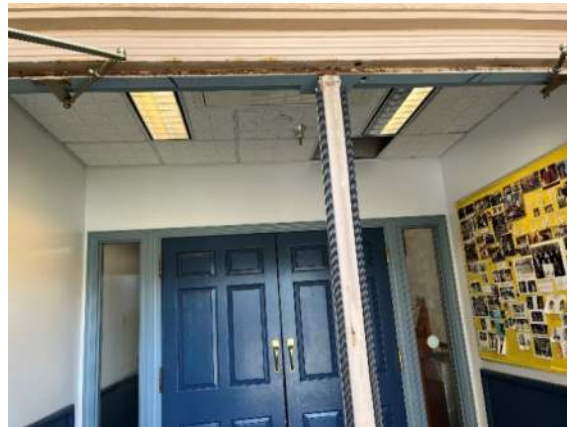
Photo AE18– Door E01, door head

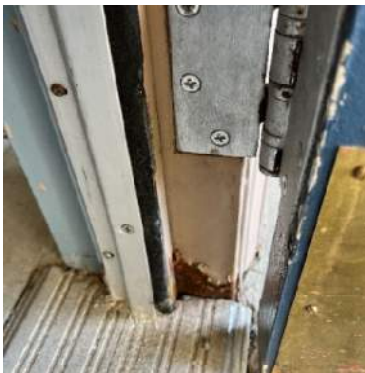
Photo AE19– Door E01, jamb at threshold

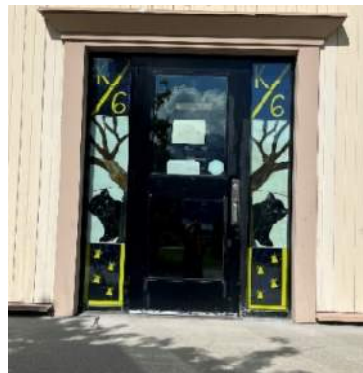
Photo AE20– Door E300, replacement alum door, typ of replacement doors

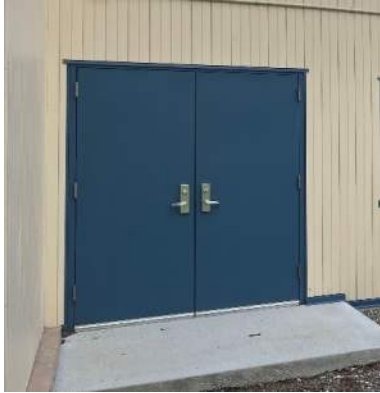
Photo AE21– Door E30A, new HM door, typ of new doors

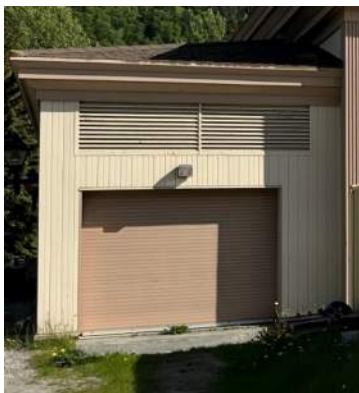
Photo AE22– Door E13C, added coiling OH door

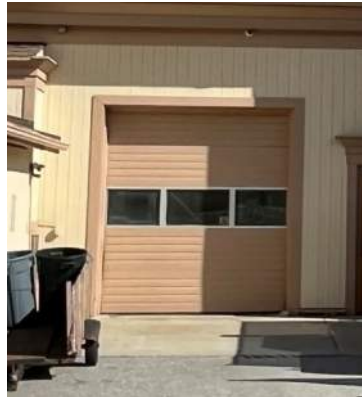
Photo AE23– Door E24B, orig sectional OH door

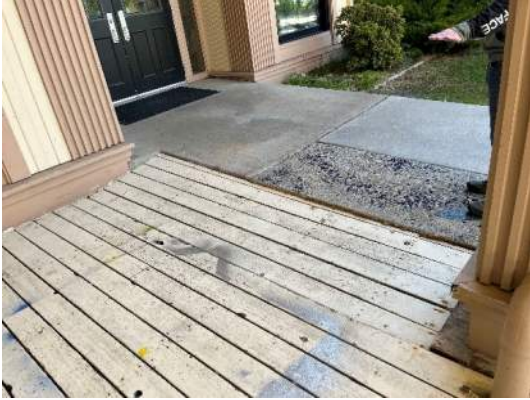
Photo AE24– Orig wood deck at entry

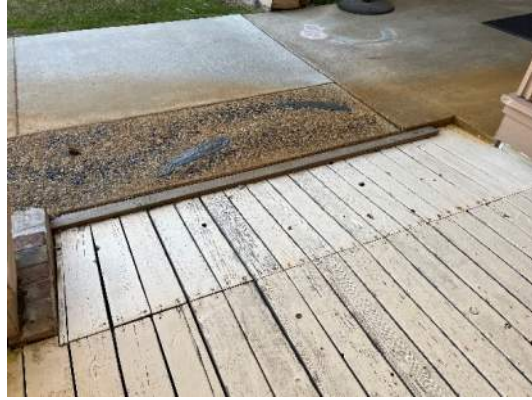
Photo AE25– Orig wood deck at entry

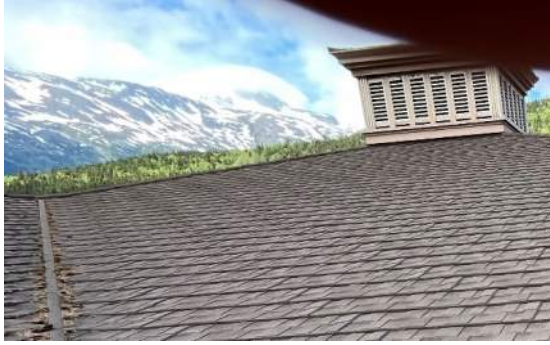
Photo AE26– Reroof 3:12 slope, typ

Existing 3:12 slope roof appears to be in good condition, notwithstanding knowing the condition of its underlayment and sheathing. To avoid the development of potential infiltration caused damage (rot, mold) we recommend preemptively verifying underlayment is performing adequately through limited destructive investigation - temporarily opening roof system to reveal sheathing. Work is recommended to occur on windward side of building in valley and/or at step flashing condition. Otherwise, correct deficient penetration flashing and provide annual cleaning to remove organics. Additionally, in accessible attic cavities, recommend replacing approx. R40 aged fiberglass batt insulation with R60 blown-in fiberglass insulation.

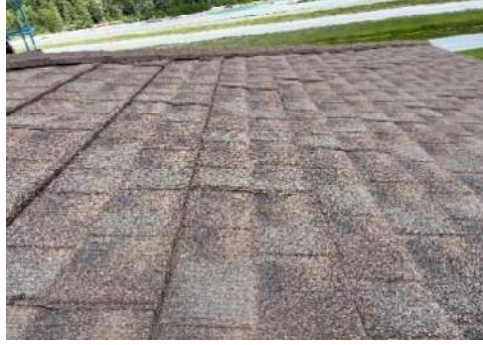
Photo AE27– Reroof 3:12 slope, open edge joints

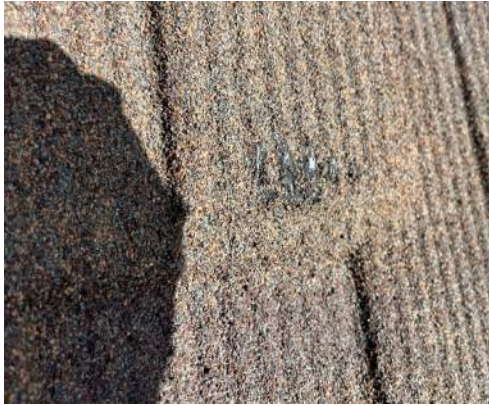
Photo AE28 - Reroof 3:12 slope, surface wear

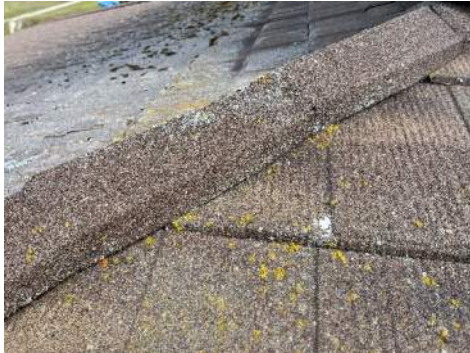
Photo A30 - Reroof 3:12 slope, exp fasteners

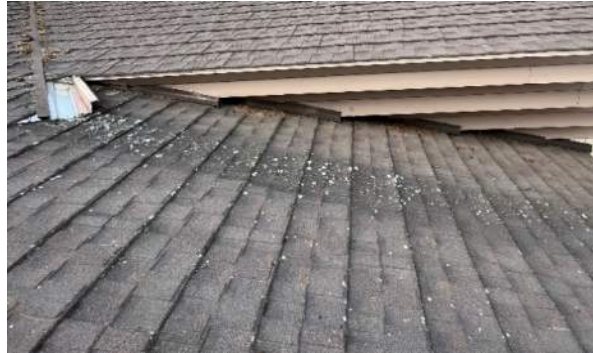
Photo A31 - Reroof 3:12slope, step flashing at corbeled fascia

For both 3:12 and 1:12 sloped roofs, if underlayment performance is inadequate, recommend re-roof with heavy-duty architectural asphalt shingles. Work should involve deconstruction and build-back of corbeled fascia/soffit assemblies to facilitate installation of proper step flashing at rake wall to roof intersections.

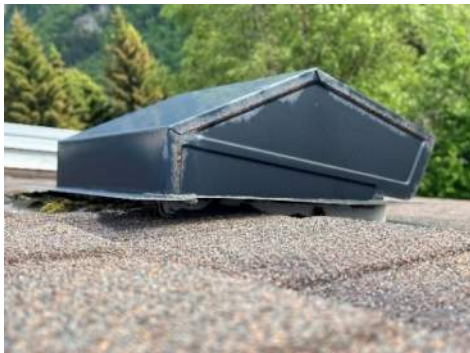
Photo A32 - Reroof 3:12 slope, improper penetration

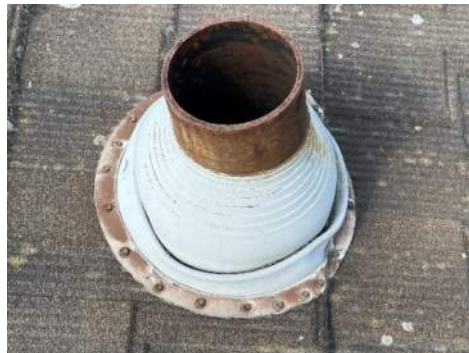
Photo A33 - Reroof 3:12 slope, improper penetration

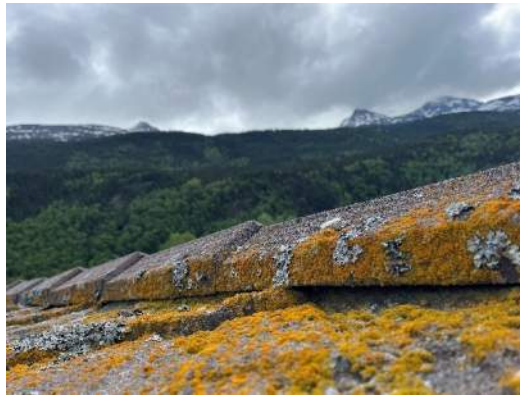
The replacement roofing is performing less well in the approx. 1:12 applications at each of the two cupolas. It is likely that this system is not warranted for low slope conditions. Moss and lichen growth are significant, causing possible infiltration. It should also be noted that the cupolas serve as the high-side venting for the roof system. The manner in which they are framed and flashed create two likely

Photo A35 - Reroof 1:12 slope supports growth

Existing 1:12 slope roof is in poor condition at surface, but true measure of condition is that of underlayment, similar to the above. Recommend verifying underlayment is performing adequately through limited, destructive investigation. Otherwise, provide annual cleaning to remove organics.

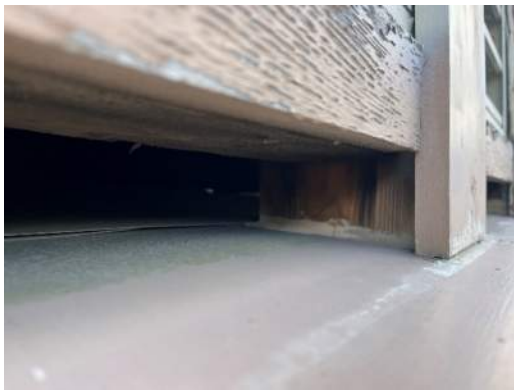
infiltration points in the cupolas' interior: positive but unsealed flashing laps in very low-slope areas is very vulnerable to infiltration from wind-blown rain as it drains down to the bottom edge of the cupolas' louvers. The vertical framing members penetrate this flashing system and appear to rely exclusively on sealant to prevent moisture intrusion at these vulnerable joints. At least one leak was identified in Gym 12 in the region of the cupola. Of note – the original construction drawings detailing construction of the louvers depict them with the wrong orientation – draining into the building. They were, however, installed in the correct orientation.

Photo AE36 - Cupola, open flashing joint and vert penetration w/ sealant

Cupolas should be deconstructed, re-detailed and built-back to address flashing and penetration deficiencies noted. This work would necessarily include new roofing in these two instances.

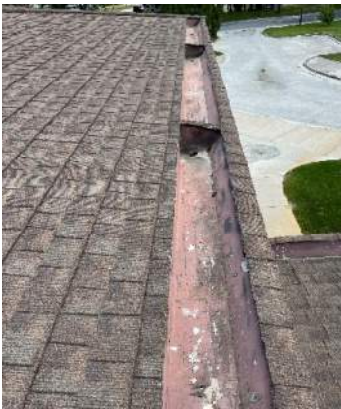
Built-in gutters are original and are used predominantly in region of building main entry to preserve architectural character of corbeled fascia/soffit assemblies but are also located in short lengths on the side opposite the main entry of the two classroom wings. They are aluminum and appear to have had a coating applied. It is unknown, but likely, that leaking is occurring at joints in the gutter pan material. It appears leaking is occurring at the gutter to downspout joints and possible along the downspouts themselves. Downspouts are internal to finish carpentry enclosures. Leakage has caused visible damage to these assemblies.

Photo AE37 – Built in gutter

Built-in gutters should be retained but lined with a continuous waterproof membrane. In advance of applying membrane, an outlet with full round flange of the same membrane material as the liner should be installed to sleeve into a replacement downspout. Downspouts should be replaced with continuous/jointless pipe downspouts. Recommend EPDM for membrane and grade 316 stainless steel tube for sleeves and downspouts. Roofing material adjacent to gutters will need to be removed to facilitate lapping membrane in and under existing roof underlayment. Exterior finish carpentry enclosures will need to be removed and replaced to facilitate this. New enclosures should be reconstructed with a removable panel to allow for periodic inspection and maintenance of the downspouts.

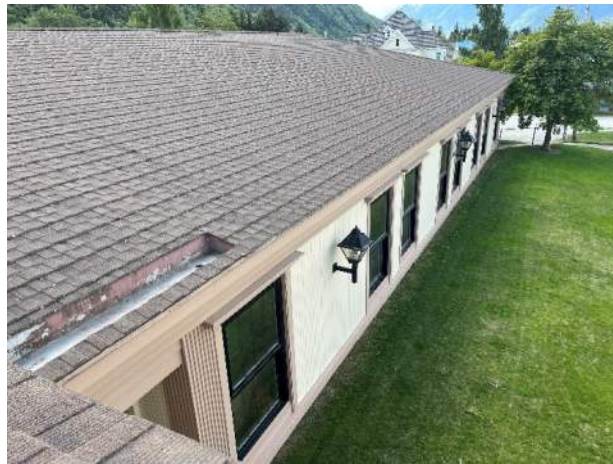
Photo AE38 – Built in gutter, otherwise no gutters except in limited applications

Fascia-mount gutters should be removed and replaced. Additionally, fascia-mount gutters should be installed for full pitched roof perimeter except where built-in gutters are located. They should be installed flat at a minimum with a slight positive slope towards downspout outlets. New gutters should be installed with continuous eave flashing providing drip edge into gutters for their full length. Gutters should be installed using heavy duty straps to prevent ice/snow loads from damaging/deforming gutters and potentially altering their slope. Recommend 20g, G90 HDG, painted sheet steel for fascia-mount gutters and associated downspouts. Gutters and downspout cross-sectional areas should be sized using roof stormwater calculations based on local rainfall data. If ice damming has been experienced historically, gutters and downspouts should be provided with thermostatically activated heat trace, supplied by dedicated circuits designed by an electrical engineer.

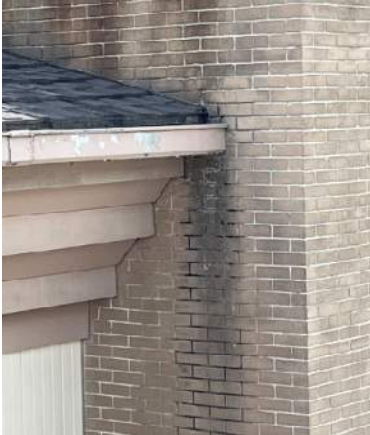
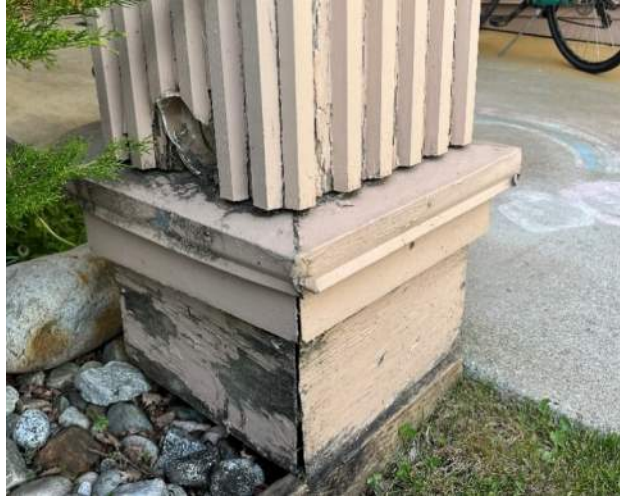
Photo AE39 – Example limited gutter Photo AE40 – Built in gutters use internal downspouts

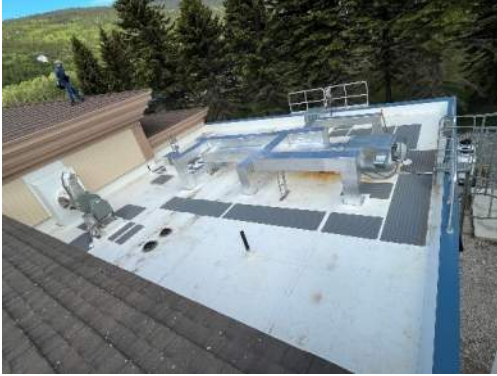
Photo AE41 – Flat roof at kitchen addition

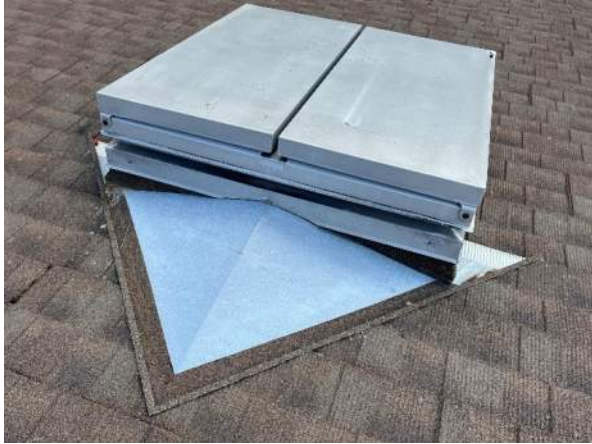
Photo AE42 - Smoke vent over room Stage 7

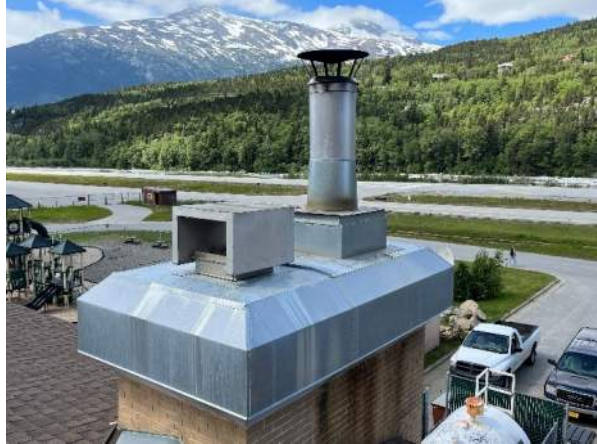
Photo AE43 – Cap flashing at south chase

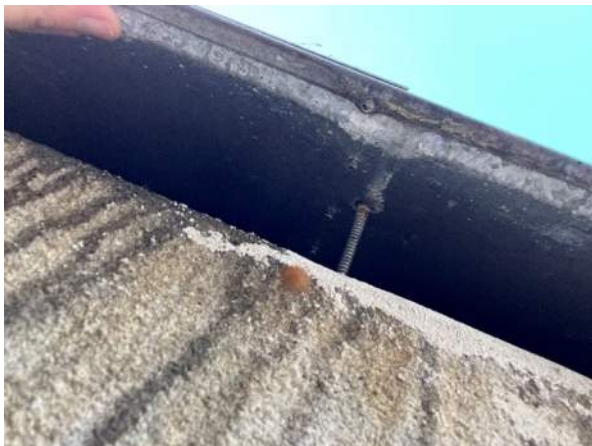
Photo AE44 – Cap flashing at south chase fastening

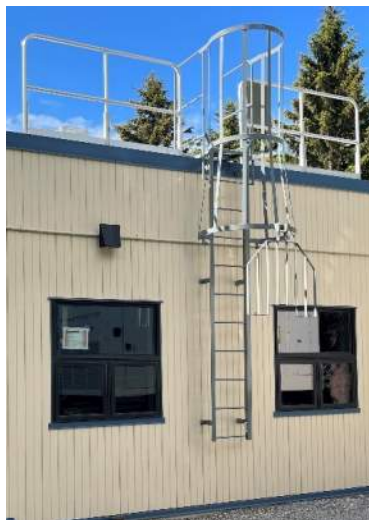
Photo AE45– Roof access ladder at kitchen addition

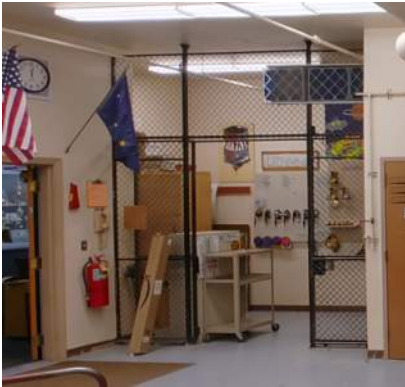
A106 – Metal Screen in Shop

Chain link enclosure incidentally acts as guard. Verify that it meets OSHA requirements for guards serving regularly unoccupied service spaces.

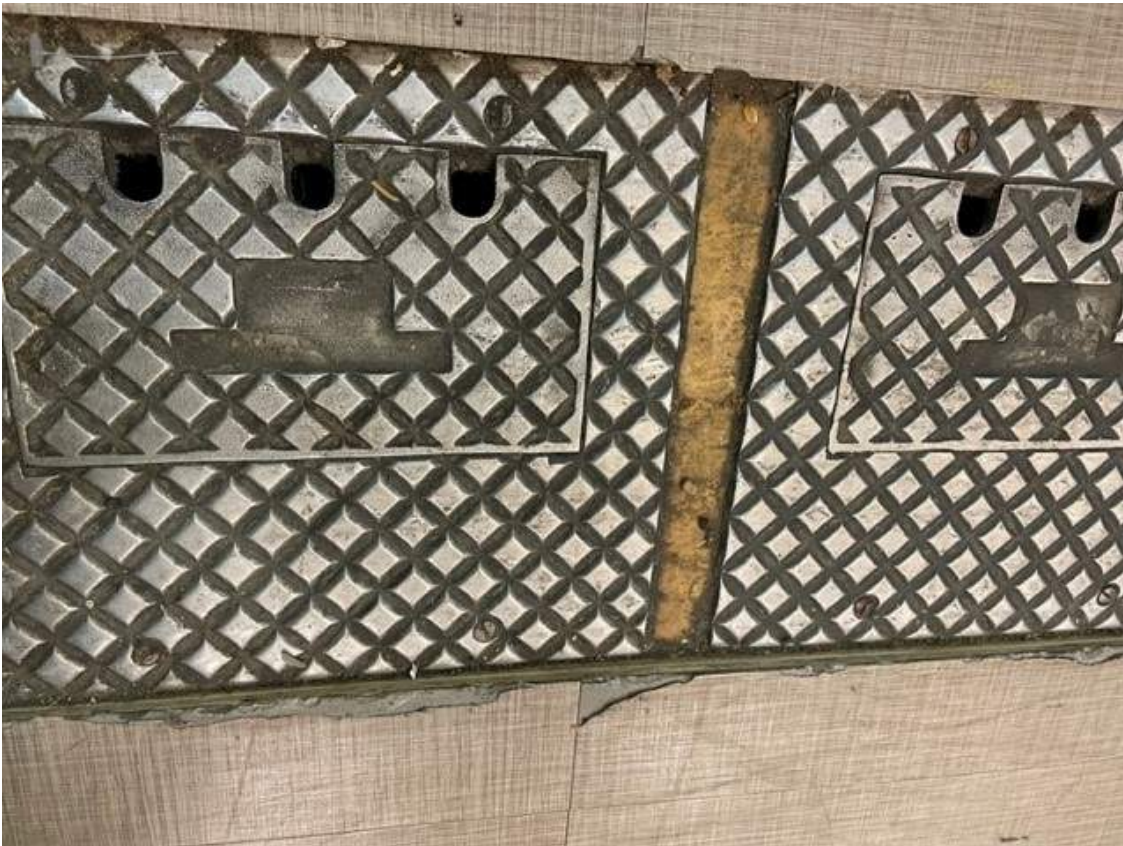
AI24a – Multi-Purpose Room – Vinyl Tile installed over Original Floor

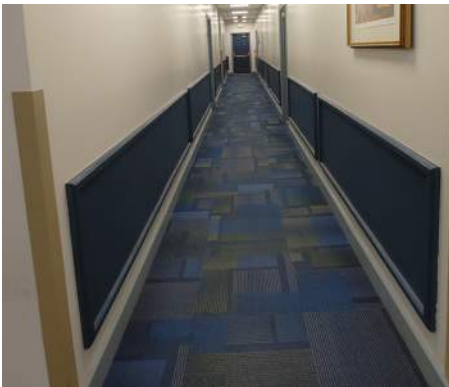
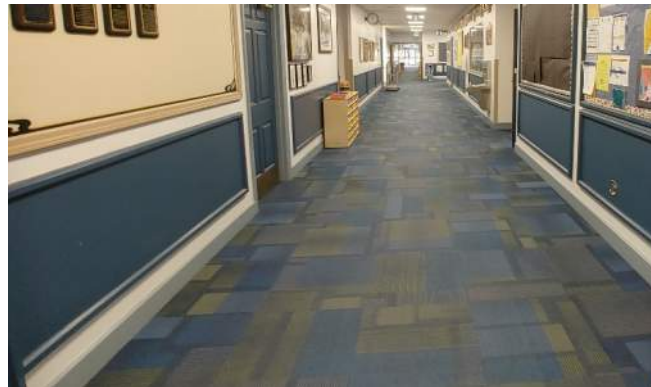
AI25 & AI26– Wood Wainscot in Hallways

- As a part of any future renovation work, recommend environmental engineer sample and test materials.
- Painted gypsum boards should be patched and repaired as needed, paint to match surrounding area
- Wood wainscot surface and finish carpentry should be repaired in areas of damage, prepped and repainted. Provide corner protection in vulnerable areas.
- Remove tile, grout and thinset or mastic. If mastic, may contain asbestos- see environmental engineer's report. Repair/prep substrate as necessary, apply new tile with appropriate modified thinset and with control/expansion joints designed to alleviate existing cracking conditions.
- Remove felt wall coverings, remove adhesive, prep underlayment or replace in kind as required for an applicable surface for a new wall covering to be installed. Replacement materials shall meet IBC Chapter 8 requirements.

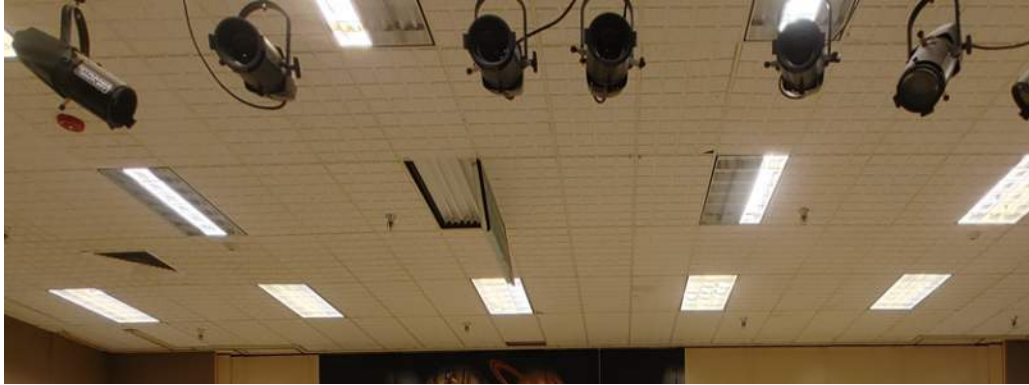
- 24”x48” ACT: Most in relatively good condition, approx.. 5% could be replaced due to wear, [3], 10 yr
- Gypsum board, painted: Most in relatively good condition with damage primarily limited to mechanical rooms [2-3], 5 yr

AI29 – 24”x48” ACT in metal grid

- As a part of any future renovation work, recommend environmental engineer sample and test materials.
- Recommend additional visual inspection of bracing and add required bracing as per ASTM E580 as needed to the suspended grid.

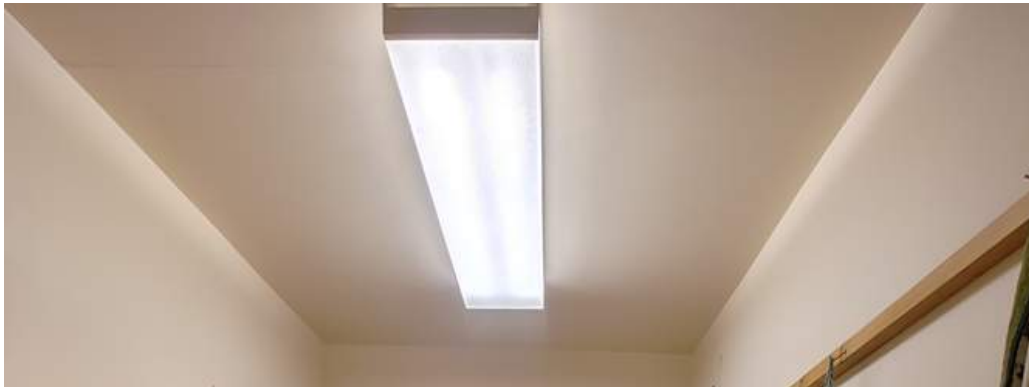
AI30 – Painted gypsum board

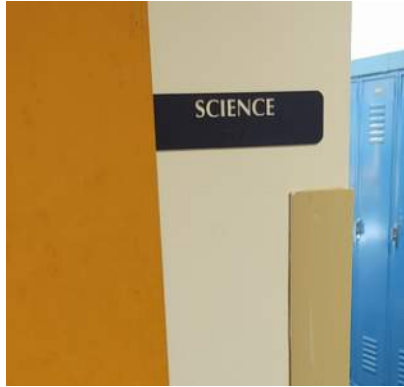
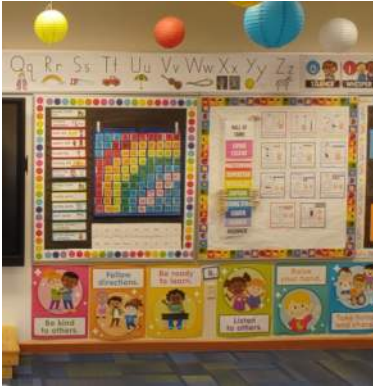
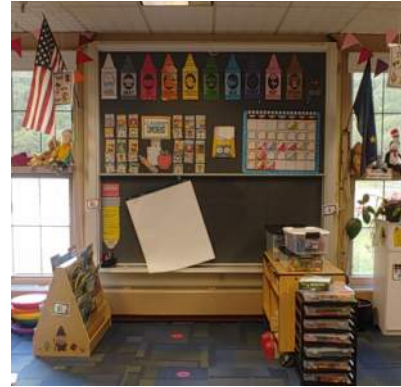
AI32, AI33 & AI34 – Signage, Tackboards and Blackboards

Room identification signage should be replaced with signage that conforms with the American Disabilities Act. Blackboards should be updated with white boards in the next five years to maintain consistency in writing surfaces for teachers.

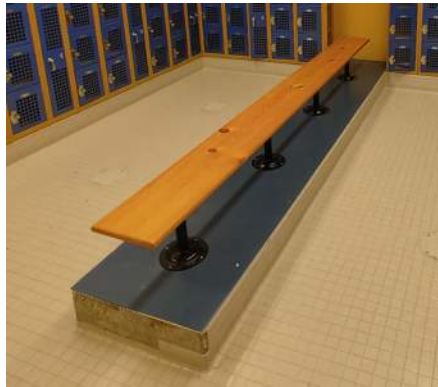
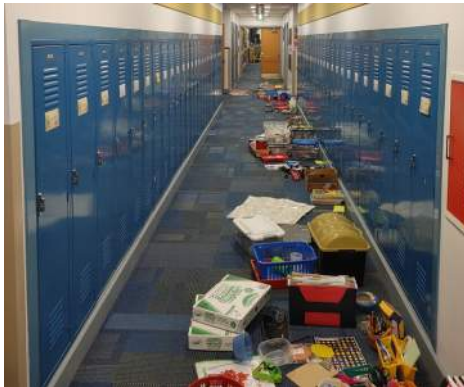
AI35 & AI36 – Locker room bench and Elementary Wing lockers

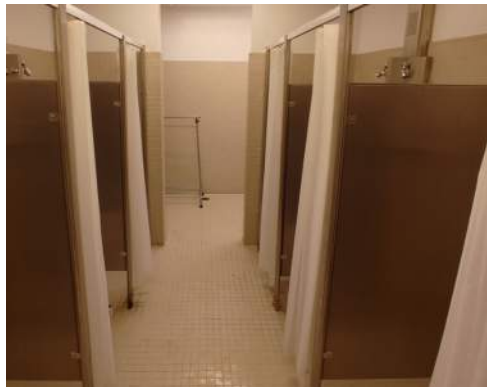
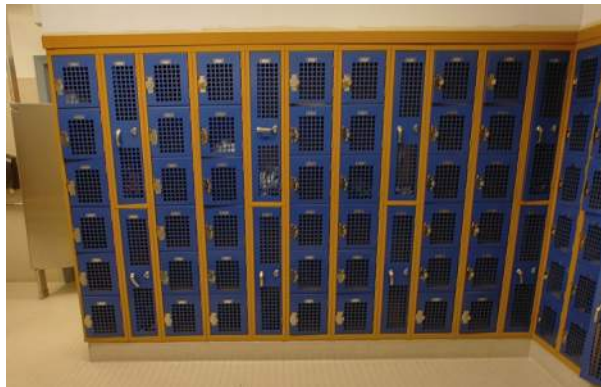
AI37 & AI38 – Shower partitions and Gym lockers

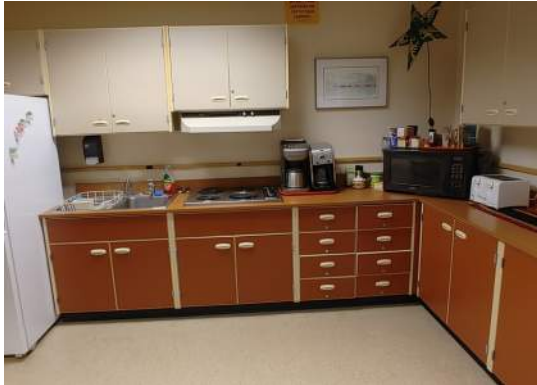
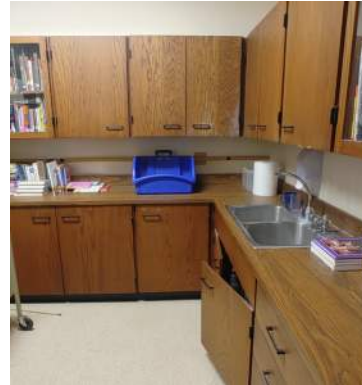
A139 & A140 – Break Room casework and Library casework

Replace all upper and lower casework with architectural plastic laminate faced premium grade, ADA compliant casework.
