CONDITION ASSESSMENT REPORT

November
2023

SKAGWAY K-12 SCHOOL FACILITY CONDITION SURVEY

**MUNICIPALITY OF
SKAGWAY BOROUGH**

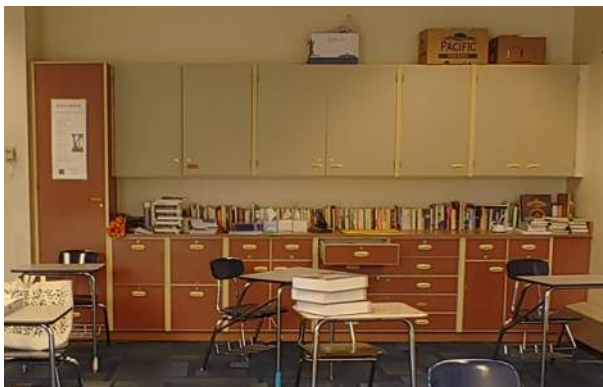
A141 – Classroom Casework

Replace all upper and lower casework with architectural plastic laminate faced premium grade, ADA compliant casework.

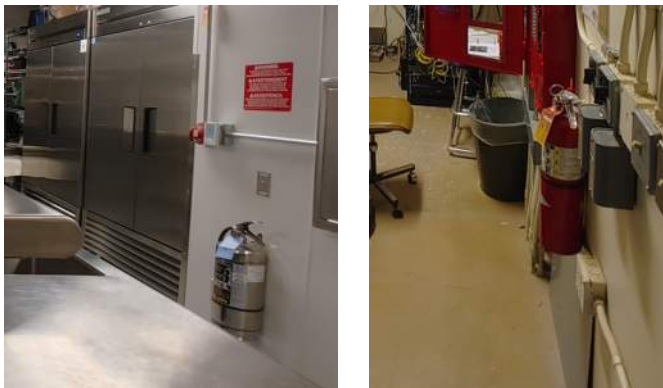
AI42 & AI43 – F.E in Kitchen, Elec

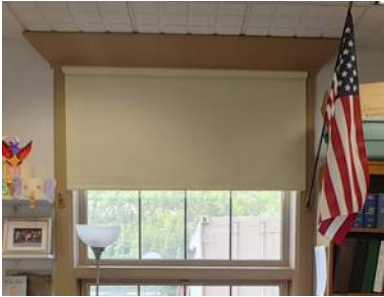
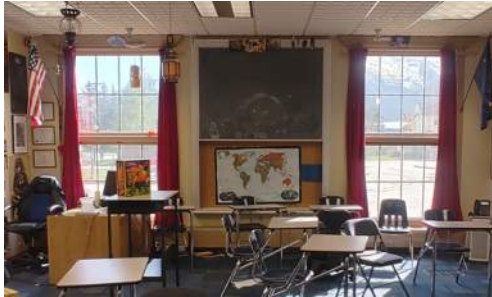
A143 & A144 – Classroom pull-down blinds and drapes

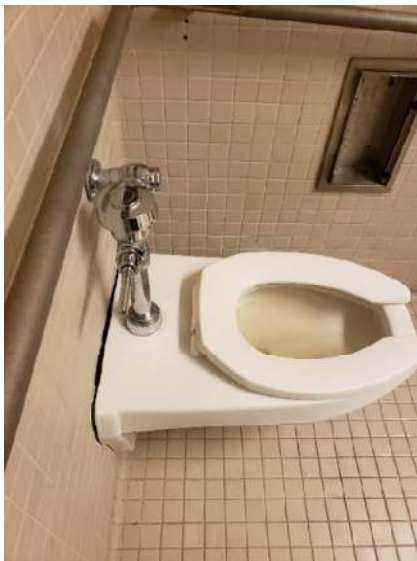
Boy’s Restroom Toilet Wall Separation

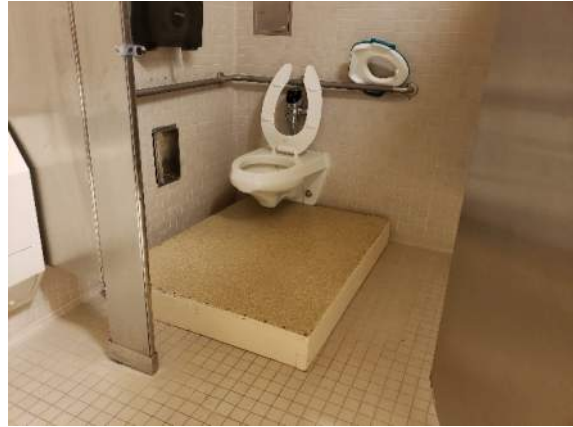
Wood Platform (Girls Restroom 305)

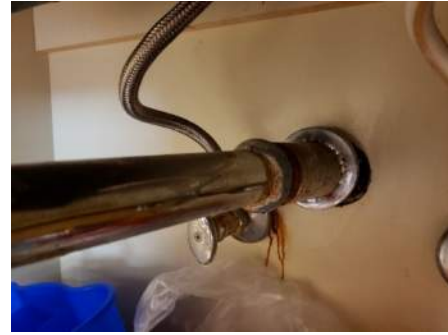
Previous Leak at Wall Penetration

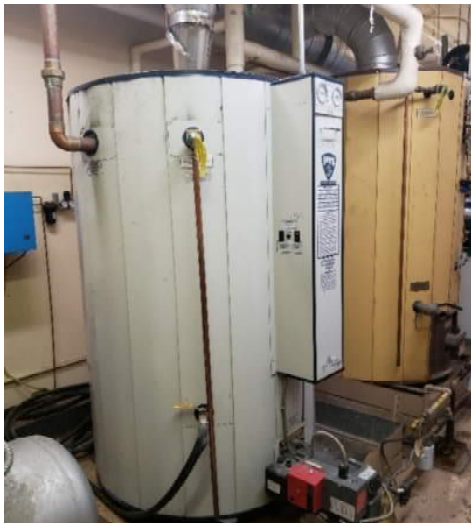
Water Heater & PRV

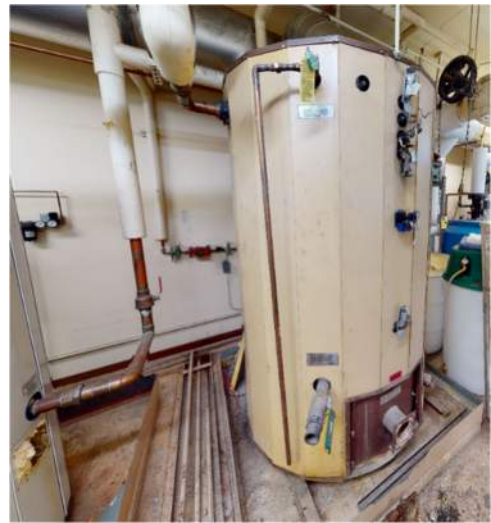
Hot Water Recirculation Pump

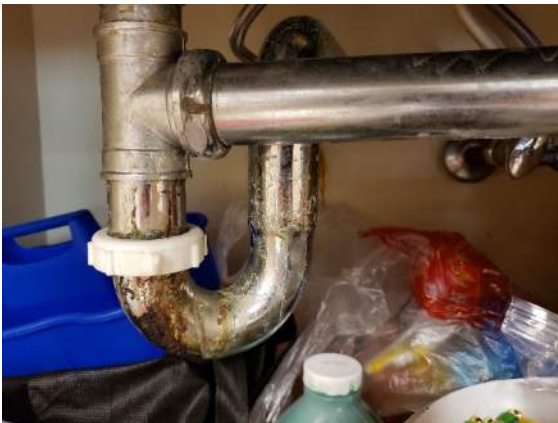
Classroom 301 Sink P-Trap

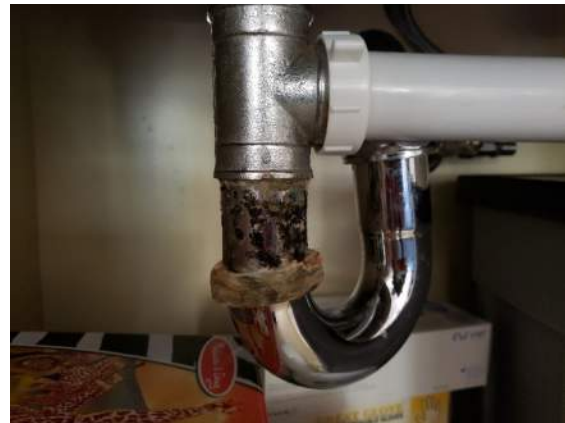
Classroom 315 Sink P-Trap

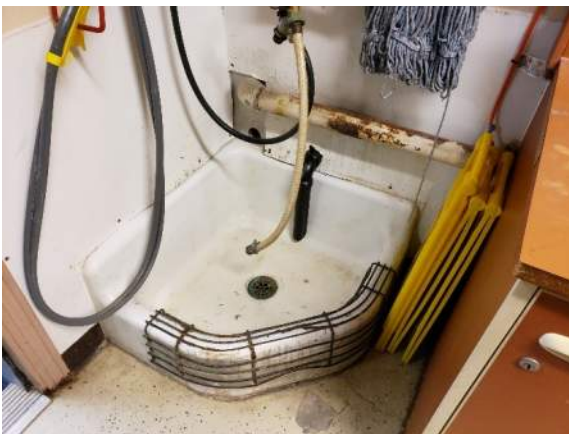
Janitor Mop Sink Drain Line w/o Air Gap

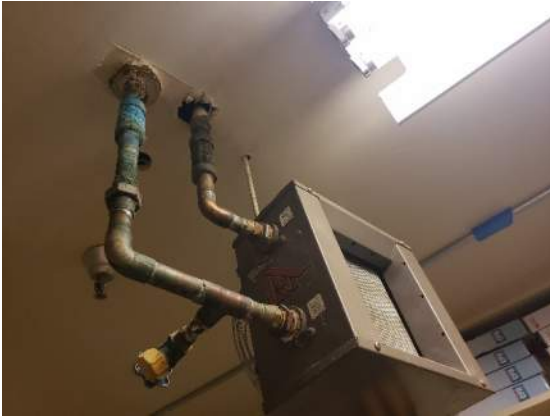
Unit Heater Flex Oxidation

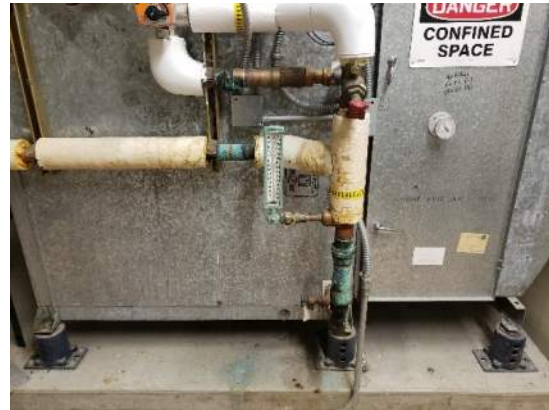
AHU-5 Heating Coil Oxidation

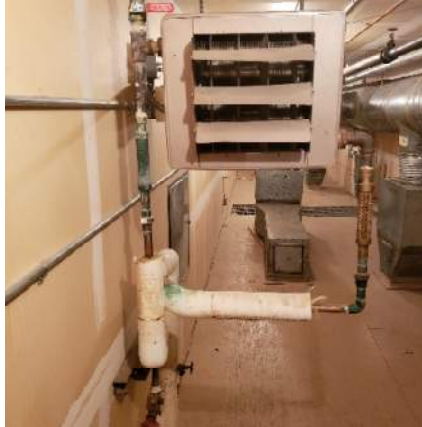
Dissimilar Metal Corrosion

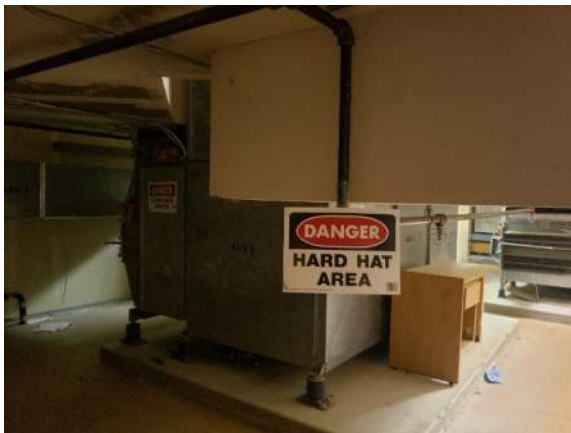
AHU-1

Air handler, AHU-1, was in poor condition. Per facility staff, the associated fan motor was fried and the unit was non-functional.

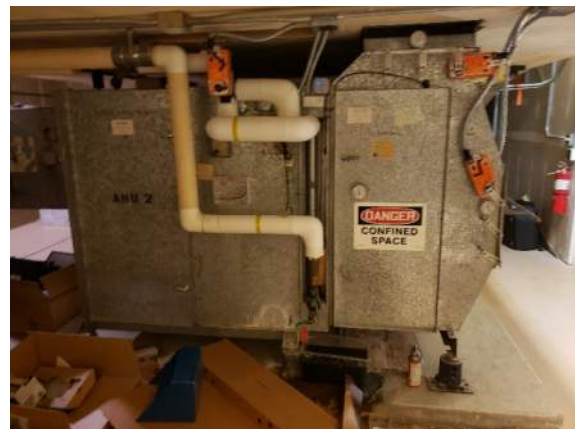
AHU-2

Air handler, AHU-2, was in poor condition. The unit had a constant squeaking sound during operation. Also, the flex duct on the supply air connection was leaking from a damaged portion. Finally, there was a severe glycol leak at the heating coil connections. Reference the heating distribution systems section for more information.

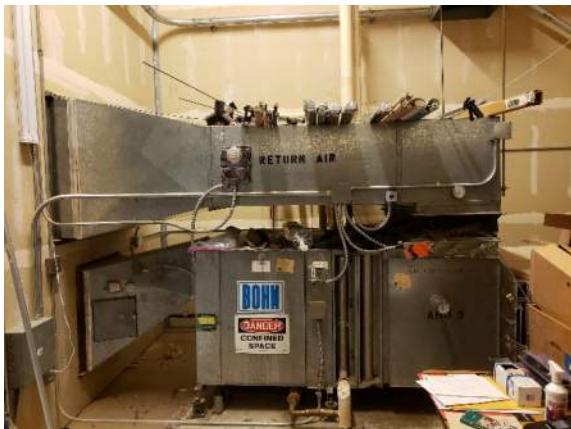
AHU-3

Air handler, AHU-3, was in fair condition. The unit air leaks on the return air flex connection to the mixing box and at the outside air flex connection. Additionally, per facility staff, the associated interlocked mixing box control damper is stuck in the open position.

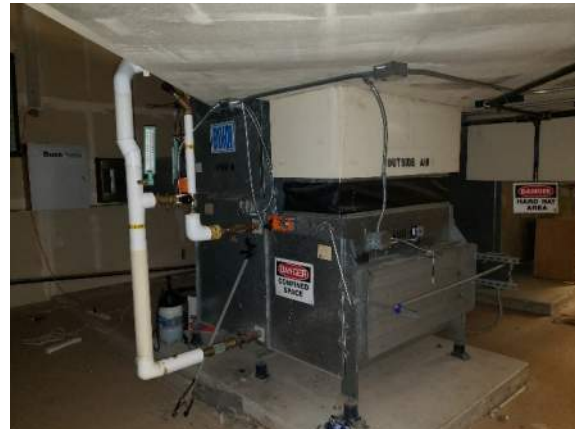
Air handlers, AHU-4 and AHU-5, were in fair condition. The units have been regularly maintained with no notable deficiencies.

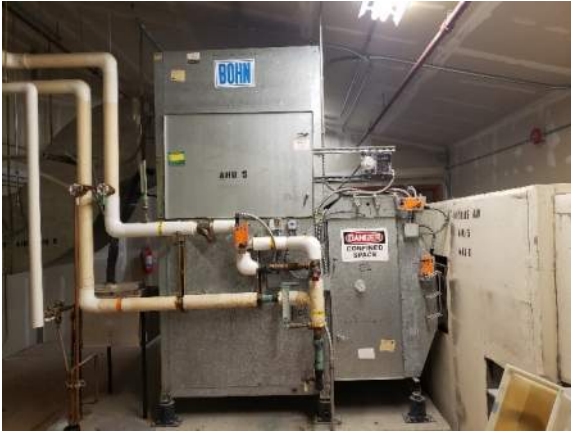
Air handler, AHU-5, serves the gymnasium and is in the gym mezzanine. AHU-5 is a Bohn VCS26ALF 12,800 CFM constant volume vertical draw through air handling unit with a 7-1/2 HP belt-driven forward curved fan. AHU-5 has an integral filter bank, mixing box, and re-heat coil. Return air and outside air dampers are actuated by DDC-controlled interlocked Belimo damper actuators. The unit is supported by spring-mount vibration isolators on a concrete housekeeping pad. The unit is connected to the supply and outside air ductwork with flex connectors. A Vaporstream VLC-24-2 electric steam humidifier adds moisture to the supply air for AHU-5. The humidifier has a capacity of 68.4 pints per hour and is located directly next to AHU-5. The humidifier is supported with angle iron from AHU-5's housekeeping pad.

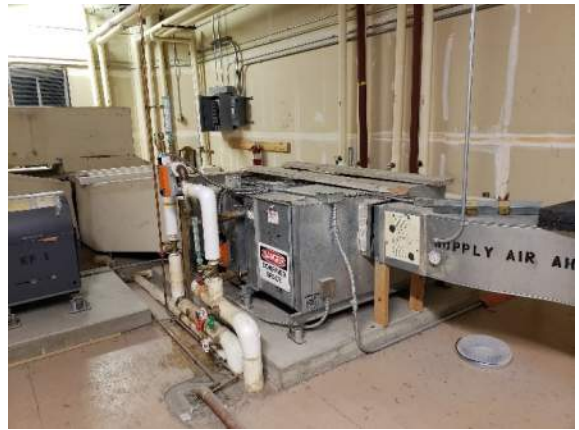
AHU-6

Air handler, AHU-6, was in poor condition. There were wood planks resting on top of the unit that spanned the length of the unit. Additionally, per facility staff, the motor was fried and the unit was non-functional.

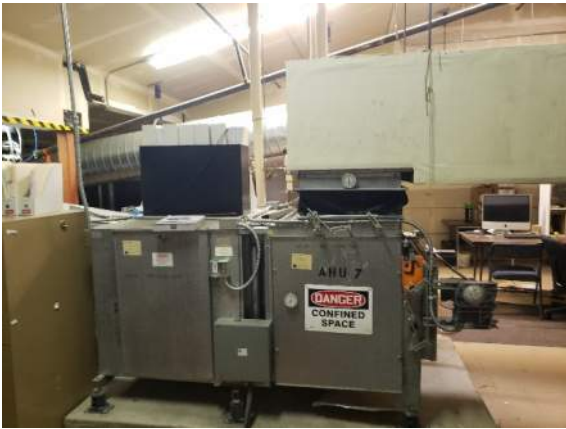
AHU-7

Air handler, AHU-7, was in poor condition. Per facility staff, the unit was never wired up and has not functioned.

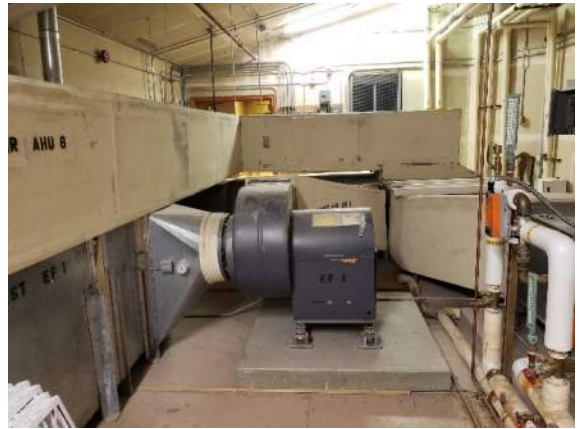
EF-1

Exhaust fan, EF-1, was in poor condition. The unit was vibrating loudly and rattling during operation. The rattling noise was transmitting to the adjacent storage spaces behind the fan room.

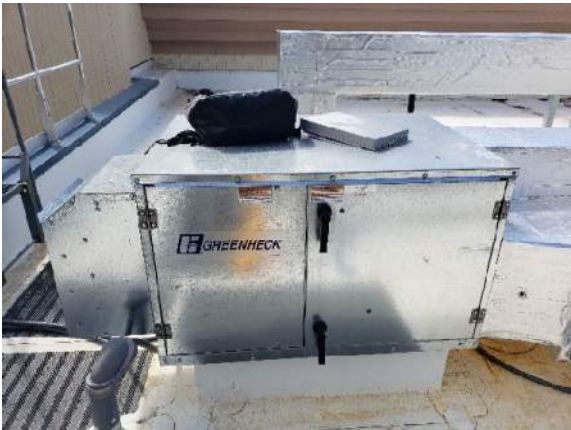
ERV-1

Energy recovery ventilator, ERV-1, was in good condition.

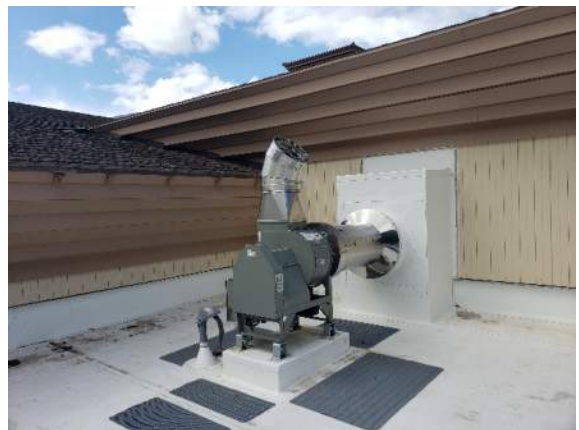
EF-3

Exhaust fan, EF-3, was in good condition.

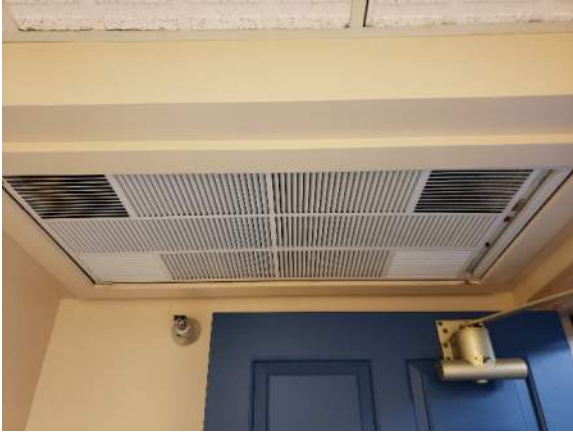
EC-1

Electronic air cleaner, EC-1, was in poor condition. The unit was extremely noisy during operation.

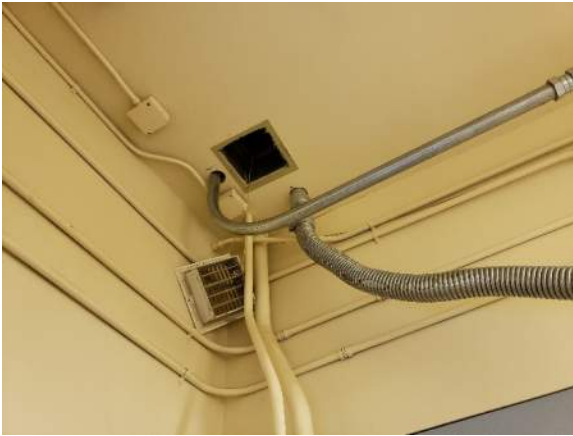
Exhaust fan, EF-5, was in fair condition. The associated exhaust grille had separated from the ceiling and was hanging from the associated ductwork by a wire.

EF-5 Exhaust Grille

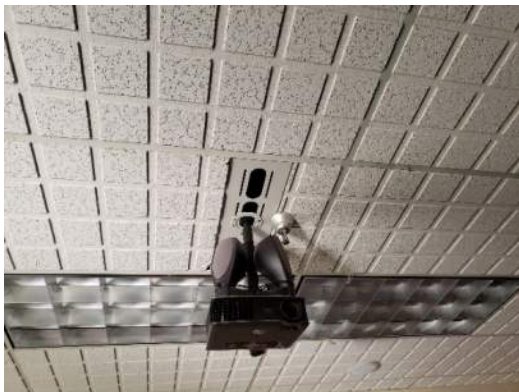
Sprinkler heads were located above the projectors in Classrooms 205, 221, and 314. The sprinkler flow pattern is obstructed as a result.

Sprinkler Head Above Projector

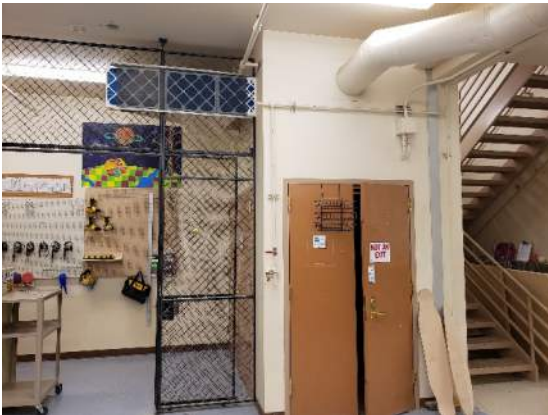
Dust Collector

Per facility staff, the dust collection system is scheduled to be modified this summer to accommodate the relocation of the art room and connection of existing shop equipment. The dust collection system was tested to be operational and confirmed by the facility staff. Overall, the dust collection system is in fair condition. The filter bank located in the fencing adjacent to the dust collector was not securely fastened.

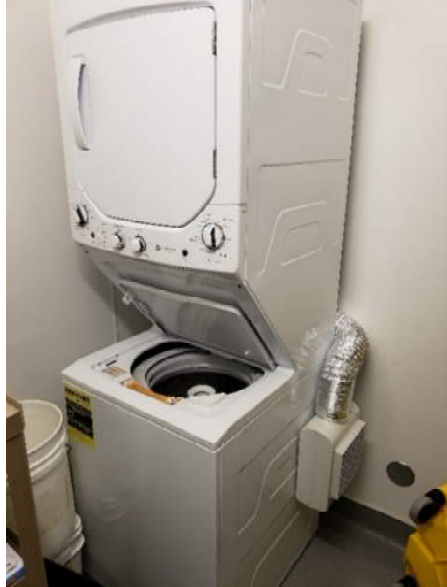
The dryer located in the kitchen was in good condition.

Kitchen Dryer

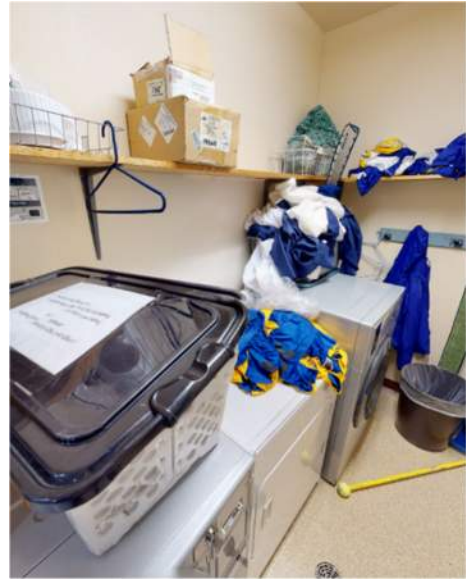
The dryers located in the laundry room were in fair condition.

Laundry Room Dryers

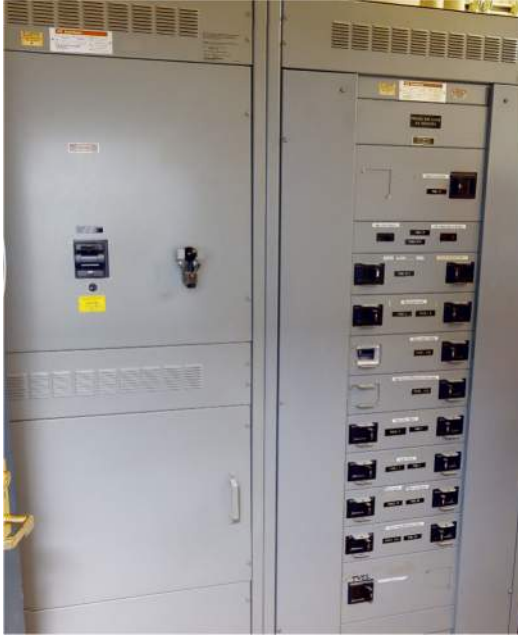
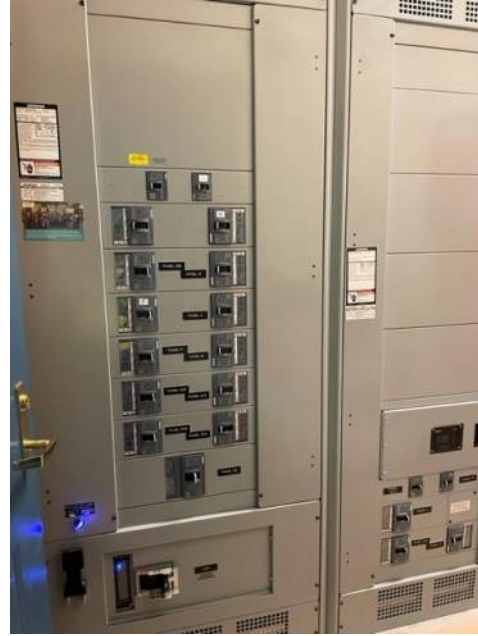
At the time of the condition assessment, the Switchgear was from the original construction but was in good condition. Staff reported that new breakers could still be obtained and almost all of the breakers are labeled. Since the condition assessment, new switchgear has been installed as part of the kitchen renovation project.

Original Switchgear (left); New Switchgear (right)

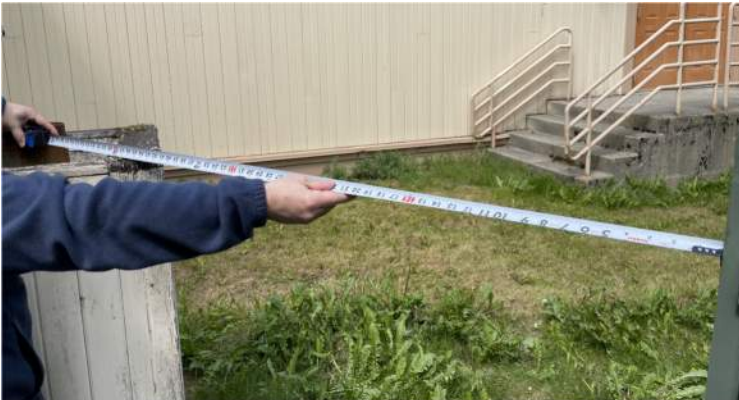
Transformer and transformer vault are located near a fuel tank located outside. The fuel tank is piped into the science classroom for Bunsen burners. The fuel tank is ~42” from the transformer, and ~36” from the transformer vault. The vault and transformer and potentially located within the hazardous location boundaries caused by the tank.

Distance between the Transformer Propane Tank

While a detailed analysis should be performed to determine the exact hazardous location boundaries, if the tank and tank enclosure are moved at least 10 feet away from any electrical equipment, conduits, vaults, or similar then no other modifications would be required.

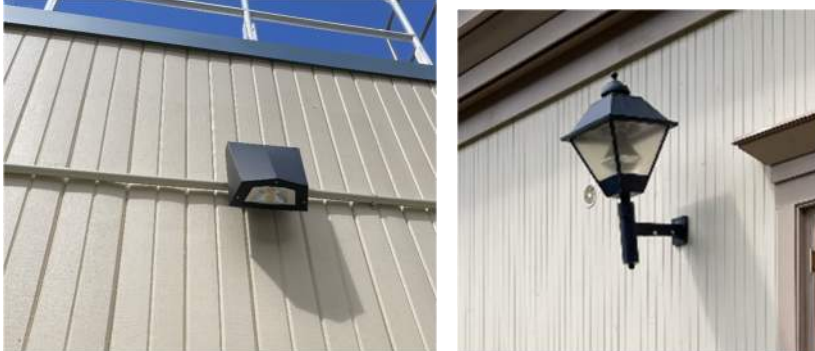
There is no site lighting for the playground. The parking lot is insufficiently lit, but due to night conditions in the summer when the site visit occurred, actual light conditions could not be measured.

Site Lighting – LED lights on Kitchen Addition (left); wall-mounted lights on original building (right)

- Add a pole light across the road for the parking spots.
- Add site lighting for the playground.
- Replace failed fixtures with new LED fixtures.

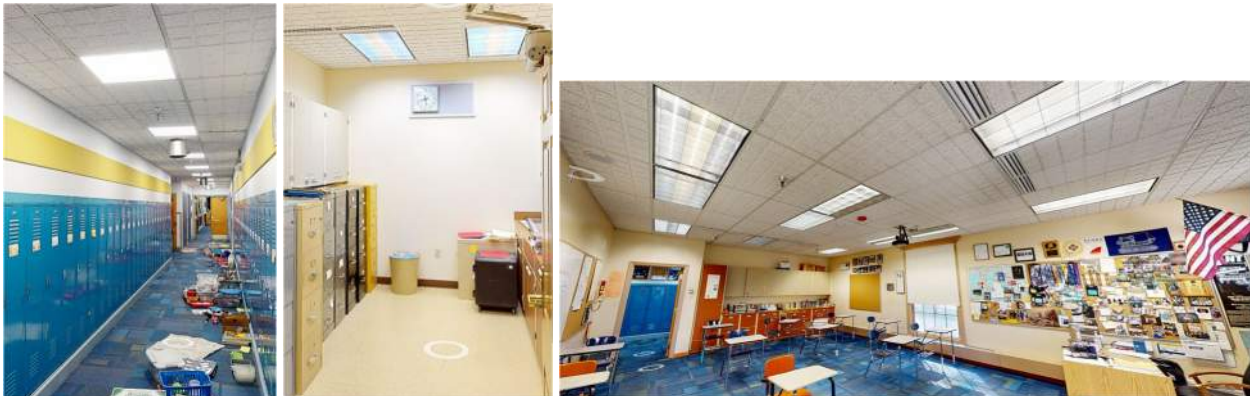
Internal Lighting, Hallways – The hallway lighting has been recently replaced with 2'x2' LED fixtures (Backlit LED Panel Light, Make: Keystone Model: KT-BPLED40PS-22-8CSA-VDIM / G2). The hallway lighting dispersion and levels are excellent, with footcandles ranging from 20 to 38, with the recommended minimum of 20 footcandles. The white light is pleasant on the eyes while providing even coverage and no harsh lighting locations.

Left to Right: Hallway with new LED lighting, Storage Room with Ex. 2'x4' fluorescent lights, Classroom with Ex. 2'x4' fluorescent lights

The new LED fixtures being used in the hallway should be used in the classrooms and offices as well for ease of installation, ordering, and minimizing different spares on site. The new 2'x2' light fixtures should be evenly spaced in the dropped ceiling across the room for even distribution. Two new 2'x2' light fixtures should be provided for every single 2'x4' being replaced, but the two 2'x2' should not be side-by-side but evenly located in the room. Ideally the classrooms will have two lighting circuits to allow for different lighting levels.

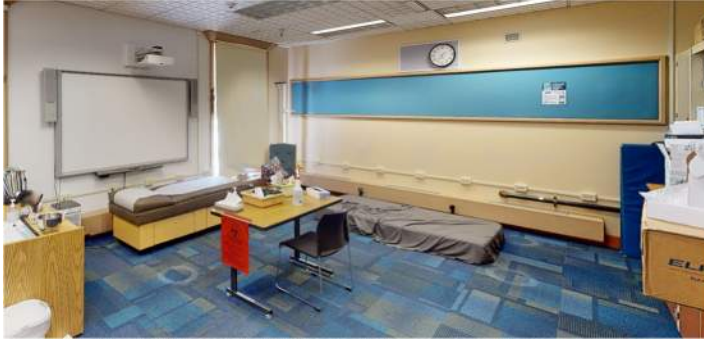
A classroom was converted into a nurse’s room and preschool room. Receptacles are plentiful but located low, within reach of preschoolers’ fingers. As the room is used for examination and first aid treatment, this room is treated by the NEC as “Patient Care Space, Basic Care (Category 3) Space”, defined as “Space in which failure of equipment or a system is not likely to cause injury to the patients, staff, or visitors but can cause patient discomfort” and “Category 3 spaces, formerly known as basic care rooms, are typically where basic medical or dental care, treatment, or examinations are performed. Examples include, but are not limited to, examination or treatment rooms in clinics, medical and dental offices, nursing homes, and limited care facilities”.

Nurse and Preschool room with low receptacles

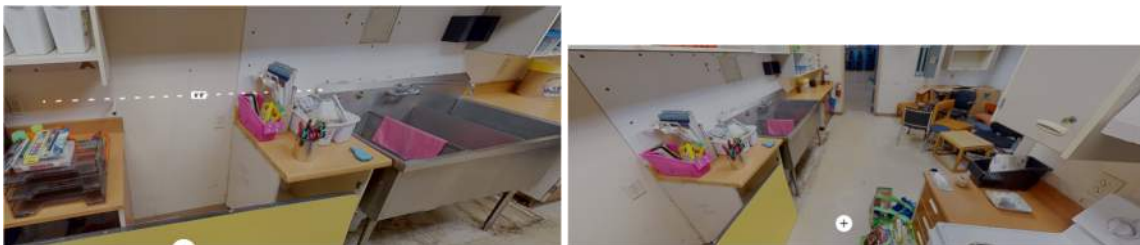
Left to Right: Sink with receptacles nearby, Sink with receptacles across the room

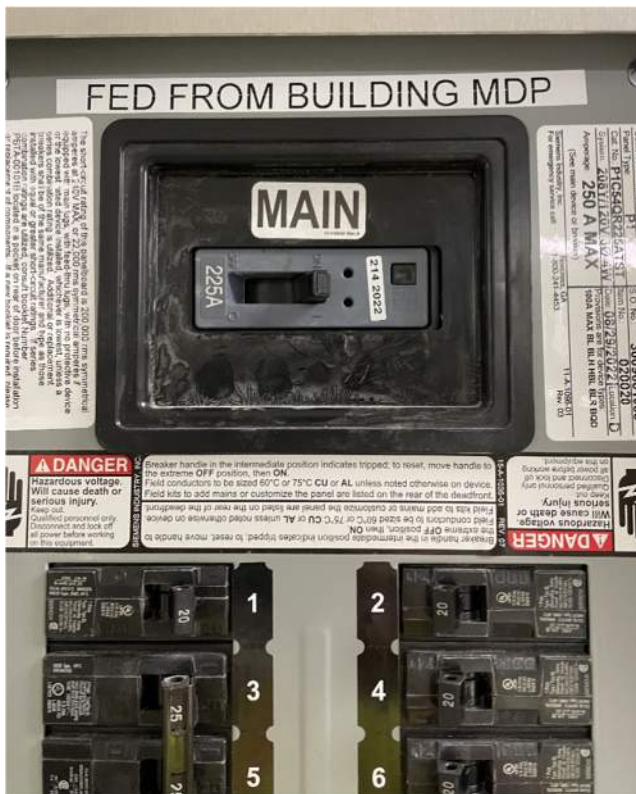
1. PROVIDE GFCI RECEPTACLES AS REQUIRED BY NEC 210.8 (B) (2). WHERE RECEPTACLES ARE NOT READILY ACCESSIBLE, PROVIDE GFCI CIRCUIT BREAKERS.

Note from Drawings (above), Kitchen electrical panel

Replace breakers for the circuits that need GFCI protection with GFCI breakers.

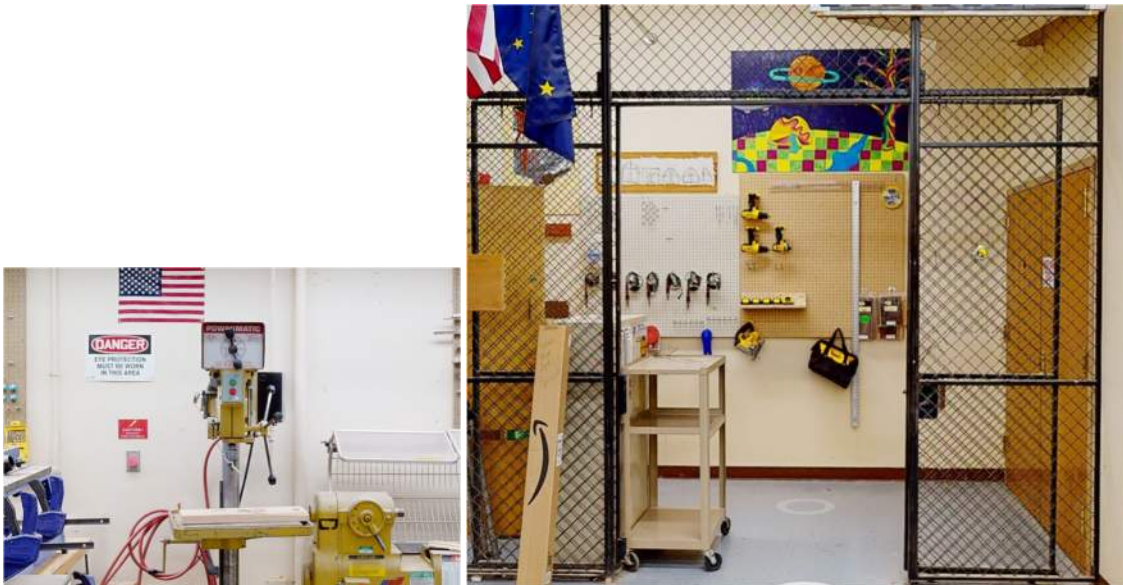
The locations of the existing shutdown buttons difficult to reach in emergency conditions.

Left to Right: Emergency Shutdown Button behind equipment, Gated off area

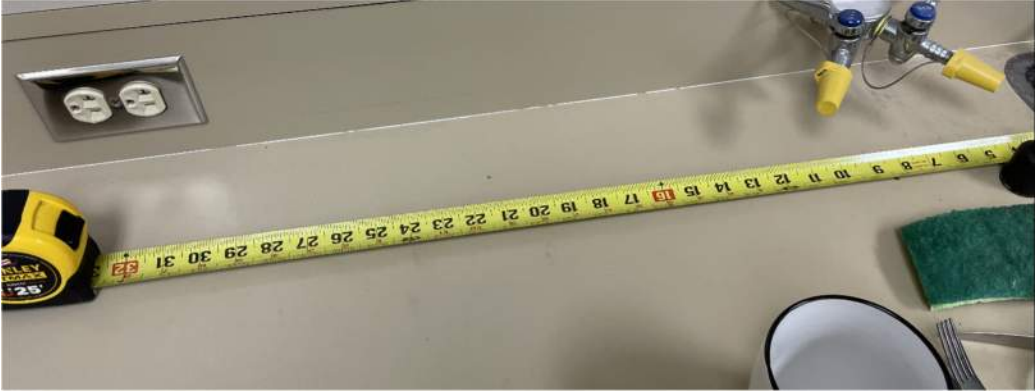
Receptacle near sink above countertop

Replace receptacles located within 6’ of sink edges with GFCI receptacles.

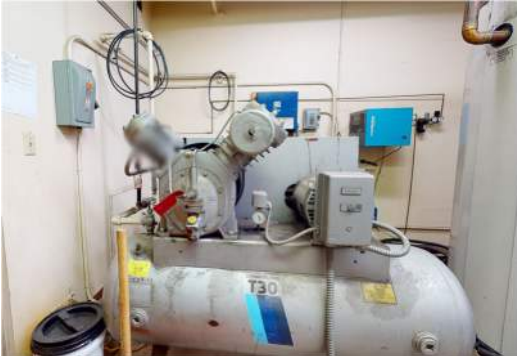
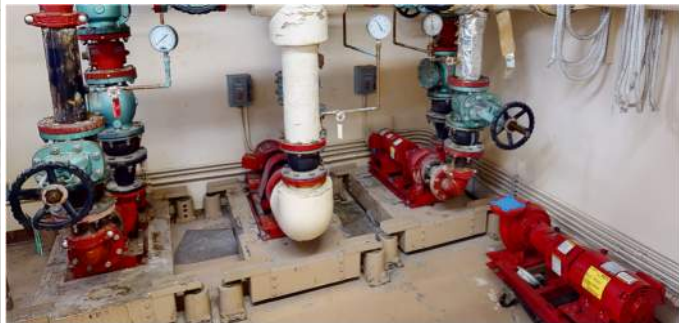
Left to Right: Disconnects blocked by tanks, Disconnects blocked by pumps

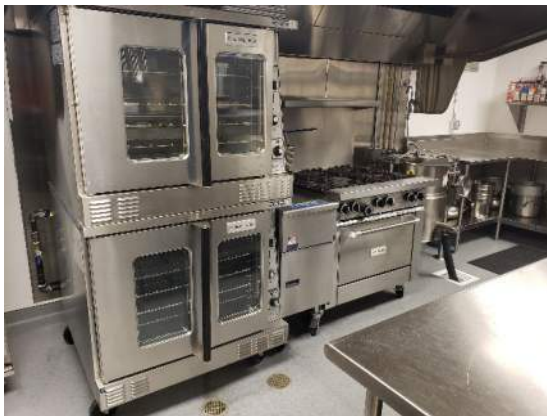
The equipment and exhaust hood are in good condition. The exhaust hood control panel and associated exhaust fan and lights were verified to operate during the survey.

Kitchen Equipment

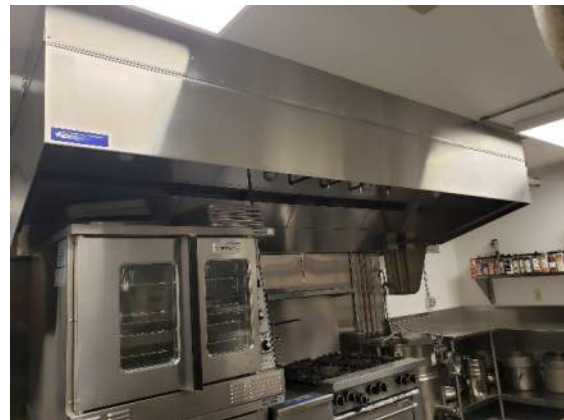
Exhaust Hood

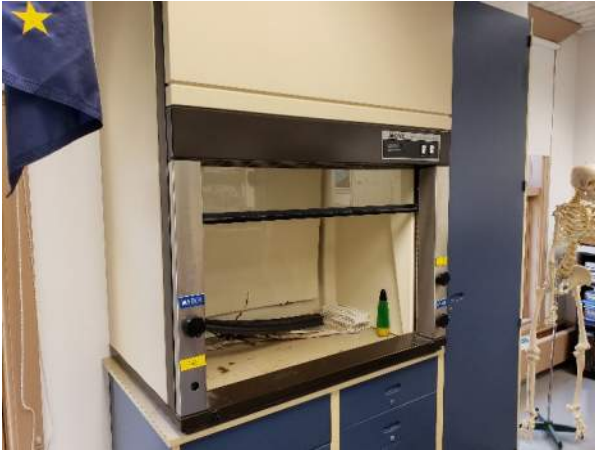
The fume hood exhaust fans and lights were operational. One of the gas knob adjustable handles had been removed. The sash sealed upon closure and the fan was manually enabled with a switch on the front face of the unit. Overall, the unit was in fair condition.

Science Lab Fume Hood

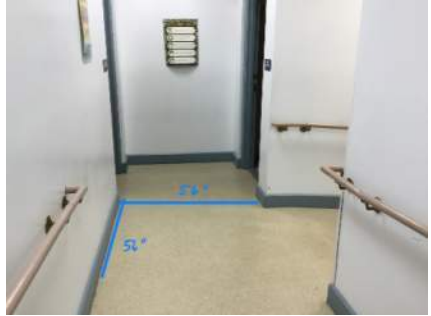
Reference	Accessibility Issue	Comments or Suggestions	Location Identifier	Image
ADA Section 405.7: Landings	Landing at point of ramp direction change (56" x 56") does not meet minimum ADA standards	Modify landing to meet 60" x 60" requirement (Appendix 1)	Top of the ramp leading to the bathrooms and stage/music room

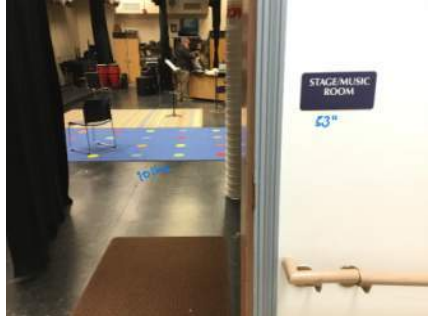
ADA Section 404.2.9: Door and Gate Hardware	Door to the stage/music room requires 10 lbs of force to pull open.	Adjust the door closer arm so the pull weight does not exceed 5 lbs of force. Instructions (Appendix 2)	Door to the stage/music room

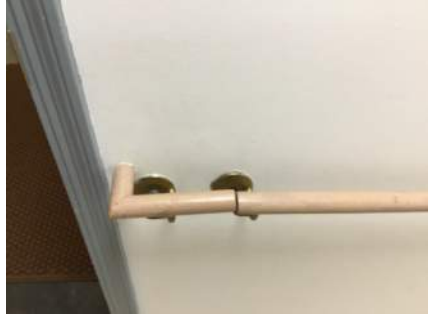
ADA Section 505.3; 505.10: Handrails	Handrail is not continuous	Replace/repair handrail	Handrail leading up to the stage/music room.

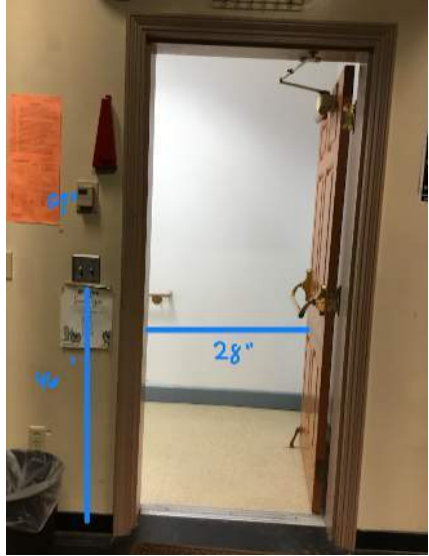
<p>ADA Section 404.2.3: Clear Width</p>	<p>Door width (28") does not meet minimum ADA standards</p>	<p>Increase door width to meet 32" minimum</p>

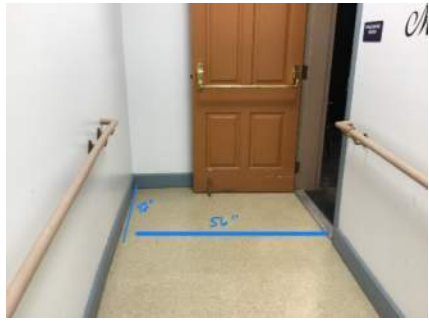
<p>ADA Section 405.7: Landings</p>	<p>Landing at bottom of ramp is too small (56" x 42")</p>	<p>Modify landing to meet 60" x 60" requirement</p>	<p>Landing near the door to the stage/music room</p>

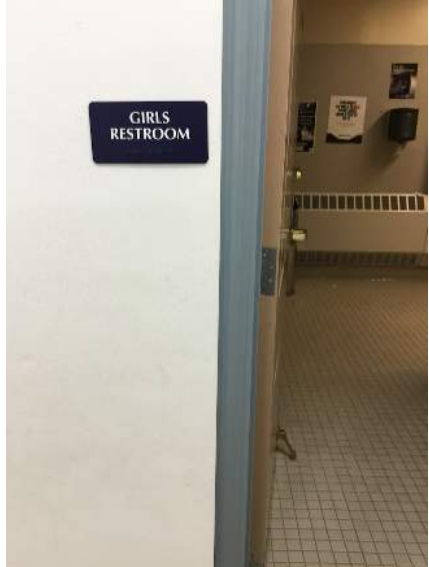
<p>ADA Section 703.4: Signs</p> <p>216.8 Toilet Rooms and Bathing Rooms</p>	<p>Door signage needs to be on latch side of door, not hinge side of door</p> <p>Signs must be provided indicating the location of the nearest accessible toilet room.</p>	<p>Move signage to opposite side of door, maintaining current height (Appendix 3)</p> <p>Add signage indicating the nearest accessible restroom.</p>	<p>Girls restroom near school/music room and main school entrance</p>

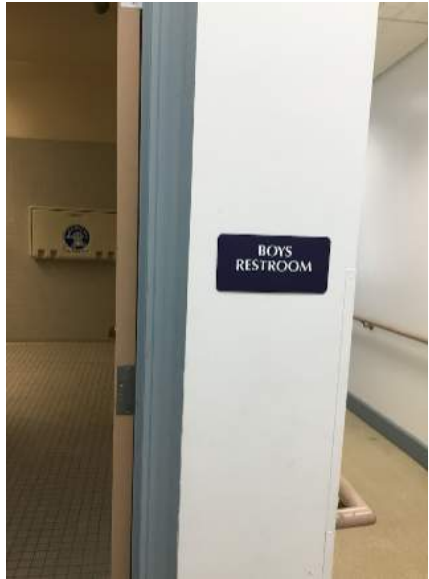
<p>ADA Section 703.4: Signs</p> <p>216.8 Toilet Rooms and Bathing Rooms</p>	<p>Door signage needs to be on latch side of door, not hinge side of door</p> <p>Signs must be provided indicating the location of the nearest accessible toilet room.</p>	<p>Move signage to opposite side of door, maintaining current height</p> <p>Add signage indicating the nearest accessible restroom.</p>	<p>Boys restroom near school/music room and main school entrance</p>

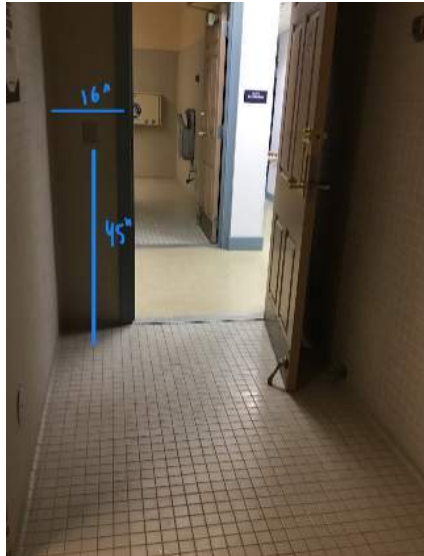
<p>ADA Section 404.2.4.1.a: Maneuvering Clearances at Manual Swinging Doors and Gates</p>	<p>Insufficient horizontal distance between wall and pull side of door (16")</p>	<p>Increase space between wall and pull side of door to 18" while maintaining appropriate door width</p>	<p>Entrance of girls restroom near the stage/music room and main school entrance</p>

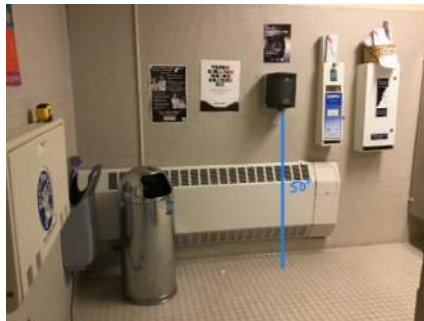
<p>ADA Section 308.2; 308.3: Reach Ranges</p>	<p>Height of operable portion of towel dispenser (50") exceeds maximum ADA standards</p>	<p>Lower towel dispenser so useable portion is a maximum of 48" from the ground</p>	<p>Girls restroom near the stage/music room and main school entrance</p>

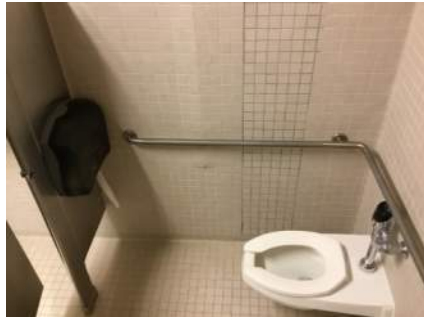
<p>ADA Section 604.9.6: Dispensers</p>	<p>Toilet tissue dispenser located in inaccessible location (on wall opposite toilet)</p>	<p>Move toilet tissue dispenser to side wall adjacent to the toilet, ensuring all ADA standards for height are maintained (Appendix 4)</p>	<p>Main stall of the girls restroom near the stage/music room and main school entrance *(Appendix 10) See clip 604.9 for varying toilet heights by age</p>

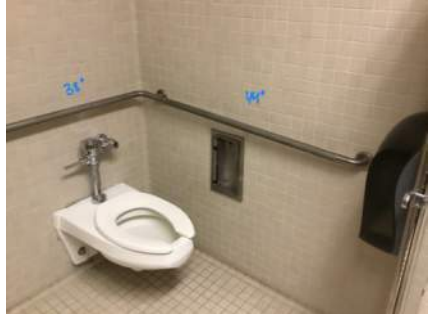
group.	
ADA Section 604.9.6: Dispensers	Toilet tissue dispenser located in inaccessible location (on wall opposite toilet)	Move toilet tissue dispenser to side wall adjacent to the toilet, ensuring all ADA standards for height are maintained	Main stall of the girls restroom near the stage/music room and main school entrance

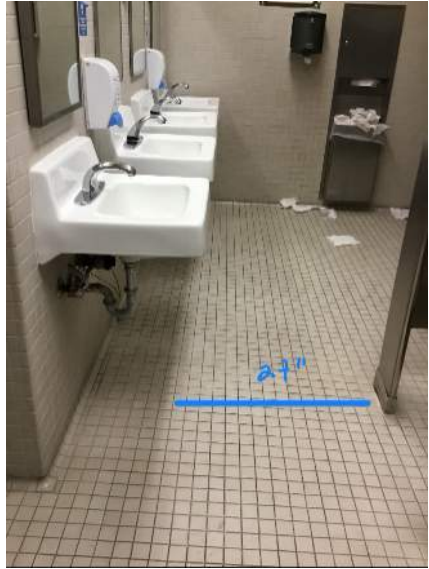
ADA Section 403.5.1: Clear width	Width of path of travel (27") does not meet ADA minimum standards	A minimum width of 36" is required for path of travel. A narrowing of the path to 32" is permitted for a maximum length of 24". Consider installing sinks which do not project as far into path of travel to ensure a 32" width minimum is maintained	Boys restroom near the stage/music room and main school entrance

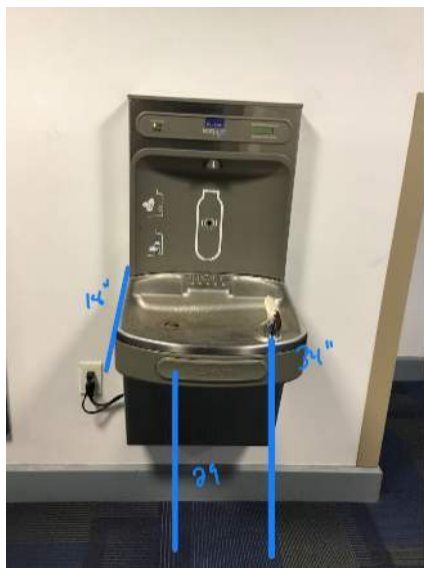
<p>ADA Section 602.1-602.6: Drinking Fountains</p>	<p>This is an ADA compliant water dispenser if the primary users are adults. Drinking fountains primarily used by children ages 12 and younger should have a maximum spout height of 30"</p>	<p>Consider lowering water fountain, pending age of main users</p>	<p>Water fountain near the library</p>

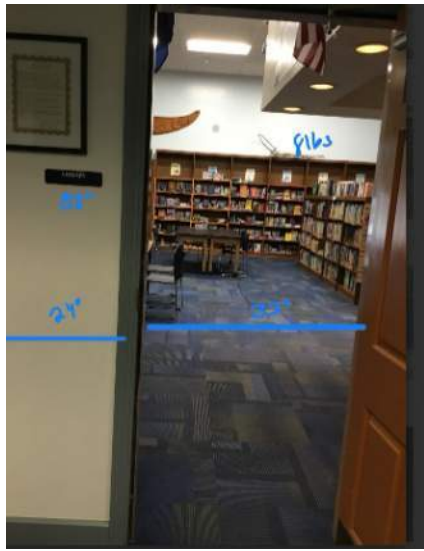
<p>ADA Section 404.2: Door and Gate Hardware</p>	<p>Door requires 8 lbs of force to pull open.</p>	<p>Adjust the door closer arm so the pull weight does not exceed 5 lbs of force.</p>	<p>Main door to the library</p>

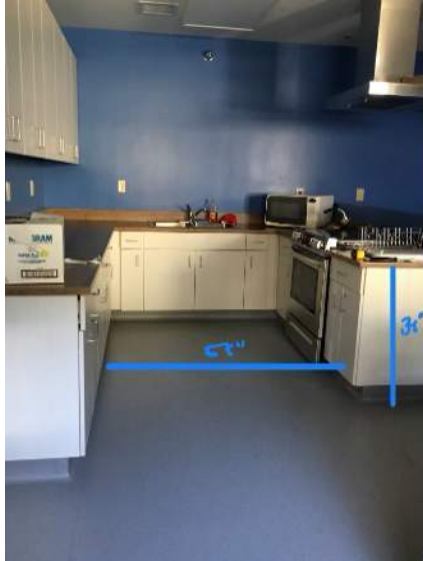
<p>ADA Section 902.3: Built-in Elements; Dining, Counters, and Work Surfaces</p> <p>ADA Section 902.4: Dining Surfaces and Work Surfaces for Children's Use</p> <p>ADA Section 606.2: Lavatories and Sinks. Clear Floor Space</p> <p>ADA Section 804.2: Kitchens and Kitchenettes</p>	<p>Height of all counters exceeds maximum allowance under ADA</p> <p>Clearance between base cabinets is 58"</p> <p>Sink does not provide knee clearance</p>	<p>Provide a counter space with height between 28" - 34" above the finished ground</p> <p>The tops of tables and counters shall be between 26"-30" if the kitchen is being used by children.</p> <p>In U-Shaped kitchens, clearance between all base cabinets should be 60 in. minimum</p> <p>Provide 24" of knee clearance from the floor.</p>	<p>Student use kitchen areas behind the cafeteria</p>

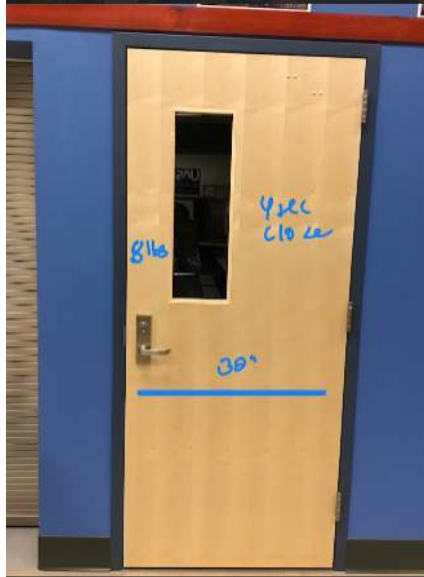
<p>ADA Section 404.2: Door and Gate Hardware</p>	<p>Door requires 8 lbs of force to pull open.</p>	<p>Adjust the door closer arm so the pull weight does not exceed 5 lbs of force.</p>	<p>Door to the student use kitchen areas behind the main cafeteria</p>

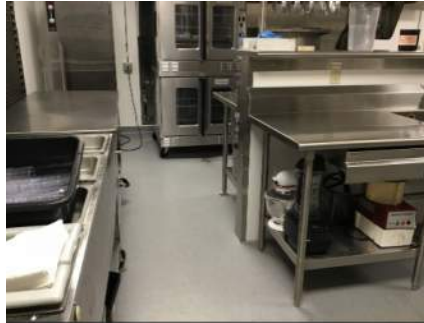
<p>ADA Section 403.5.1: Clear width</p>	<p>Obstacles present obstructing clear walkway path and limiting accessible pathway width to less than minimum ADA allowance</p>	<p>Remove or relocate items to ensure a 36" wide minimum clear path is maintained along the route of travel.</p> <p>Exception: Note that the clear width can reduce to 32" for a maximum length of 24 inches provided that reduced width segments are separated by segments that are 48 inches long and 36 inches wide minimum.</p>	<p>Commercial kitchen</p>

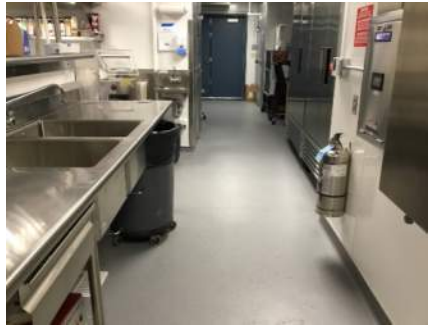
<p>ADA Section 606.2.7: Lavatories and Sinks</p>	<p>No sinks provide roll under options</p>	<p>Provide one sink which has 11"-25" of knee depth below the sink (Appendix 5)</p>	<p>Commercial kitchen</p>

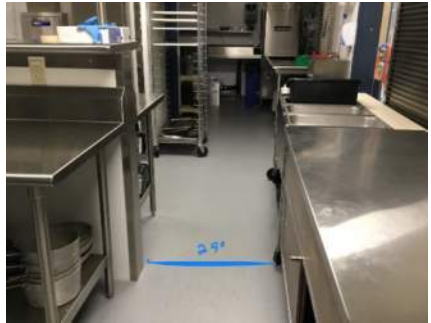
<p>ADA Section 403.5.1: Clear width</p>	<p>Obstacles present obstructing clear walkway path and limiting accessible pathway width to less than minimum ADA allowance</p>	<p>Remove or relocate items to ensure a 36" wide minimum clear path is maintained along the route of travel.</p> <p>Exception: Note that the clear width can reduce to 32" for a maximum length of 24 inches provided that reduced width segments are separated by segments that are 48 inches long and 36 inches wide minimum.</p>	<p>Commercial kitchen</p>

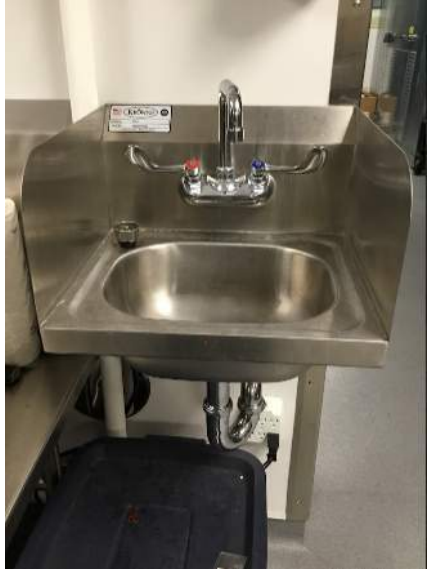
<p>ADA Section 606.2.7: Lavatories and Sinks</p>	<p>Storage obstructing accessible, roll under sink</p>	<p>Relocate storage box to ensure appropriate knee and foot clearance distance under sink</p>	<p>Commercial kitchen</p>

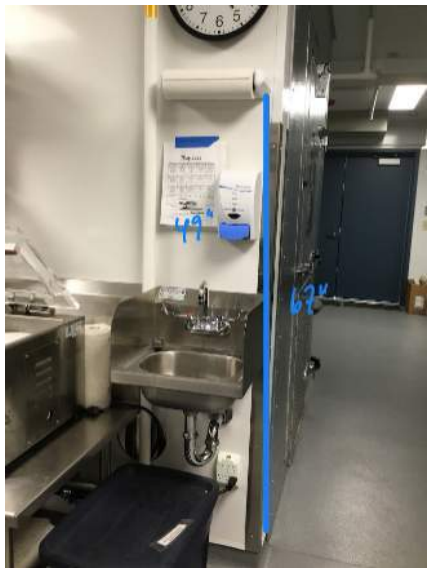
<p>ADA Section 308.3: Reach Ranges</p>	<p>Height of operable portion of towel dispenser (67") exceeds maximum ADA standards</p>	<p>Lower towel dispenser so that operable portion is a maximum of 48" from the ground</p>	<p>Commercial kitchen</p>

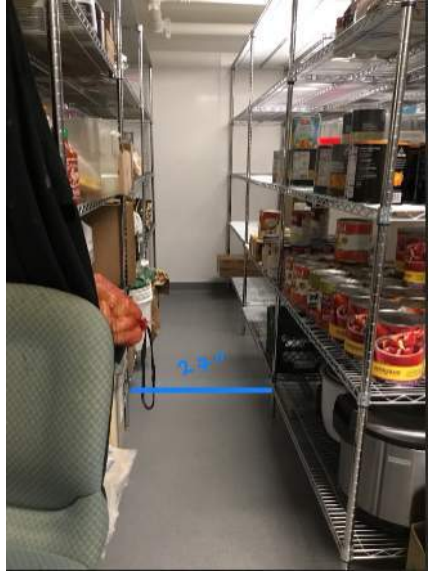
<p>ADA Section 403.5.1: Clear width</p>	<p>Obstacles present obstructing clear walkway path and limiting accessible pathway width to less than minimum ADA allowance</p>	<p>Remove or relocate items to ensure a 36" wide minimum clear path is maintained along the route of travel.</p> <p>Exception: Note that the clear width can reduce to 32" for a maximum length of 24 inches provided that reduced width segments are separated by segments that are 48 inches long and 36 inches wide minimum.</p>	<p>Commercial kitchen</p>

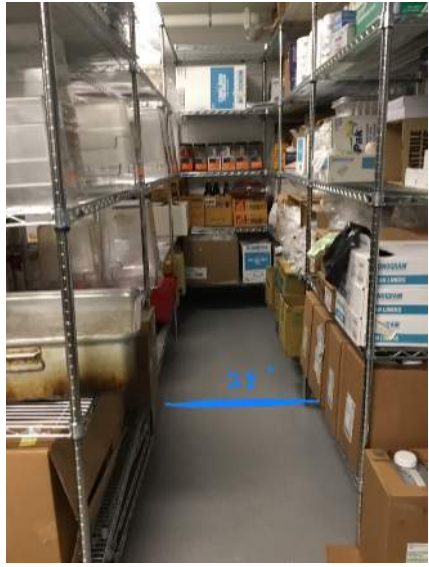
<p>ADA Section 403.5.1: Clear width</p>	<p>Obstacles present obstructing clear walkway path and limiting accessible pathway width to less than minimum ADA allowance</p>	<p>Remove or relocate items to ensure a 36" wide minimum clear path is maintained along the route of travel.</p> <p>Exception: Note that the clear width can reduce to 32" for a maximum length of 24 inches provided that reduced width segments are separated by segments that are 48 inches long and 36 inches wide minimum.</p>	<p>Commercial kitchen</p>

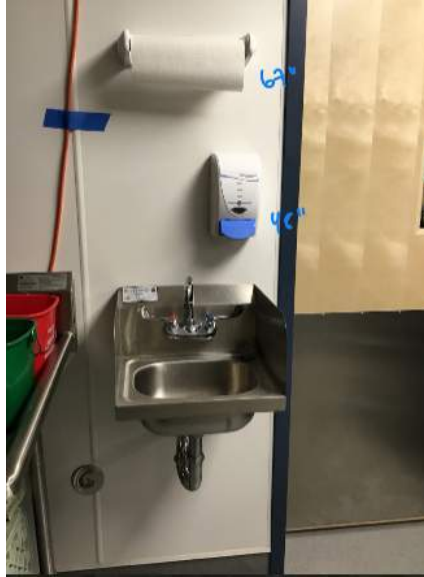
<p>ADA Section 308.3: Reach Ranges</p>	<p>Height of operable portion of towel dispenser (67") exceeds maximum ADA standards</p>	<p>Lower towel dispenser so that operable portion is a maximum of 48" from the ground</p>	<p>Commercial kitchen</p>

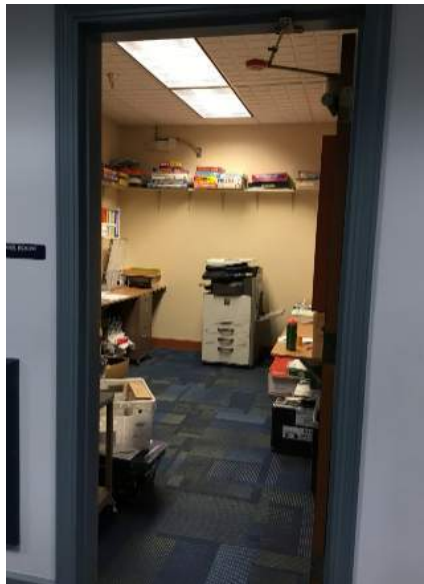
<p>ADA Section 603.2.1/304: Turning Space</p>	<p>Not enough clear floor space to allow for ADA-compliant turning radius</p>	<p>Ensure floor space is cleared to provide for a 60" diameter circle or T-shaped space for turning</p>	<p>Mail room near main entrance</p>

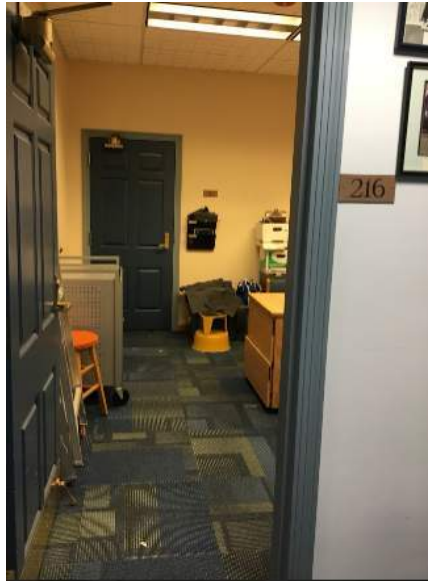
<p>ADA Section 403.5.1: Clear width</p>	<p>Obstacles present obstructing clear walkway path and limiting accessible pathway width to less than minimum ADA allowance</p>	<p>Remove or relocate items to ensure a 36" wide minimum clear path is maintained along the route of travel.</p> <p>Exception: Note that the clear width can reduce to 32" for a maximum length of 24 inches provided that reduced width segments are separated by segments that are 48 inches long and 36 inches wide minimum.</p>	<p>Room 216</p>

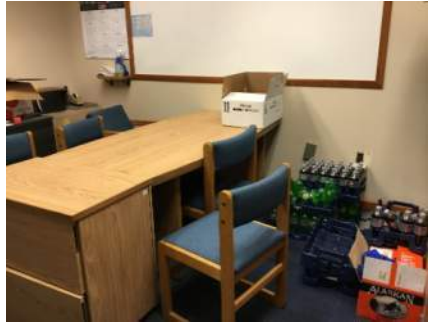
<p>ADA Section 403.5.1: Clear width</p>	<p>Obstacles present obstructing clear walkway path and limiting accessible pathway width to less than minimum ADA allowance</p>	<p>Remove or relocate items to ensure a 36" wide minimum clear path is maintained along the route of travel.</p> <p>Exception: Note that the clear width can reduce to 32" for a maximum length of 24 inches provided that reduced width segments are separated by segments that are 48 inches long and 36 inches wide minimum.</p>	<p>Room 216</p>

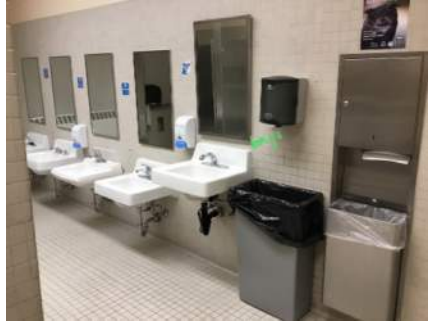
<p>ADA Section 213.3.4: Sinks</p>	<p>Exposed plumbing pipes under sink</p>	<p>Place covering over exposed pipes at the accessible sink to protect against knee contact</p>	<p>Boys bathroom near 5th grade classrooms</p>
