CONDITION ASSESSMENT REPORT

November
2023

SKAGWAY K-12 SCHOOL FACILITY CONDITION SURVEY

**MUNICIPALITY OF
SKAGWAY BOROUGH**

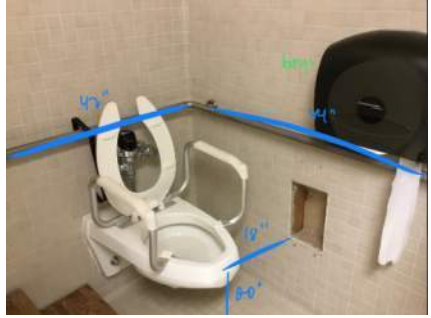
<p>ADA Section 604.7: Dispensers</p>	<p>Toilet tissue dispenser located above grab bar.</p> <p>When toilet paper dispensers are installed above the grab bar, the outlet of the toilet paper dispenser must be 48" maximum above the finish floor and the top of the gripping surface of the grab bar must be 33-36" maximum above the finish floor.</p>	<p>Move toilet tissue dispenser so the the toilet paper outlet is a maximum height of 48" above the finish floor.</p> <p>Maintaining at least 2" between the top gripping surface of the grab bar and the toilet paper dispenser outlet.</p>	<p>Boys bathroom near 5th grade classrooms</p>

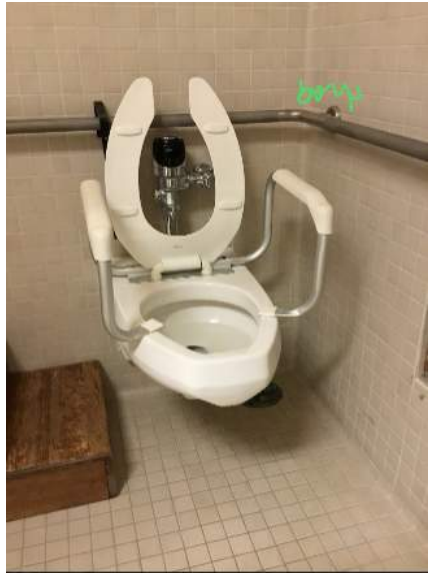
<p>ADA Section 604.5: Grab bars</p>	<p>Grab bars attached to toilet are redundant when appropriate grab bars are placed around toilet.</p>	<p>Remove grab bars attached to toilet as they may provide a barrier to a lateral transfer</p>	<p>Boys bathroom near 5th grade classrooms</p>

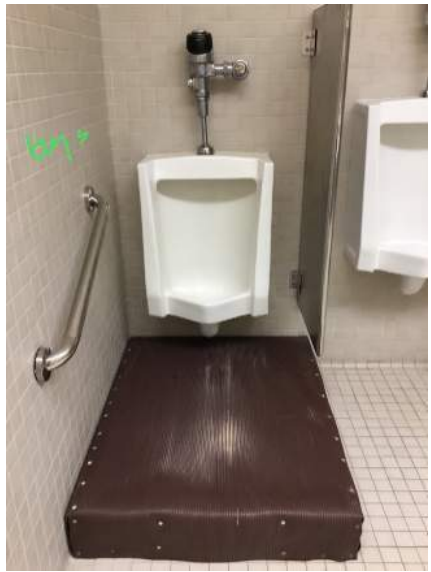
<p>ADA Section 605.2: Urinals height and depth</p>	<p>Presence of step-up platform decreases the accessibility of the urinal</p>	<p>Ensure height of accessible urinal has a rim with a maximum height of 17" above the finished floor and remove the platform (Appendix 6)</p>	<p>Boys bathroom near 5th grade classrooms</p>

97	Architecture - ADA		11.181 Other Repairs/Replacement/Demolition (Estimate)	ADA report (Attachment B) Page 17	Multiple	HLS	ADA Section 604.5: Grab bars; ADA Section 213.3.4: Sinks; ADA Section 605.2: Urinals height and depth	0	Bathrooms: boys bathroom near 5th grade classroom. Remove grab bars attached to toilet. Cover exposed pipes at accessible sink to protect knees against contact. In girls' locker room replace toilet with one that has flush on 'open' side. Move toilet tissue dispensers in 5 bathrooms so the the toilet paper outlet is a maximum height of 48" above the finish floor and maintaining at least 2' between the top gripping surface of the grab bar and the toilet paper dispenser outlet (ADA report page 6,7,16,18,24). In girls restroom near the stage/music room and main school entrance, and in commercial kitchen, lower towel dispenser so that operable portion is a maximum of 48" from the ground. Ensure height of accessible urinal has a rim with a maximum height of 17" above the finished floor and remove the platform (Appendix 6).	\$9,000	\$189,774	Misc

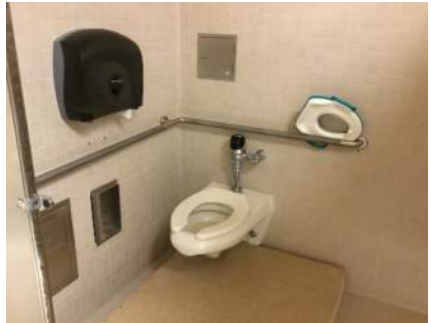
<p>ADA Section 604.7: Dispensers</p>	<p>Toilet tissue dispenser located above grab bar.</p> <p>When toilet paper dispensers are installed above the grab bar, the outlet of the toilet paper dispenser must be 48" maximum above the finish floor and the top of the gripping surface of the grab bar must be 33 -36" maximum above the finish floor.</p>	<p>Move toilet tissue dispenser so the toilet paper outlet is a maximum height of 48" above the finish floor</p>	<p>Boys bathroom near 5th grade classrooms</p>

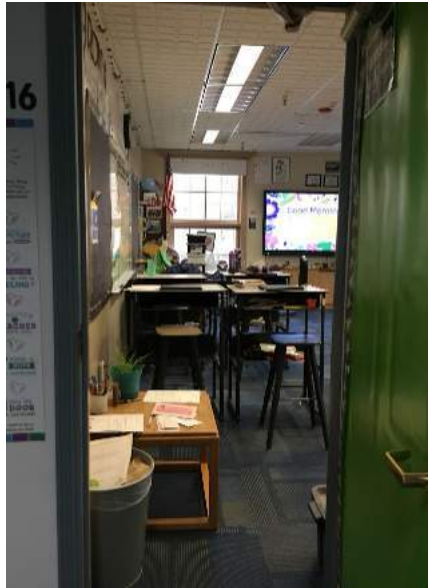
<p>ADA Section 403.5.1: Clear width</p>	<p>Obstacles present obstructing clear walkway path and limiting accessible pathway width to less than minimum ADA allowance</p>	<p>Remove or relocate items in front of the doorway to ensure a 36" wide minimum clear path is maintained along the route of travel.</p> <p>Exception: Note that the clear width can reduce to 32" for a maximum length of 24 inches provided that reduced width segments are separated by segments that are 48 inches long and 36 inches wide minimum.</p>	<p>Room 316</p>

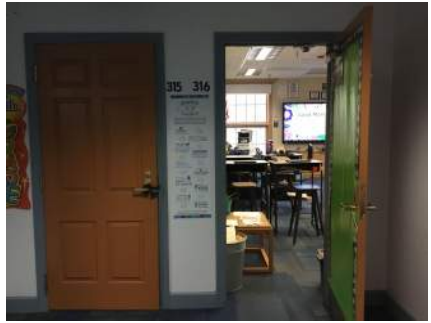
<p>ADA Section 703.4: Signs</p>	<p>Doors signs do not have raised characters or braille lettering</p>	<p>Door signage needs to have raised characters and braille lettering. When replacing the signs, ensure the new ones are placed between 48"-60" above the ground. The 48" minimum should be measured from the lowest tactile character and the 60" maximum should be measured from the highest tactile character.</p>	<p>Classroom Signs (General) - Using room 315 and 316 as an example</p>

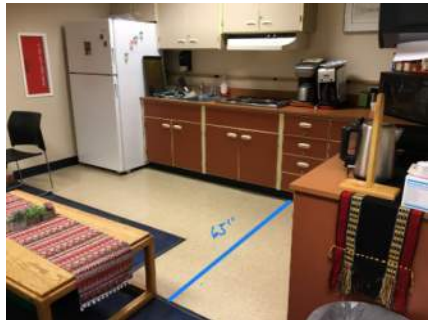
<p>ADA Section 308.3: Reach Ranges</p>	<p>Height of operable portion of freezer exceeds maximum ADA standards</p>	<p>Consider replacement of fridge/freezer with one that has freezer drawer on bottom</p>	<p>Teacher's lounge</p>

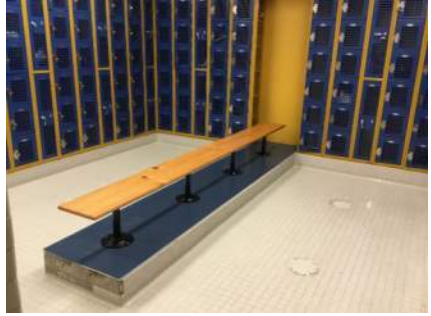
<p>ADA Section 222/803: Locker Rooms 903: Benches</p>	<p>Bench obstructs clear floor space and does not allow for sufficient turning radius</p>	<p>Remove bench from center of locker room and install bench which meets minimum ADA requirements (20" deep, 42" long, 17" above finished floor), flush to wall (Appendix 7)</p>	<p>Boys locker room</p>

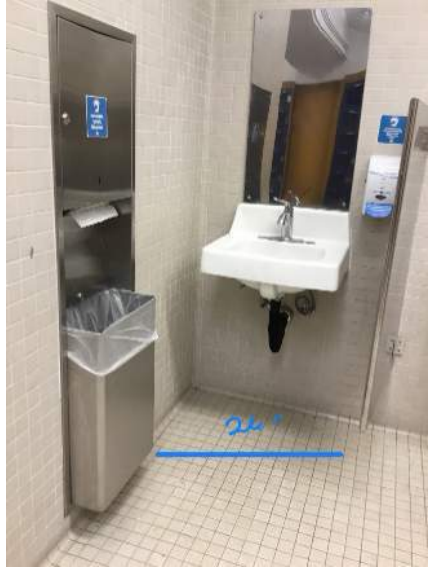
<p>ADA Section 305.3: Clear Floor or Ground Space</p>	<p>Obstacles present are obstructing the 30" x 48" clear floor space at sink and limiting access width to less than minimum ADA allowance</p>	<p>Remove or relocate items to ensure a 30" width minimum is maintained along the route of travel. Consider replacing the garbage can with one which does not protrude into the path of travel in front of sink</p>	<p>Boys locker room</p>

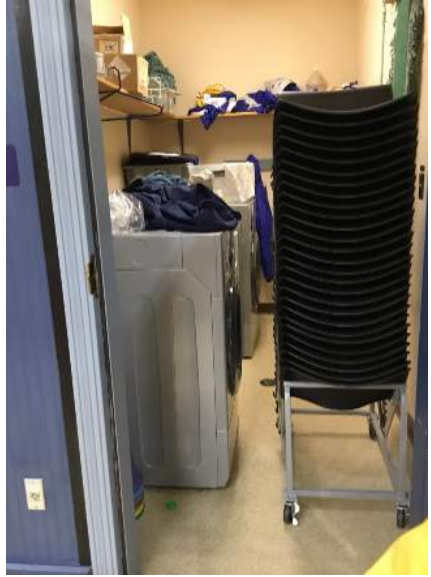
<p>ADA Section 403.5: Clear width 304.3: Turning Space</p>	<p>Obstacles present obstructing clear walkway path and limiting accessible pathway width to less than minimum ADA allowance. Additionally, the lacks lack clear turning space.</p>	<p>Remove or relocate items in front of the doorway to ensure a 36" wide minimum clear access path is maintained along the route of travel.</p> <p>Provide a 60" round or T-shaped turning area.</p>	<p>Gymnasium laundry room</p>

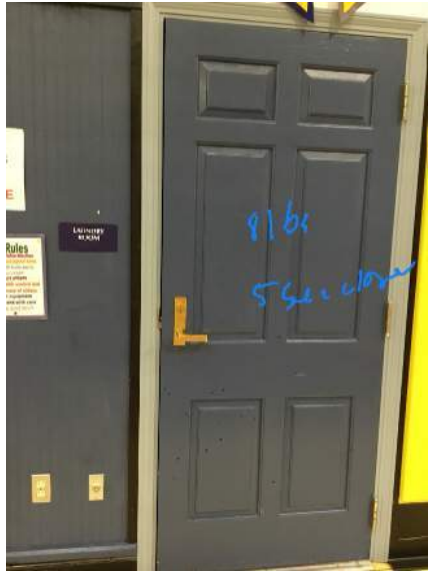
<p>ADA Section 404.2: Door and Gate Hardware</p>	<p>Door requires 8 lbs of force to pull open.</p>	<p>Adjust the door closer arm so the pull weight does not exceed 5 lbs of force.</p>	<p>Entrance to gymnasium laundry room</p>

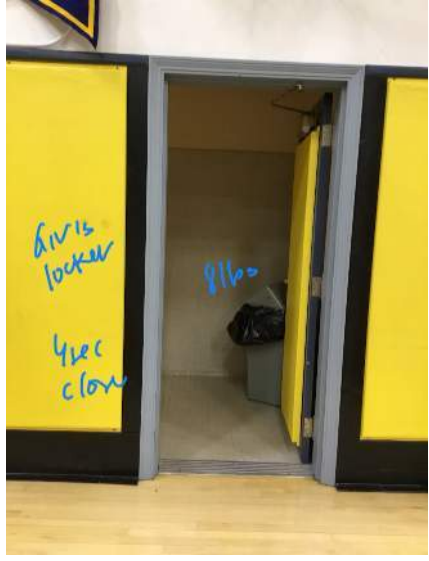
<p>ADA Section 404.2: Door and Gate Hardware</p>	<p>Door requires 8 lbs of force to pull open.</p>	<p>Adjust the door closer arm so the pull weight does not exceed 5 lbs of force.</p>	<p>Entrance to girls locker room</p>

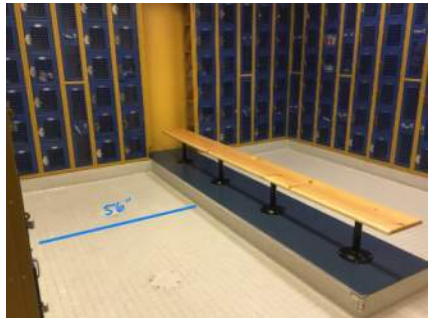
<p>ADA Section 222/803: Locker Rooms 903: Benches</p>	<p>Bench obstructs clear floor space and does not allow for sufficient turning radius</p>	<p>Remove bench from center of locker room and install bench which meets minimum ADA requirements (20" deep, 42" long, 17" above finished floor), flush to wall</p>	<p>Girls locker room</p>

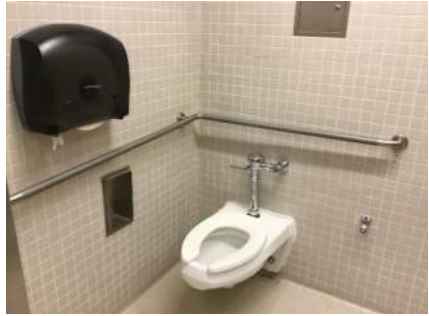
<p>ADA Section 604.7: Dispensers</p> <p>ADA Section 604.8.2: Flush controls</p>	<p>Toilet tissue dispenser located above grab bar</p> <p>Flushing mechanism is located on the "closed", or wall-side, of the toilet</p>	<p>Move toilet tissue dispenser so the the toilet paper outlet is a maximum height of 48" above the finish floor</p> <p>Replace toilet with one which has flushing mechanism on the "open" side</p>	<p>Girls locker room</p>

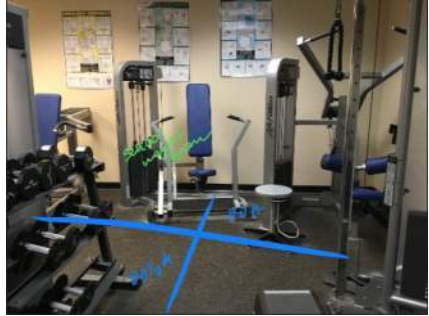
<p>ADA Section 304: Turning Space</p> <p>403.5.1: Clear width circulation paths</p>	<p>Not enough clear floor space to allow for either ADA-compliant corridors or turning radius</p>	<p>Consider removal/relocation of some fixed gym equipment to ensure enough floor space is cleared to provide for a 36" wide pathway to/from the door. Also, consider keeping a 60" diameter circle of floor space free near free-weight area to allow for activity space</p>

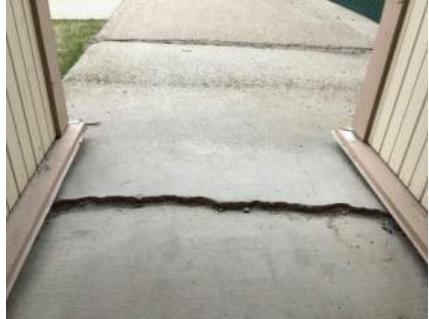
<p>303: Changes in level 302.3: Openings in floor or ground surface</p>	<p>Gaps and/or damage in sidewalk access route exceed 1/2 inch wide and 1/4 inch tall in places</p>	<p>Repair concrete path so that it is level</p>	<p>Back entrance (near playground)</p>

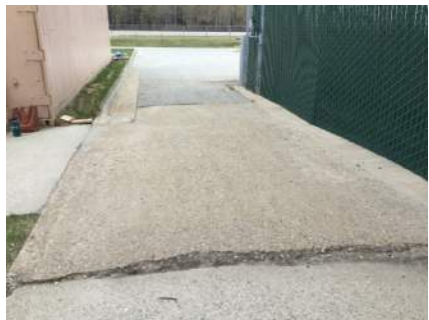
<p>303: Changes in level 302.3: Openings in floor or ground surface</p>	<p>Gaps and/or damage in sidewalk access route exceed 1/2 inch wide and 1/4 inch tall in places</p>	<p>Repair concrete path so that it is level</p>	<p>Back entrance (near playground)</p>

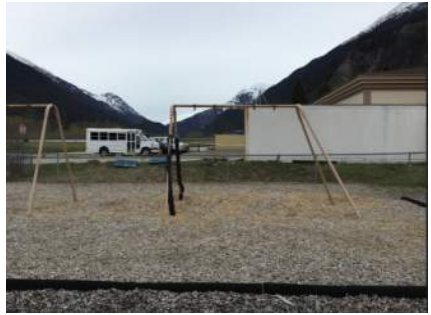
<p>American Society for testing and Materials (ASTM) F 1487, ASTM F 1951-99</p>	<p>Inaccessible surface en route to, an under, swingset</p>	<p>Replace with surface such as rubber tiles or poured in place rubber.</p> <p>Consider accessible swing seat accessory and harness</p>	<p>Playground</p>

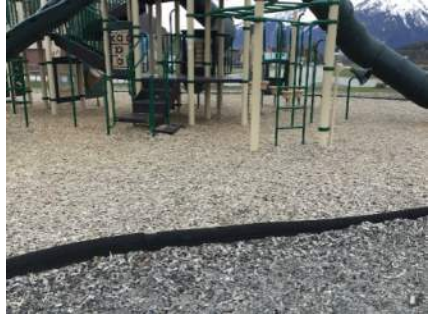
<p>American Society for testing and Materials (ASTM) F 1487, ASTM F 1951-99</p>	<p>Inaccessible access route to play structure.</p>	<p>Replace with surface such as rubber tiles or poured in place rubber. Ensure, specifically, that the transfer step onto the play structure is along an accessible route</p>	<p>Playground</p>

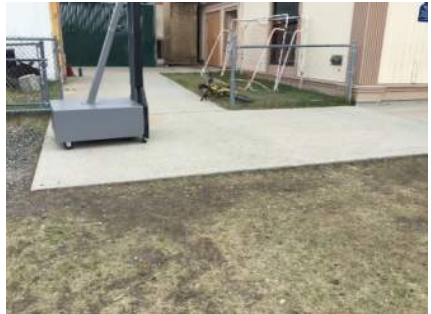
<p>ADA Section 403.5: Clear width</p>	<p>Obstacle present obstructing clear walkway path and limiting accessible pathway width to less than minimum ADA allowance</p>	<p>Remove or relocate item along corridor to ensure a 36" width minimum is maintained along the route of travel</p>	<p>Playground</p>

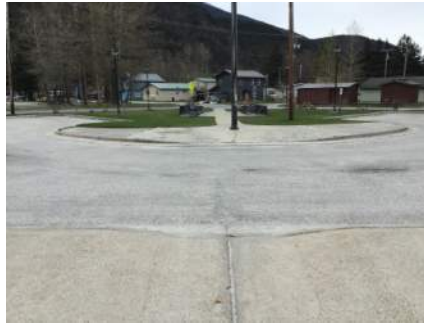
<p>ADA Section 303.4: Curb ramps</p> <p>406.8: Detectable warnings</p>	<p>Curb ramp not marked</p>	<p>Install ADA-complaint, marked curb cut. While an exhaustive list of such requirements is beyond the scope of this report, a helpful introductory guide can be found below³</p>	<p>School entrance</p>

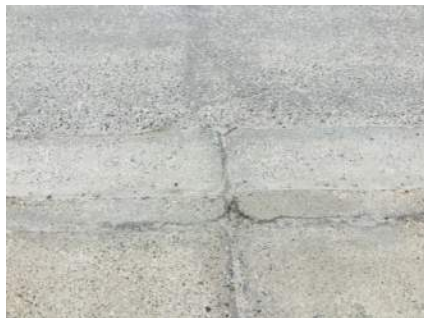
<p>302.3 Openings in Ground Surface</p>	<p>Gaps and/or damage in sidewalk access route exceed ½ inch wide and ¼ inch tall in places</p>	<p>Repair concrete path so it is level</p>	<p>School entrance - Ramp entry point</p>

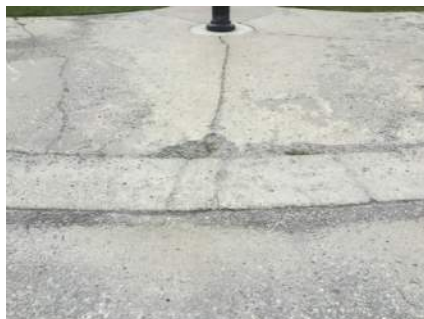
<p>302.3 Openings in Ground Surface</p>	<p>Gaps and/or damage in sidewalk access route exceed ½ inch wide and ¼ inch tall in places</p>	<p>Repair concrete path so it is level</p>	<p>School entrance - Ramp entry point</p>

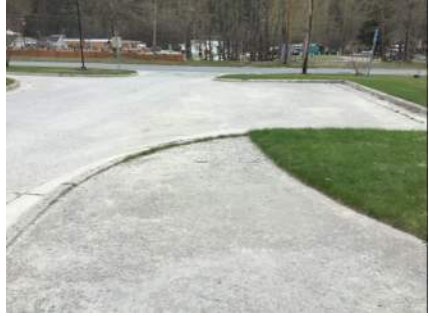
<p>35.151 Construction and alterations: streets, roads, sidewalks, highways</p>	<p>Transitions from the walkway to the street must be flush (level) and free of abrupt level changes</p>	<p>Curb removal or installation of an additional curb ramp at site of abrupt transition</p> <p>Note that changes in level greater than 1/2" blunt shall be ramped and comply with 405 or 406</p>	<p>School entrance - Sidewalk from accessible parking</p>

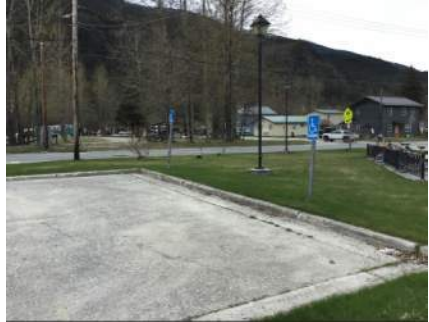
<p>ADA Section 206.2.1: Site Arrival Points to Accessible Routes</p> <p>502: Accessible Parking Spaces</p> <p>502.6: Sign Identification</p> <p>406: Curb Ramps</p>	<p>Accessible parking spaces not clearly marked</p> <p>Van accessible space is not delineated (?)</p> <p>No curb cut provided for access to an accessible path (?)</p>	<p>Line parking lot to clearly delineate the dedicated, marked, accessible spaces⁴</p> <p>Install signs, including van accessible, per ADA Standards</p> <p>Ensure path of travel does not go behind parked vehicles or across the active parking lot.</p> <p>Install a ramped curb cut for access to the accessible path.</p>	<p>Accessible parking at school's entrance</p>

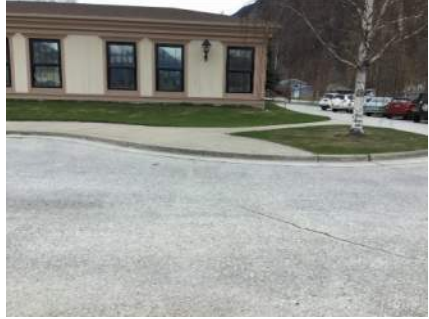
<p>35.151 Construction and alterations: streets, roads, sidewalks, highways</p> <p>206.2.1: Site Arrival Points to Accessible Routes</p>	<p>Transitions from the walkway to the street must be flush (level) and free of abrupt level changes</p>	<p>Curb removal or installation of an additional curb ramp at site of abrupt transition</p>	<p>School entrance</p>

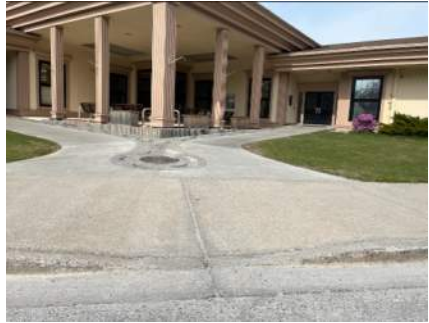
<p>406: Curb Ramps</p>				
<p>ADA Section 206: Accessible Routes</p> <p>303.4: Curb ramps</p> <p>406.8: Detectable warnings</p>	<p>Curb ramp not marked</p>	<p>Install ADA-complaint, marked curb cut. Introductory guide to installation requirements found in above footnote</p> <p>Confirm slope does not exceed maximum allowable slope of 1:12</p> <p>Patch and smooth concrete for smooth transitions</p>	<p>School entrance</p>

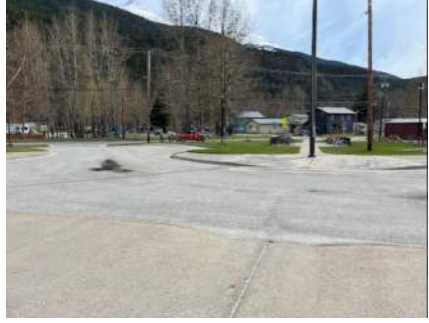
<p>ADA Section 206: Accessible Routes</p> <p>303.4: Curb ramps</p> <p>406.8: Detectable warnings</p>	<p>Curb ramp not marked</p>	<p>Install ADA-complaint, marked curb cut. Introductory guide to installation requirements found in above footnote</p>	<p>School entrance</p>

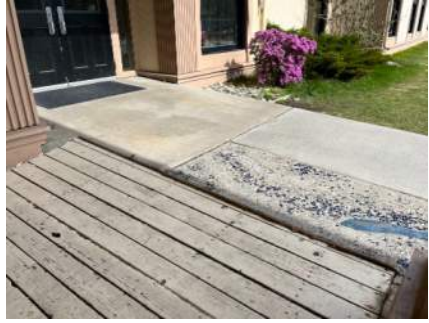
<p>405.2 Slope and Cross Slope</p> <p>405.2: Ramp Slope</p>	<p>Transitions between walkways must be flush (level) and free of abrupt level changes</p>	<p>Changes in level greater than ½" blunt shall be ramped and comply with 405 or 406</p> <p>Bevel the edge of concrete or install a 1:8-1:10 ramped threshold transition from the edge of the concrete to patio deck, ensuring a smooth transition</p>	<p>School entrance - Patio area near main entrance</p>

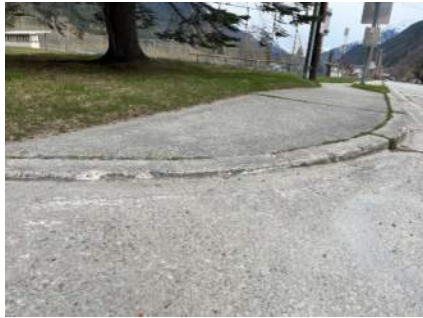
<p>ADA Section 303.4: Ramps</p> <p>406: Curb ramps</p> <p>406.8: Detectable warnings</p>	<p>Curb ramp not marked</p>	<p>Install ADA-complaint, marked curb cut. Introductory guide to installation requirements found in above footnote</p>	<p>Sidewalk near school parking</p>
