Observer	Elliot Wilson, PE	Report Date	6/18/2021
Visit Date/Time	5/10-5/11/21	Client #	
Temperature	-	PDC #	20216JN
Weather	-	Project Name	Skagway Waterfront Master Plan
RE	Skagway Ore Dock – Condition Review / Engineer’s Estimate of Value – Rev 1

INTRODUCTION

PDC Engineers, a RESPEC Company, was hired to conduct an inspection of the ore dock in Skagway, Alaska. The intent of the inspection was to determine the current condition of the dock to aid in the assessment of dock value. The site visit was conducted on May 10 and 11, 2021. Attending the site visit were Elliot Wilson, PE, from PDC; Matt O’Boyle, Harbormaster; and Brad Ryan, Skagway Manager for the Municipality of Skagway.

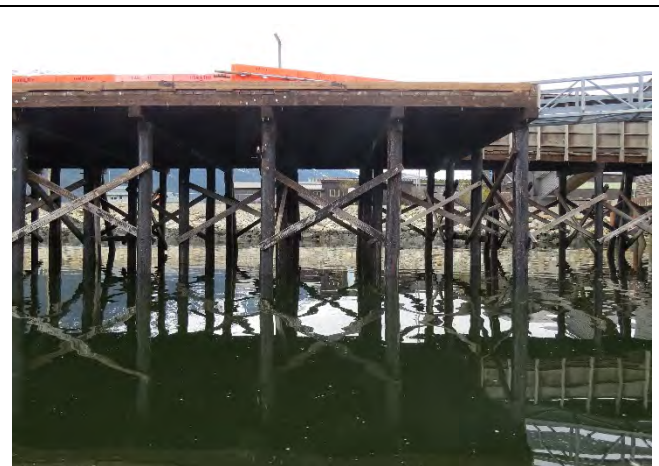
Photo 6- South timber (2 of 2)

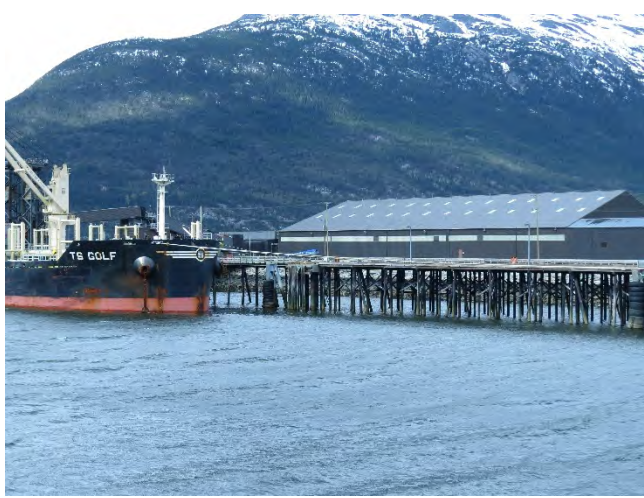
Photo 13- North timber platform, circa 1998 (1 of 3)

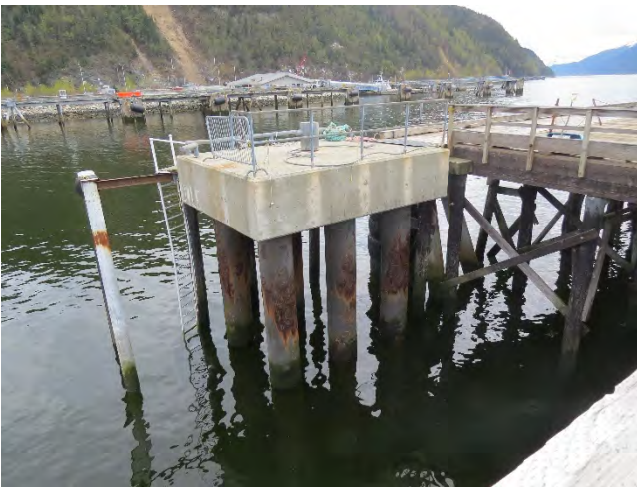
Photo 54 – Dolphin AML2

- Concrete Caps: Concrete on piles appeared to be in fair condition except for one location at Dolphin D4; see Photos 68 & 70.
- Two sets of fenders need repair.
- Numerous ladders accessing dolphins from the waterline were missing rungs.
- Ship Loader – Outside scope of work
- AML Dolphins and Barge Dock (outside scope-of-work)- Galvanized steel, designated as AML1-AML4.
 - Vertical Piles: Bent in numerous locations, and broken at AML2; see Photo 89.

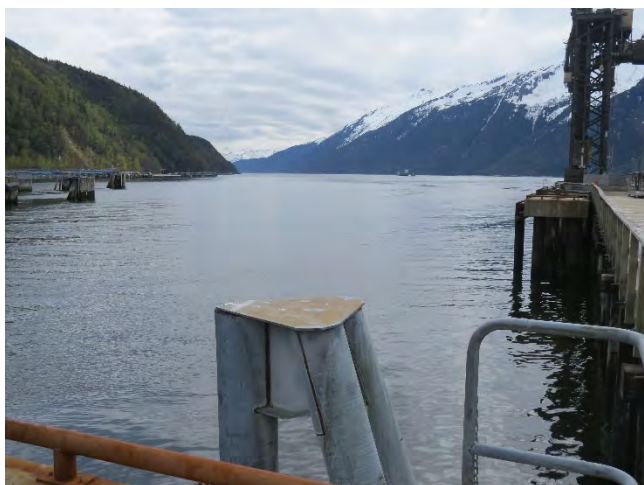
Photo 60 – Dolphin D2 (2 of 2)

- Ore Ship Loader Breasting Dolphins – Concrete-capped, painted steel piles (paint no longer remains), designated as D1 thru D5:
 - Vertical Piles: Deterioration of piles varies, but all piles show significant rusting. Rusting ranges from 0-100% loss in thickness of steel. One location on Dolphin D2 had complete section loss at the -1 to -2-foot elevation; see Photo 60. Other locations showed pitting of 30-50% section loss; see Photos 86 & 87.

The estimated dock value used in for this report assumes that piles in the service platform and the Ore Ship Loader Breasting Dolphins need to be replaced. This damage is located at the -2-foot level of the steel piles; see Photos 60 & 85. These may be isolated locations; however, without additional underwater inspection that cannot be assumed at this time. Further investigation of these piles would enable further refinement of this engineer’s estimate, possibly allowing us to extend the assumed service life of the pier and decrease the expected repair costs assumed in the estimate.

Investigation of piers below the -1-foot level is advisable for the steel piles located on the Ore Ship Loader Breasting Dolphins and the piles located on the Service Platform. PDC recommends underwater investigation of all of these steel piles to verify the service life and the installation of cathodes. Without this additional information, it should be assumed that all the estimated repairs are needed within the next 5 years in order of in-service date of the platform and the dolphins.
